## Lake Lure Dam

Independent Consultant  
Dam Safety Inspection  
*November 2006*

Town of Lake Lure  
North Carolina

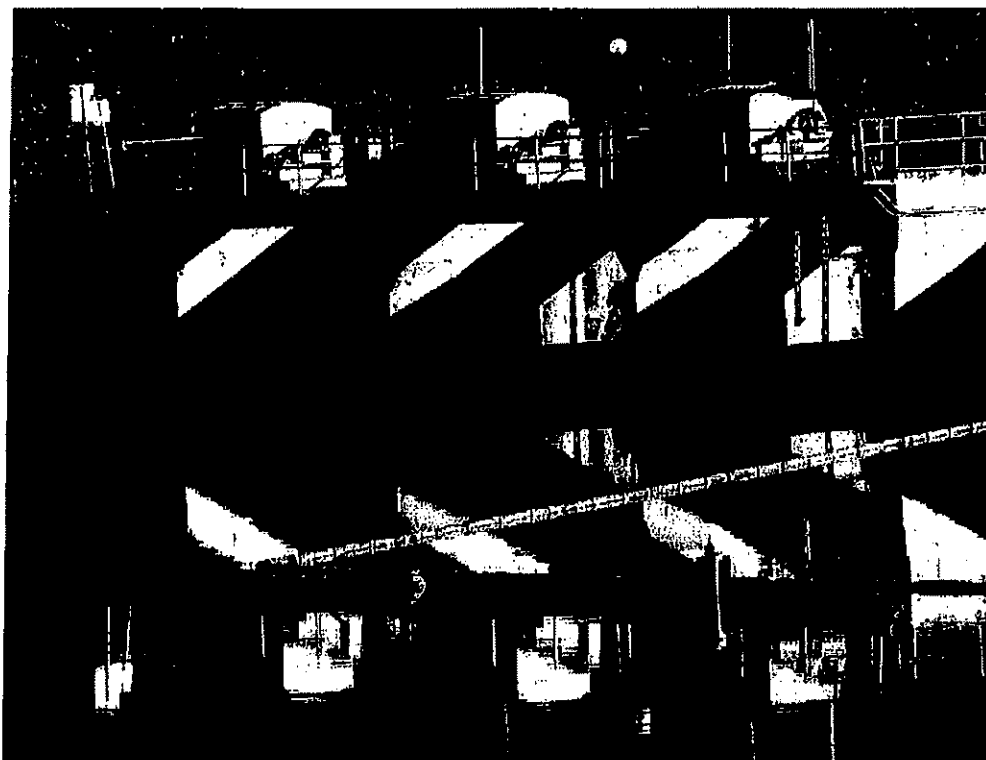
**Photograph 2 Spillway Gates**

The three steel frame radial gates (Photographs 2,6 and7) are in good condition and reported to operate well. Maintenance, including new seals was performed in the mid 1980's. The gates are operated to prevent the elevation of Lake Lure from rising significantly above full pond and to route significant storm events. Each gate has a dedicated hoist with a single lift chain which connects/wye's to cables attached to each side of the base of the gate. The coating of the gates is in good condition. Leakage was occurring, but was not excessive and seemed concentrated at the gate corner where the bottom and side seals intersect. This is a common location for some leakage to occur in this type gate. Some vegetation is growing on steel cross members and should be removed to protect the coating system and facilitate observation.

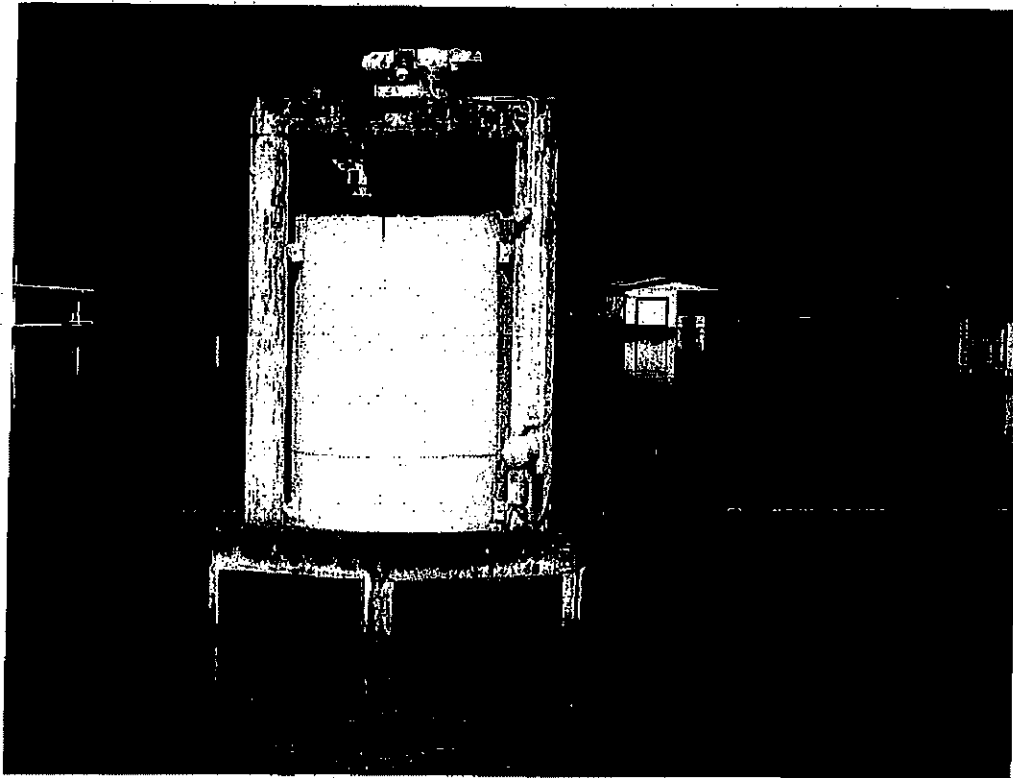
**Photograph 3 Intake and Cylinder Gate**

The intake to the hydroelectric station (Photograph 3) is a vertical concrete tower with a steel cylinder gate. The intake was observed from the bridge deck. No evidence of structural distress was observed. The cylinder gate is not normally operated and there was reportedly difficulty opening it the last time it was closed. The gate reportedly could be closed in an emergency.

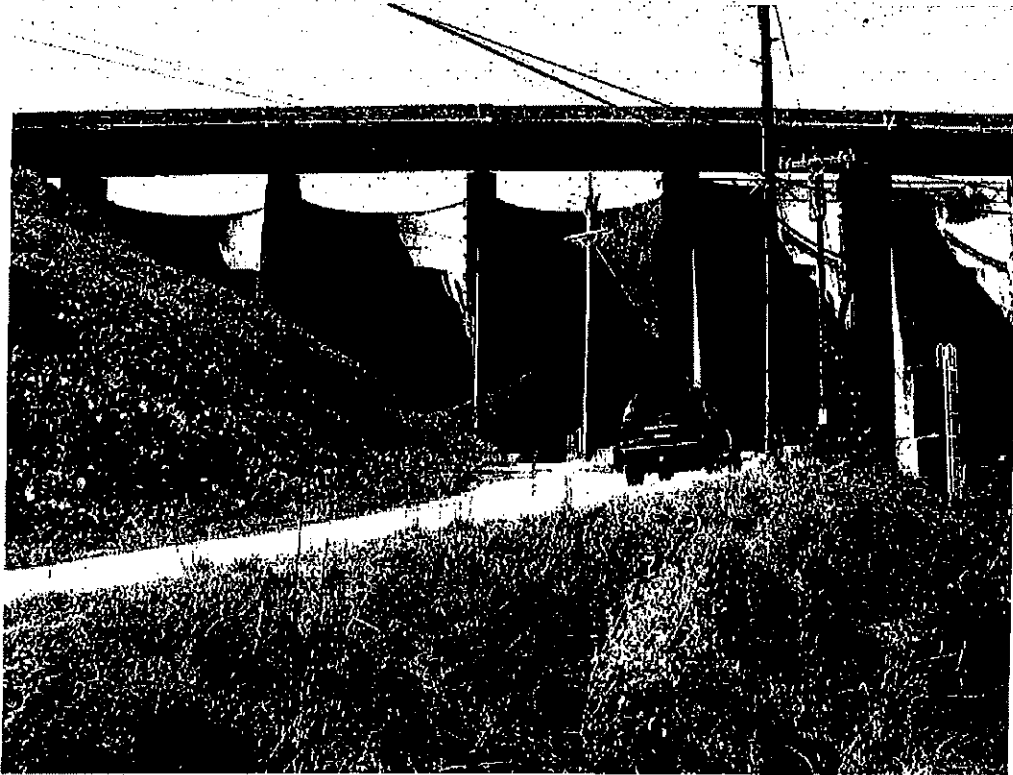
**Photograph 11 Arch and Buttress Sections**

The abutments were covered in very dense vegetation, mostly kudzu (Photographs 11, 12 and 13). There was no evidence of serious erosion or significant seepage at either abutment. The retaining wall along the left (facing downstream) abutment appears in good condition with no evidence of misalignment or other structural defects.

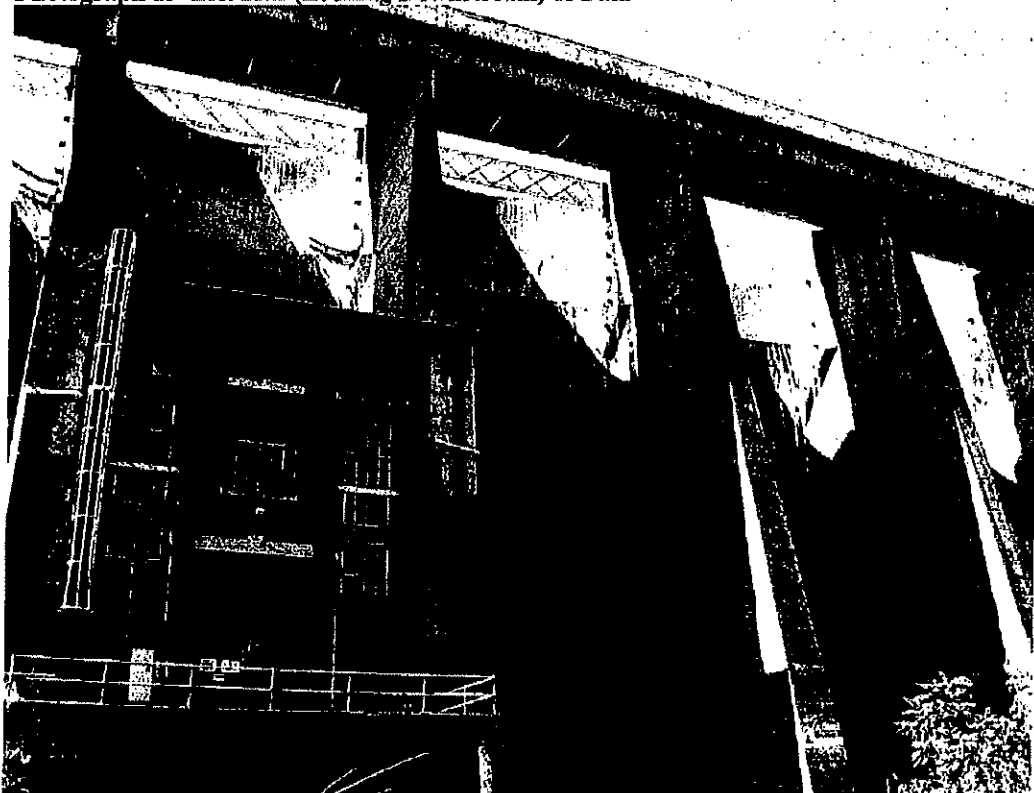
**Photograph 14 Powerhouse**

The powerhouse (Photograph 14) is a concrete and brick masonry structure. It is in good condition for its age and both generating units are operable. The powerhouse is structurally independent from the dam.
