**Notice of Inspection with Maintenance**

RE: **Lake Lure Dam**, State ID No. **RUTHE-003**  
Hazard Potential: High; Rutherford County

# DAM SAFETY INSPECTION REPORT

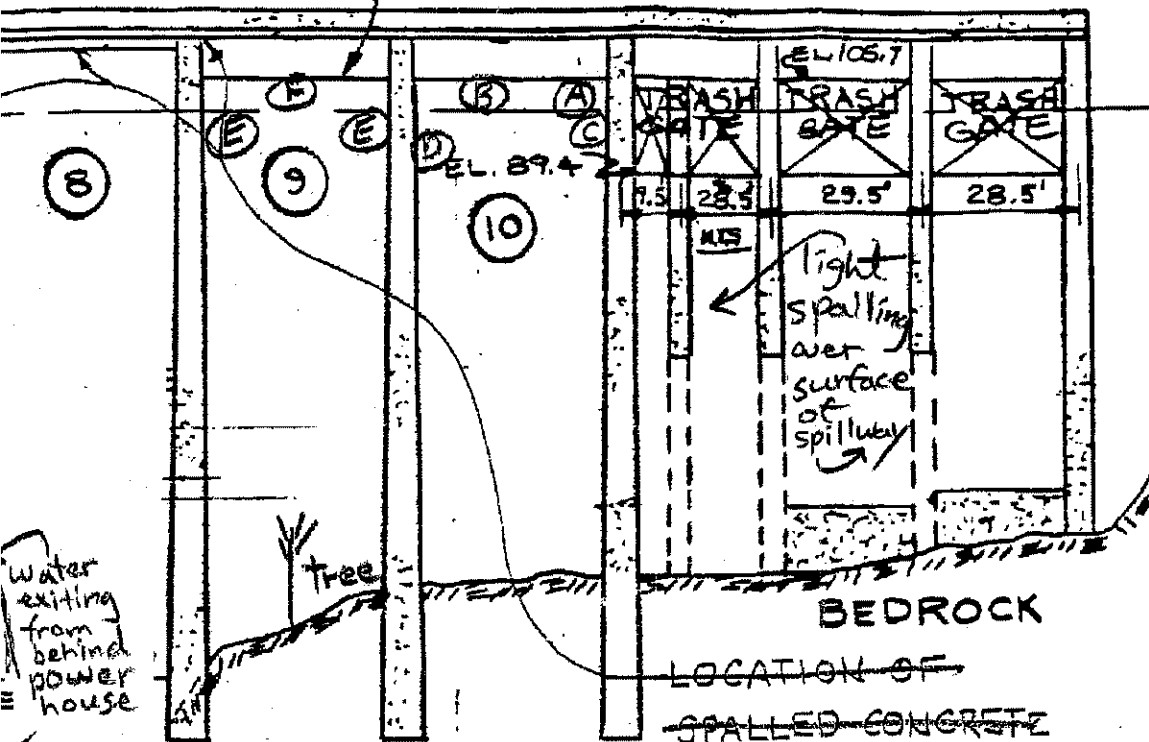
- (A) Seepage in the cond joint from the top is more than previously noted. It is leaking near the left and center of the bay looking downstream. About 1.5 gal/min. at the left. About 2 gal/min in the center.
- (B) Bushes in 2nd joint from the top of the Arch.

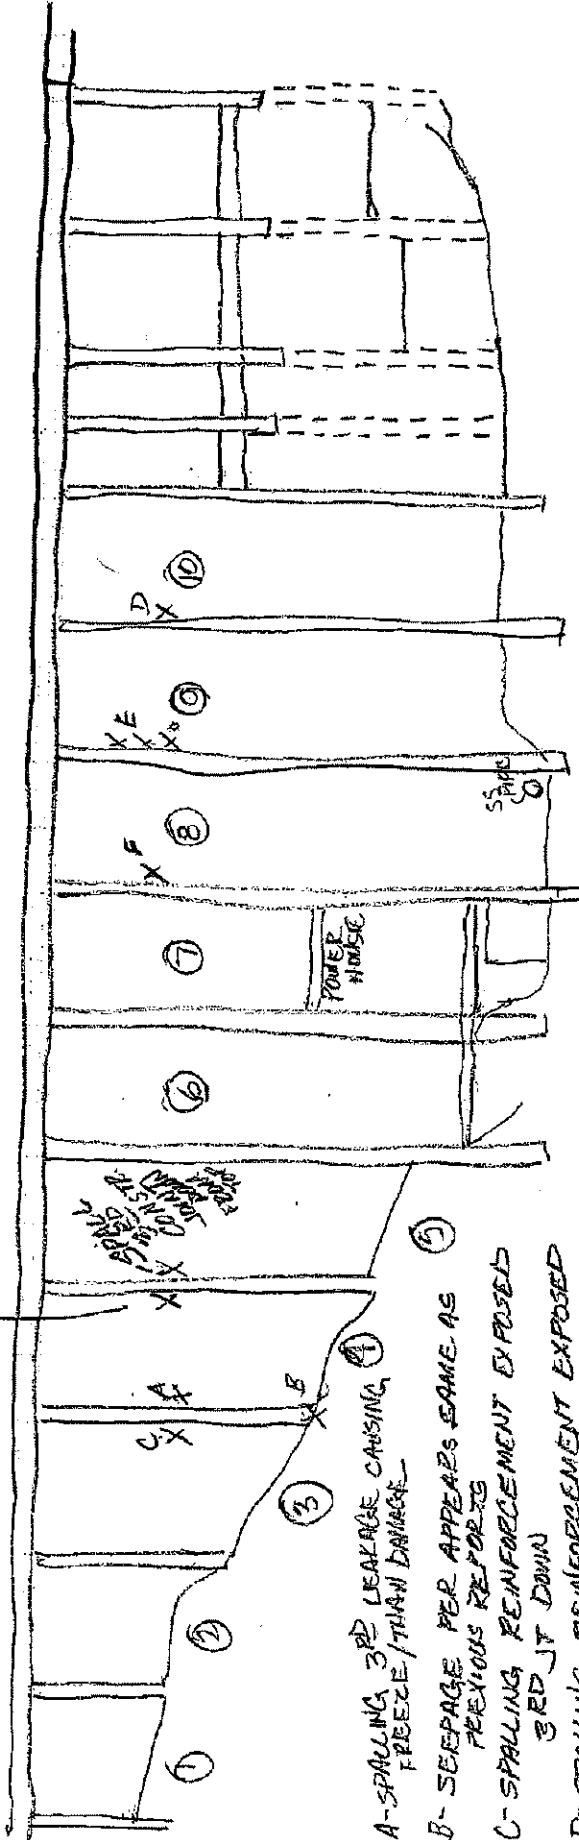
SPILL 3  
3RD DOWN  
FROM TOP

A-SPALLING 3RD LEAKAGE CAUSING  
FREEZE/THAW DAMAGE

B-SEEPAGE PER APPEARS SAME AS  
PREVIOUS REPORTS

C-SPALLING REINFORCEMENT EXPOSED  
3RD JT DOWN

D-SPALLING REINFORCEMENT EXPOSED  
2ND JT DOWN

E-SPALLING TOP DOWN THEN 3RD JT

F-SPALLING BETWEEN 2ND & 3RD JTS
