NORTH CAROLINA DEPARTMENT OF  
ENVIRONMENT AND NATURAL RESOURCES  
DIVISION OF LAND RESOURCES

RE: Lake Lure Dam  
Rutherford County  
RUTHE-003  
Broad River Basin

RE: LUKE LURE DAM - RUTHERFORD COUNTY (003)

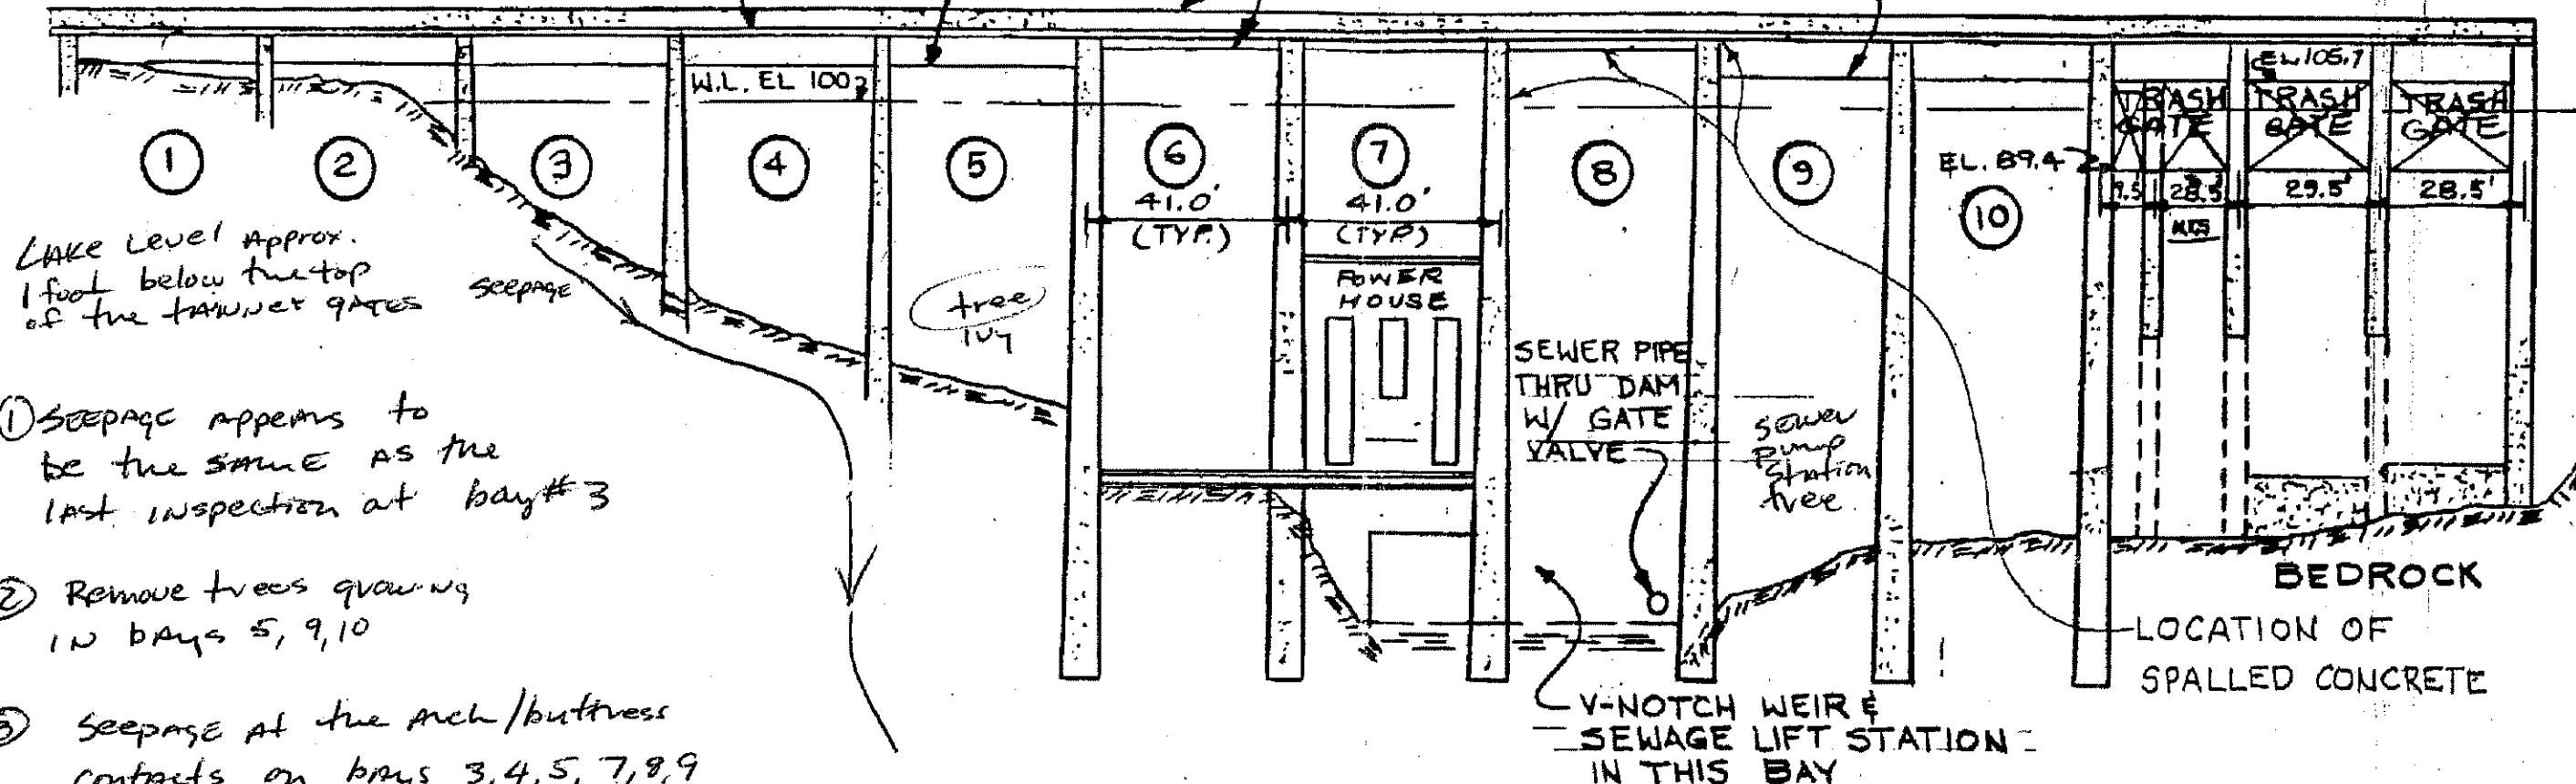
DOWNSTREAM ELEVATION

- ① Seepage appears to be the same as the last inspection at bay #3
- ② Remove trees growing in bays 5, 9, 10
- ③ Seepage at the arch/butress contacts on bays 3, 4, 5, 7, 8, 9
- ④ Seepage at bay #7 behind the turbines appears to have ~~decreased~~ decreased since the last inspection
- ⑤ Spalling has exposed reinforced steel. Concrete is deteriorating over most of the downstream surface

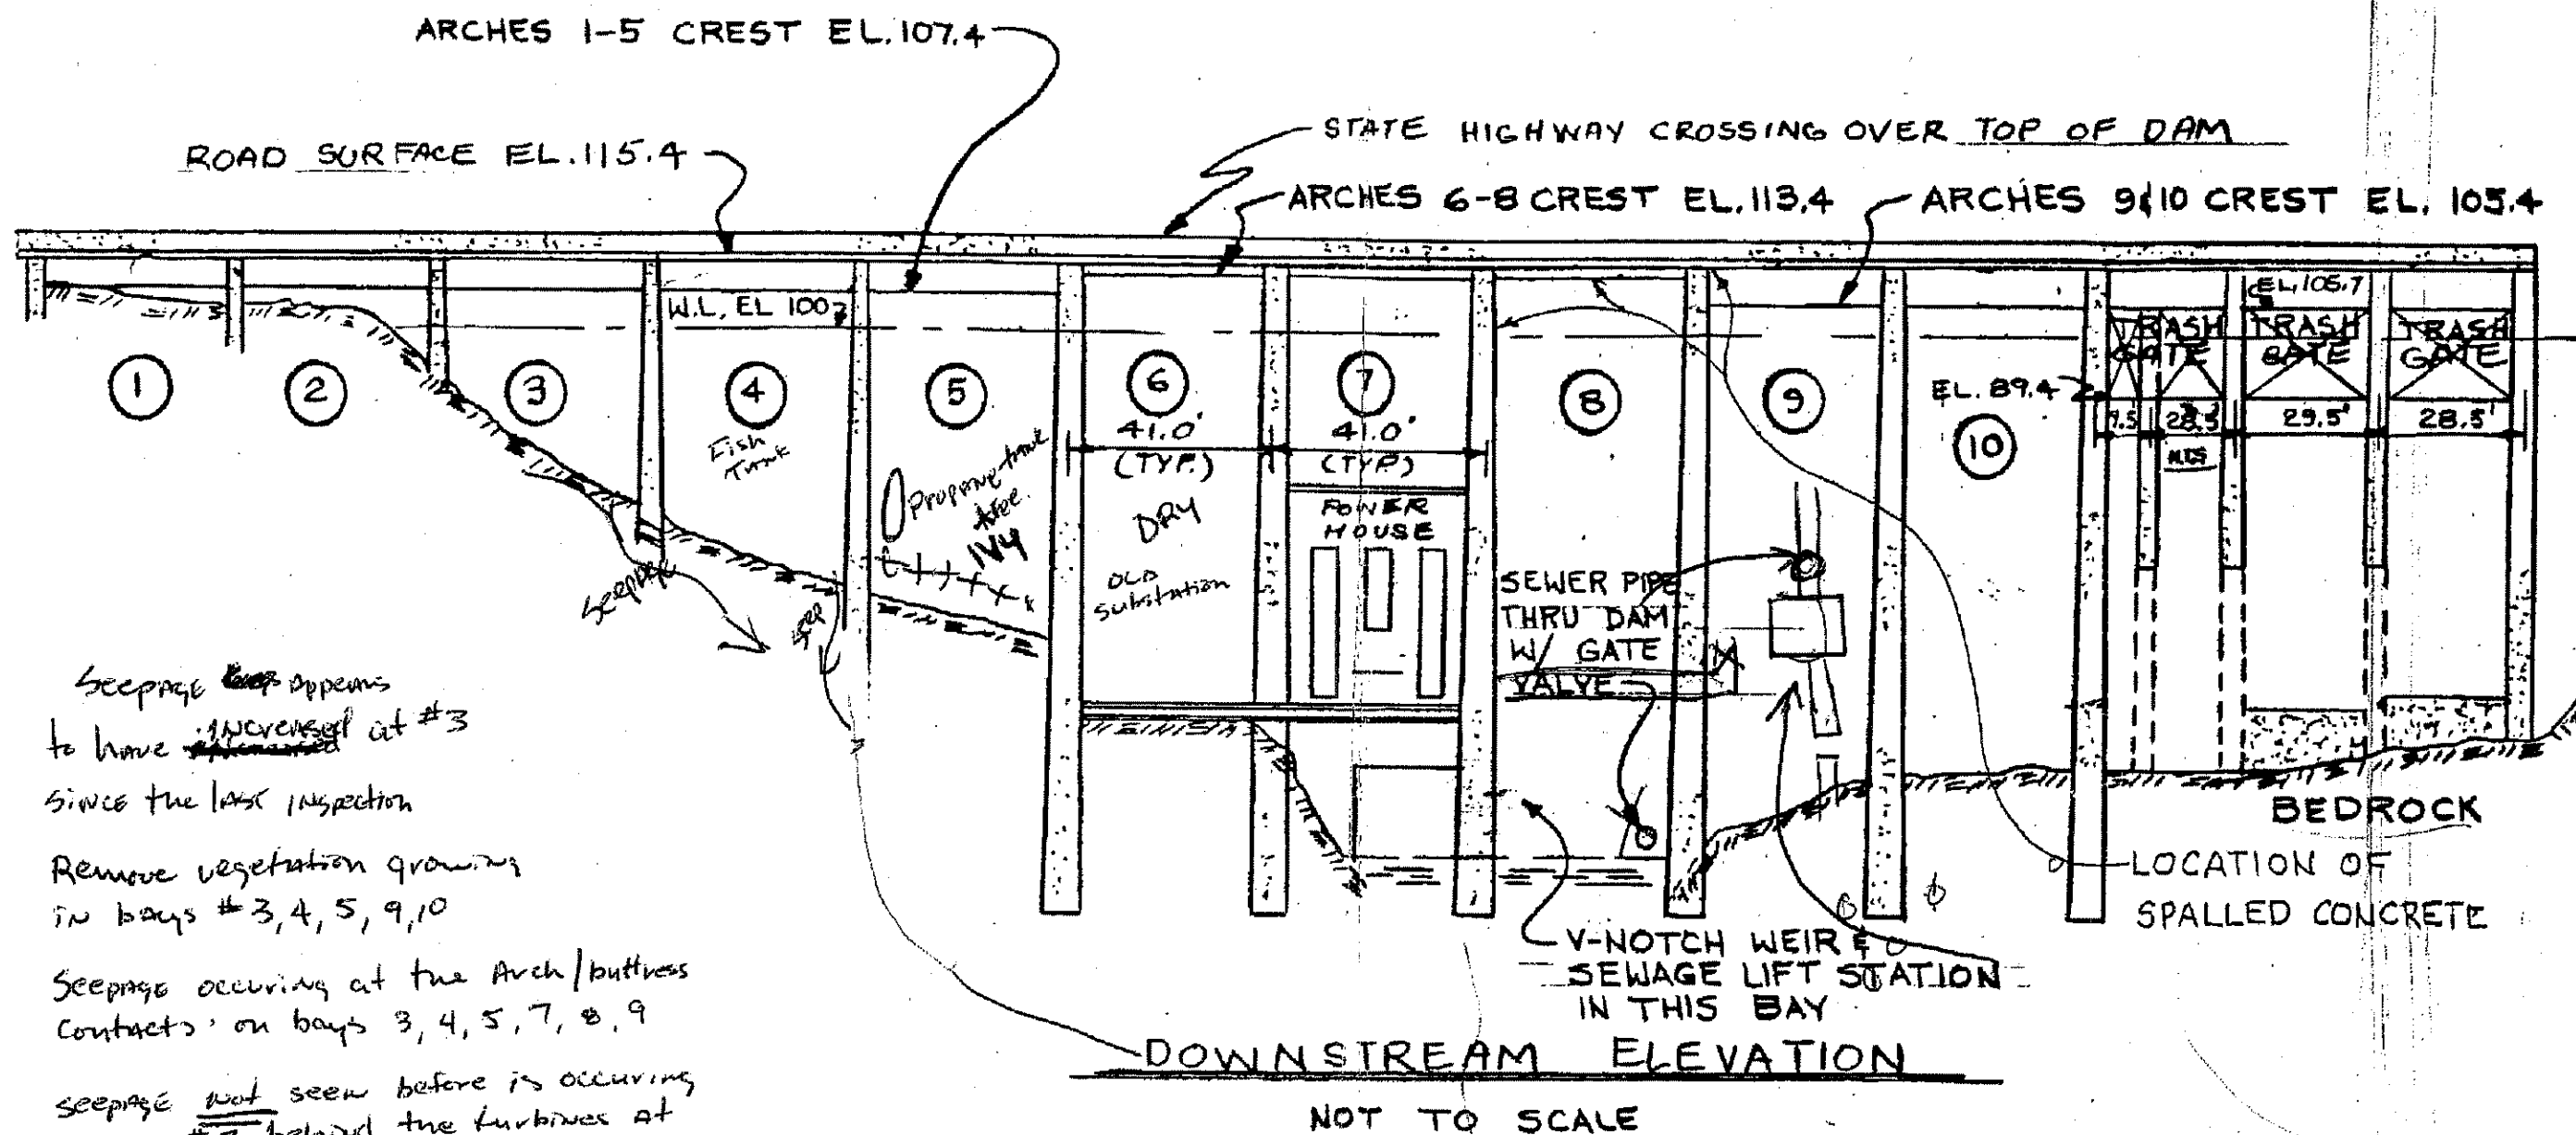
Seepage ~~has~~ appears to have ~~increased~~ at #3 since the last inspection

Spalling has exposed reinforced steel concrete deteriorating over most of the downstream surface.

Remove vegetation growing in bays #3, 4, 5, 9, 10
