RE: Lake Lure Hydro Project  
Rutherford County  
Project Number 92-0499

# DAM SAFETY INSPECTION REPORT

| NAME<br><b>LAKE LUKE DAM</b> | | COUNTY<br><b>Rutherford</b> | NO.<br><b>003</b> | INSPECTED BY<br><b>JCA</b> | DATE<br><b>4/9/91</b> |

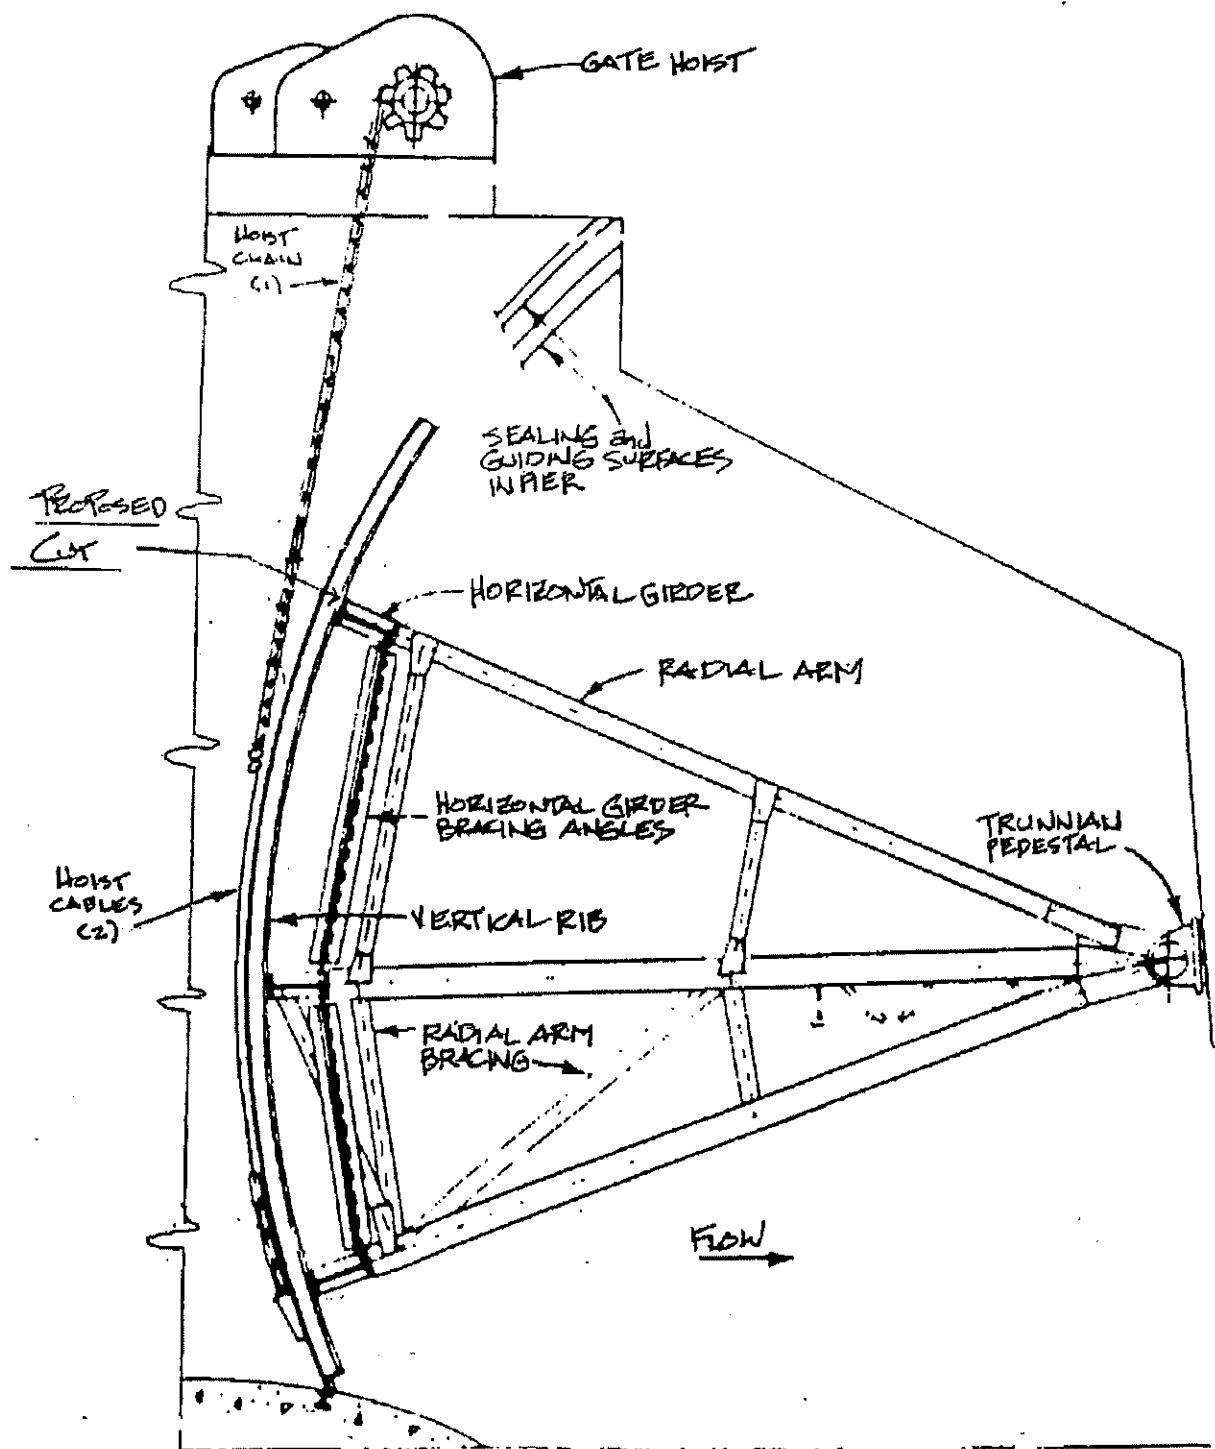
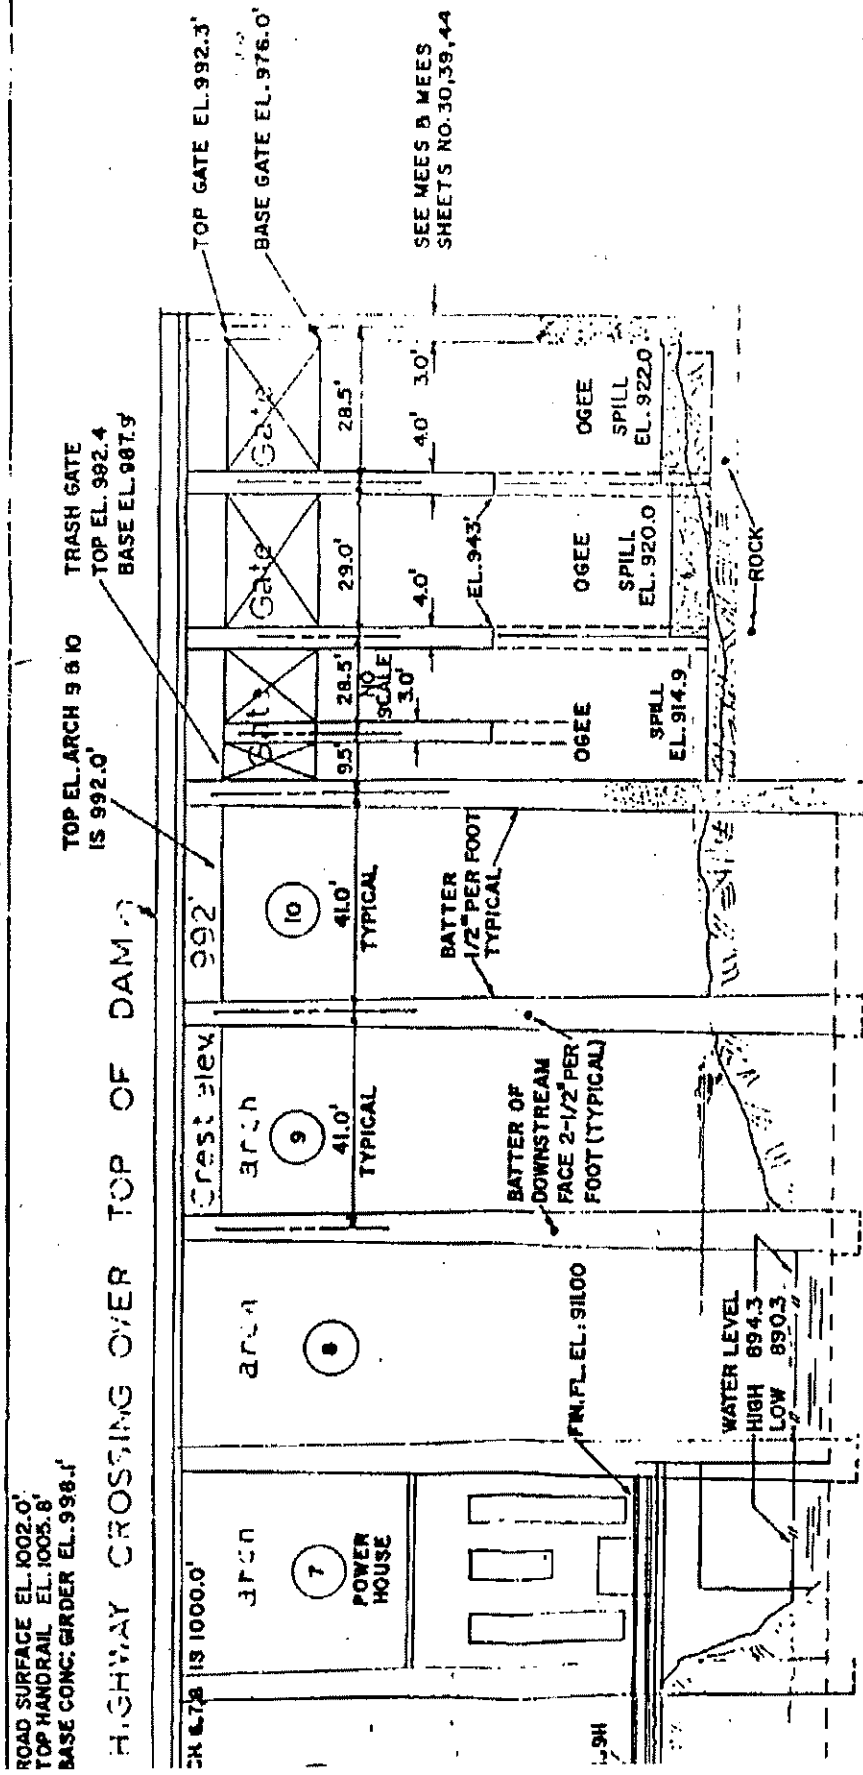
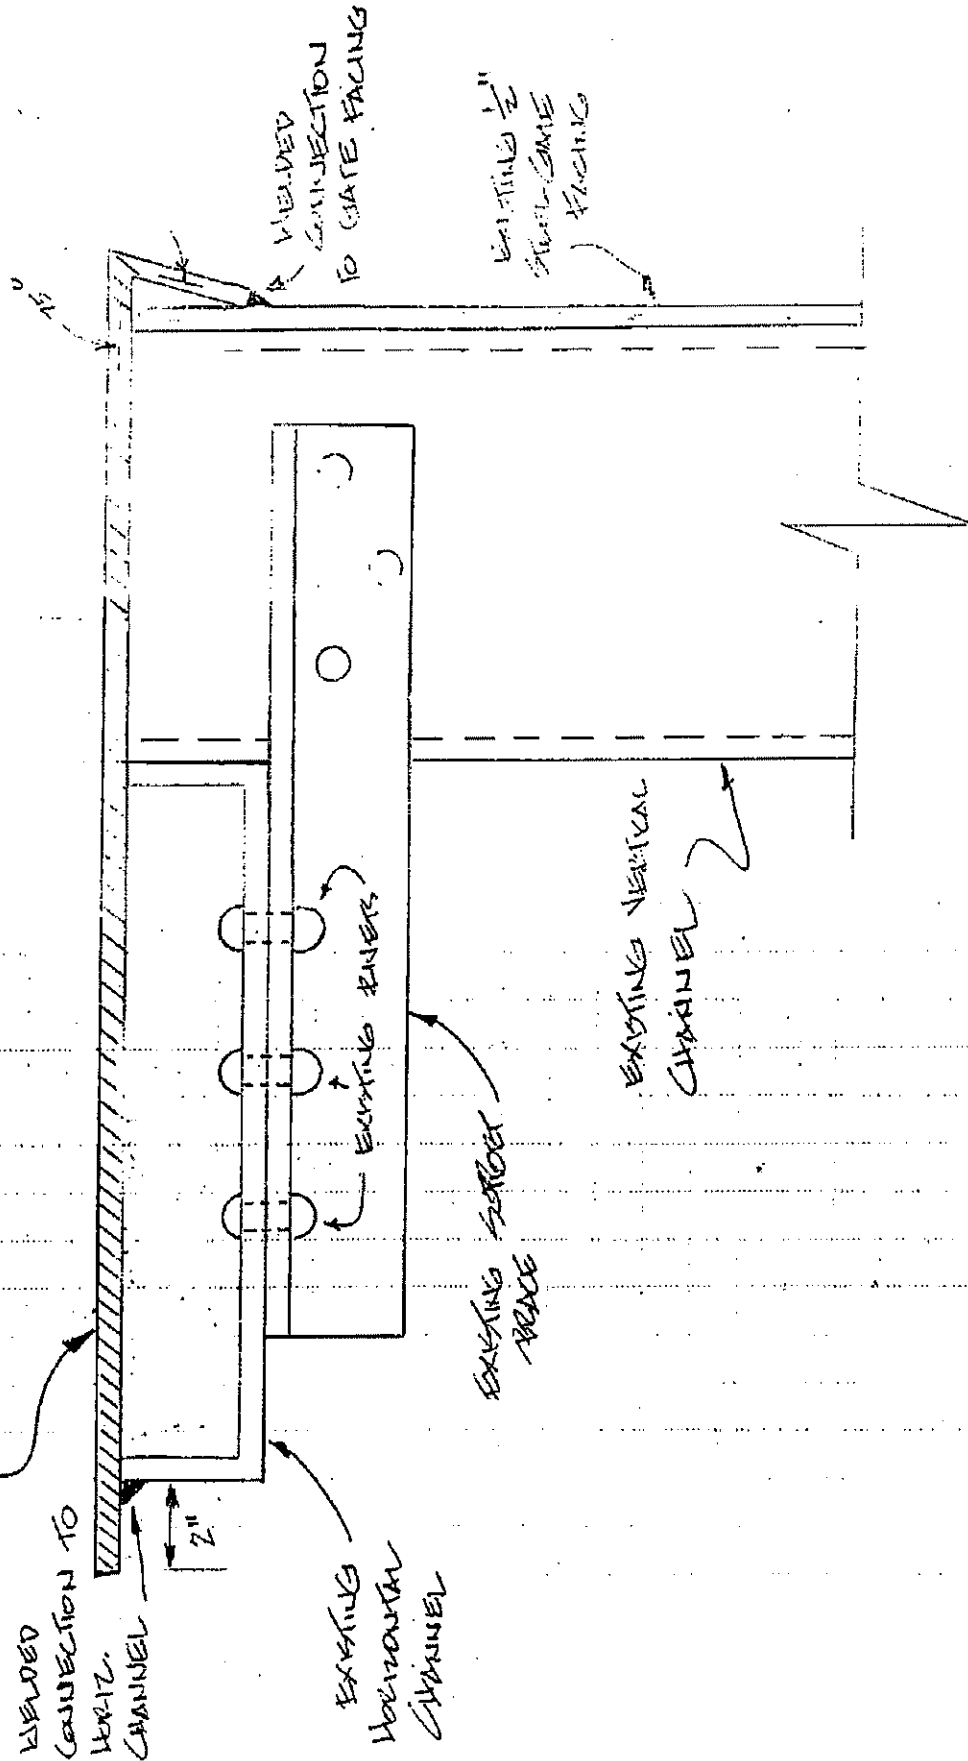
SECTION THROUGH GATE

In order to provide for a more fail safe system we are proposing to cut and remove the top 16 inches of each of the 3 floodgates. The proposed work will remove only the skin plate and braces and will not effect the main structure of each gate. With the crest of each gate lowered to elevation 990.67 the gates will act as weir gates allowing water to discharge across the top of each gate. With this set up in place the Town will no longer have to be concerned with having a person on duty at all times to monitor lake levels. The mechanism for opening the gates will remain in place in case the gates must be opened in the future.

NOTE: GATE FACING AND VERTICAL CHANNEL SURFACE TO BE PAINTED ALONG A HORIZONTAL LINE @ ELEV. OF: TOP OF HORIZONTAL 12" WIDE FLANGE

PROPOSED 1/2" STEEL OVERFLOW RATE \*  
TO FIT ALONG ENTIRE WIDTH OF GATE \*

\* CONTRACTOR TO VERIFY ACTUAL CHANNEL DIMENSIONS AND GATE WIDTHS BEFORE DIMENSIONING LENGTH AND WIDTH OF OVERFLOW RATE
