## Lake Lure Dam

Independent Consultant  
Post Earthquake -  
Dam Safety Inspection  
*December 2007*

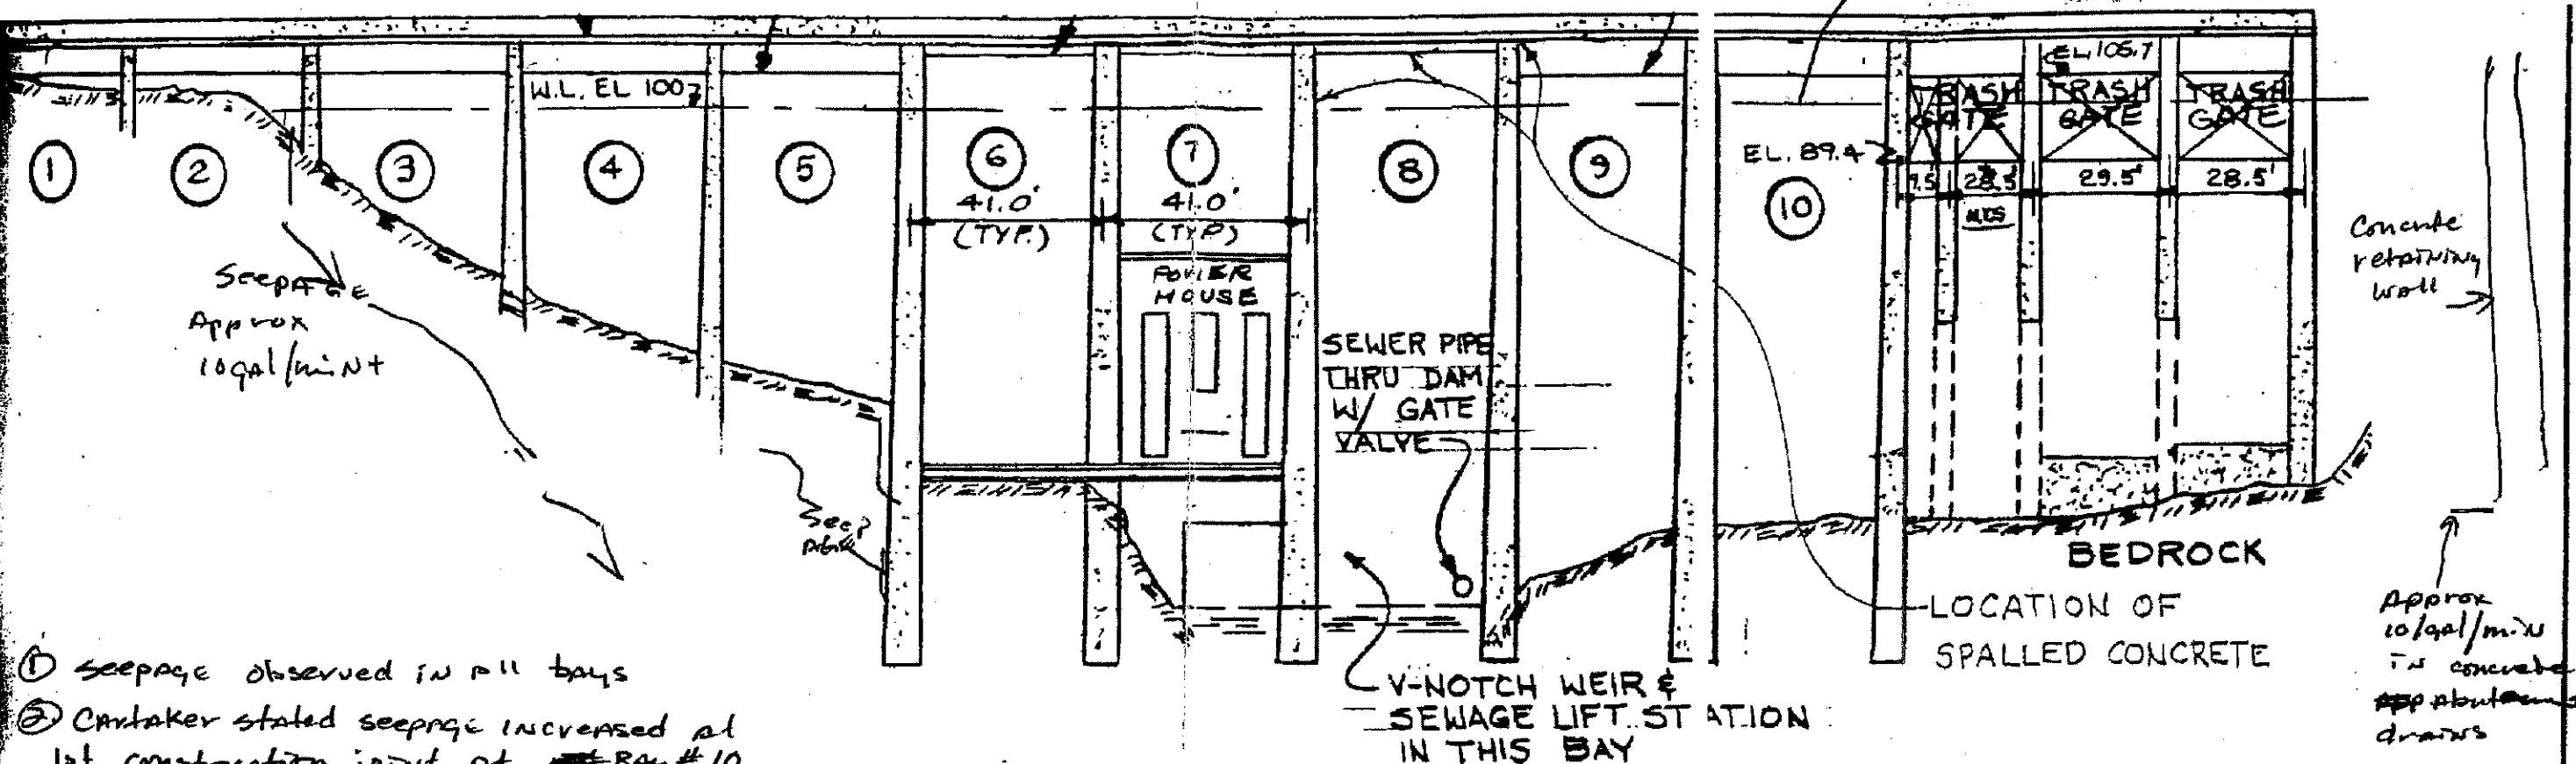
INCREASED SEEPAGE AFTER EARTH QUAKE

- ① seepage observed in all bays
- ② Cartaker stated seepage increased at 1st construction joint at Bay #10
- ③ Spalling & concrete deterioration occurring on all the concrete arches.
- ④ Abutments appear to be in good condition
- ⑤ NO vertical cracks observed in any of the bays
- ⑥ SEEPAGE behind powerhouse at bay #7 needs to be monitored.
