# **VOLUME III**

### **DOCUMENTARY AERIAL DAM SAFETY INSPECTION** **PHOTOGRAPHS** **LAKE LURE DAM AND APPURTENANCES**

**North Carolina ID No. RUTHE-003**  
**Federal ID No. NC – 100**  
**Project No. ME-16-006**

**September 1, 2017**

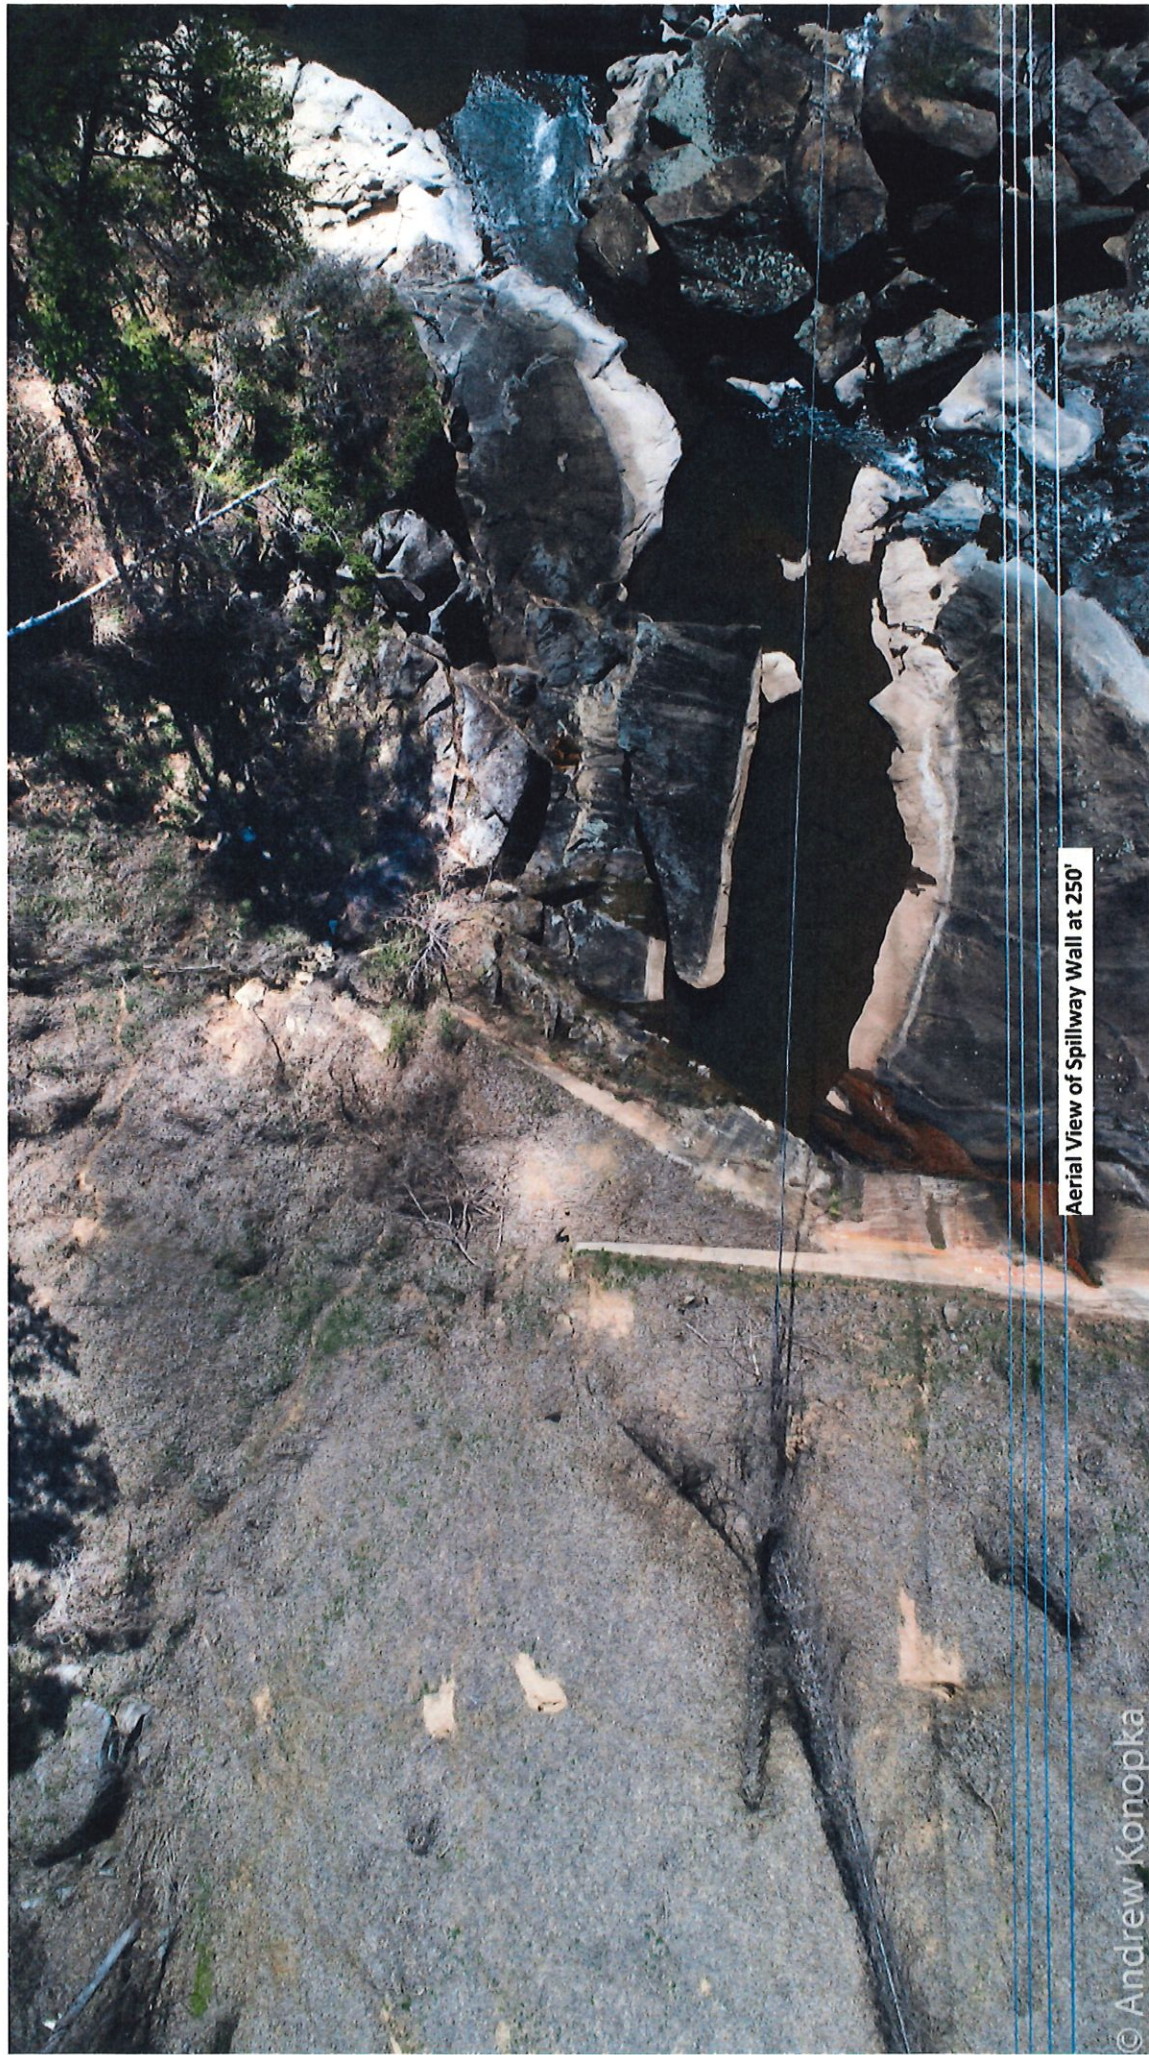
Aerial View of Spillway Wall at 250'

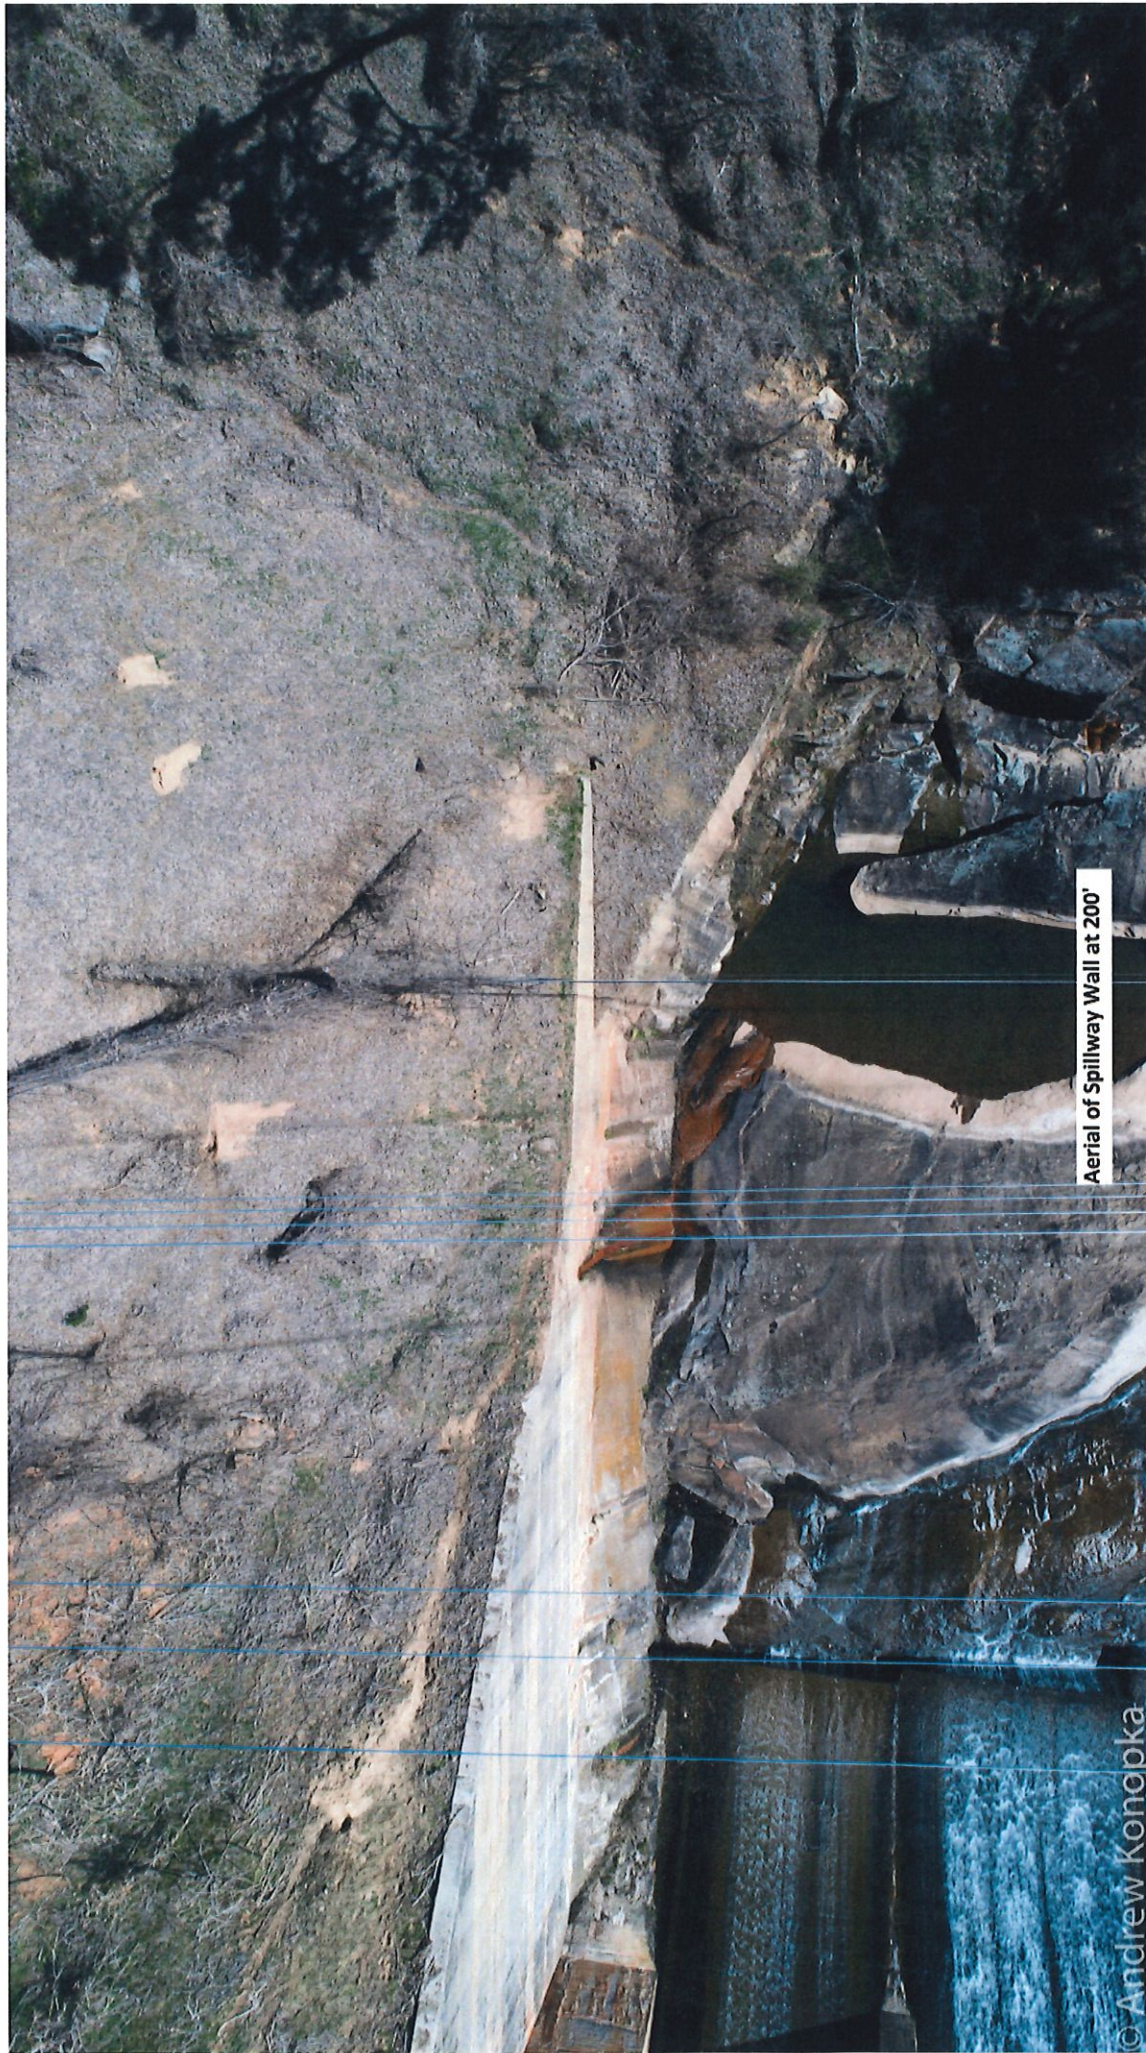
Aerial of Spillway Wall at 200'

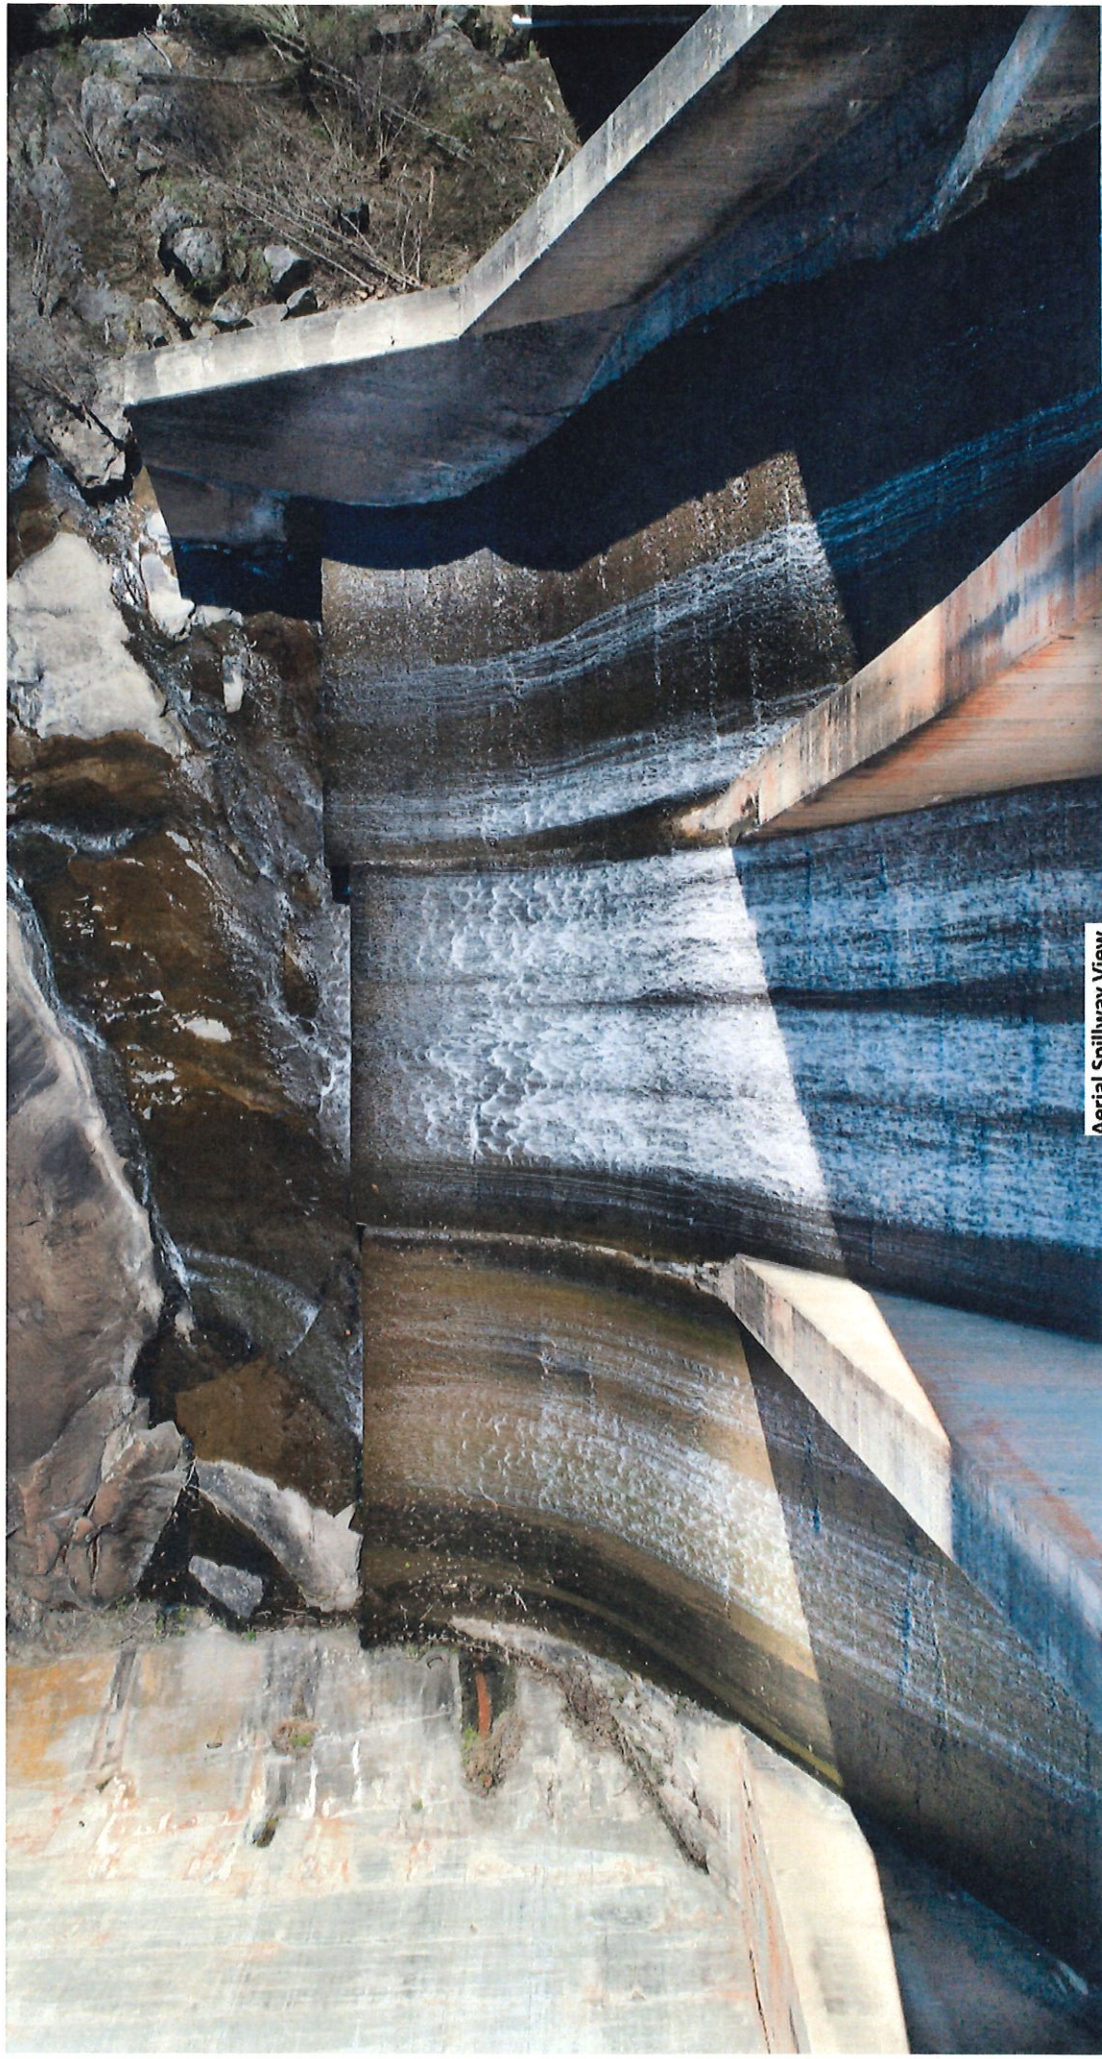
Aerial Spillway View

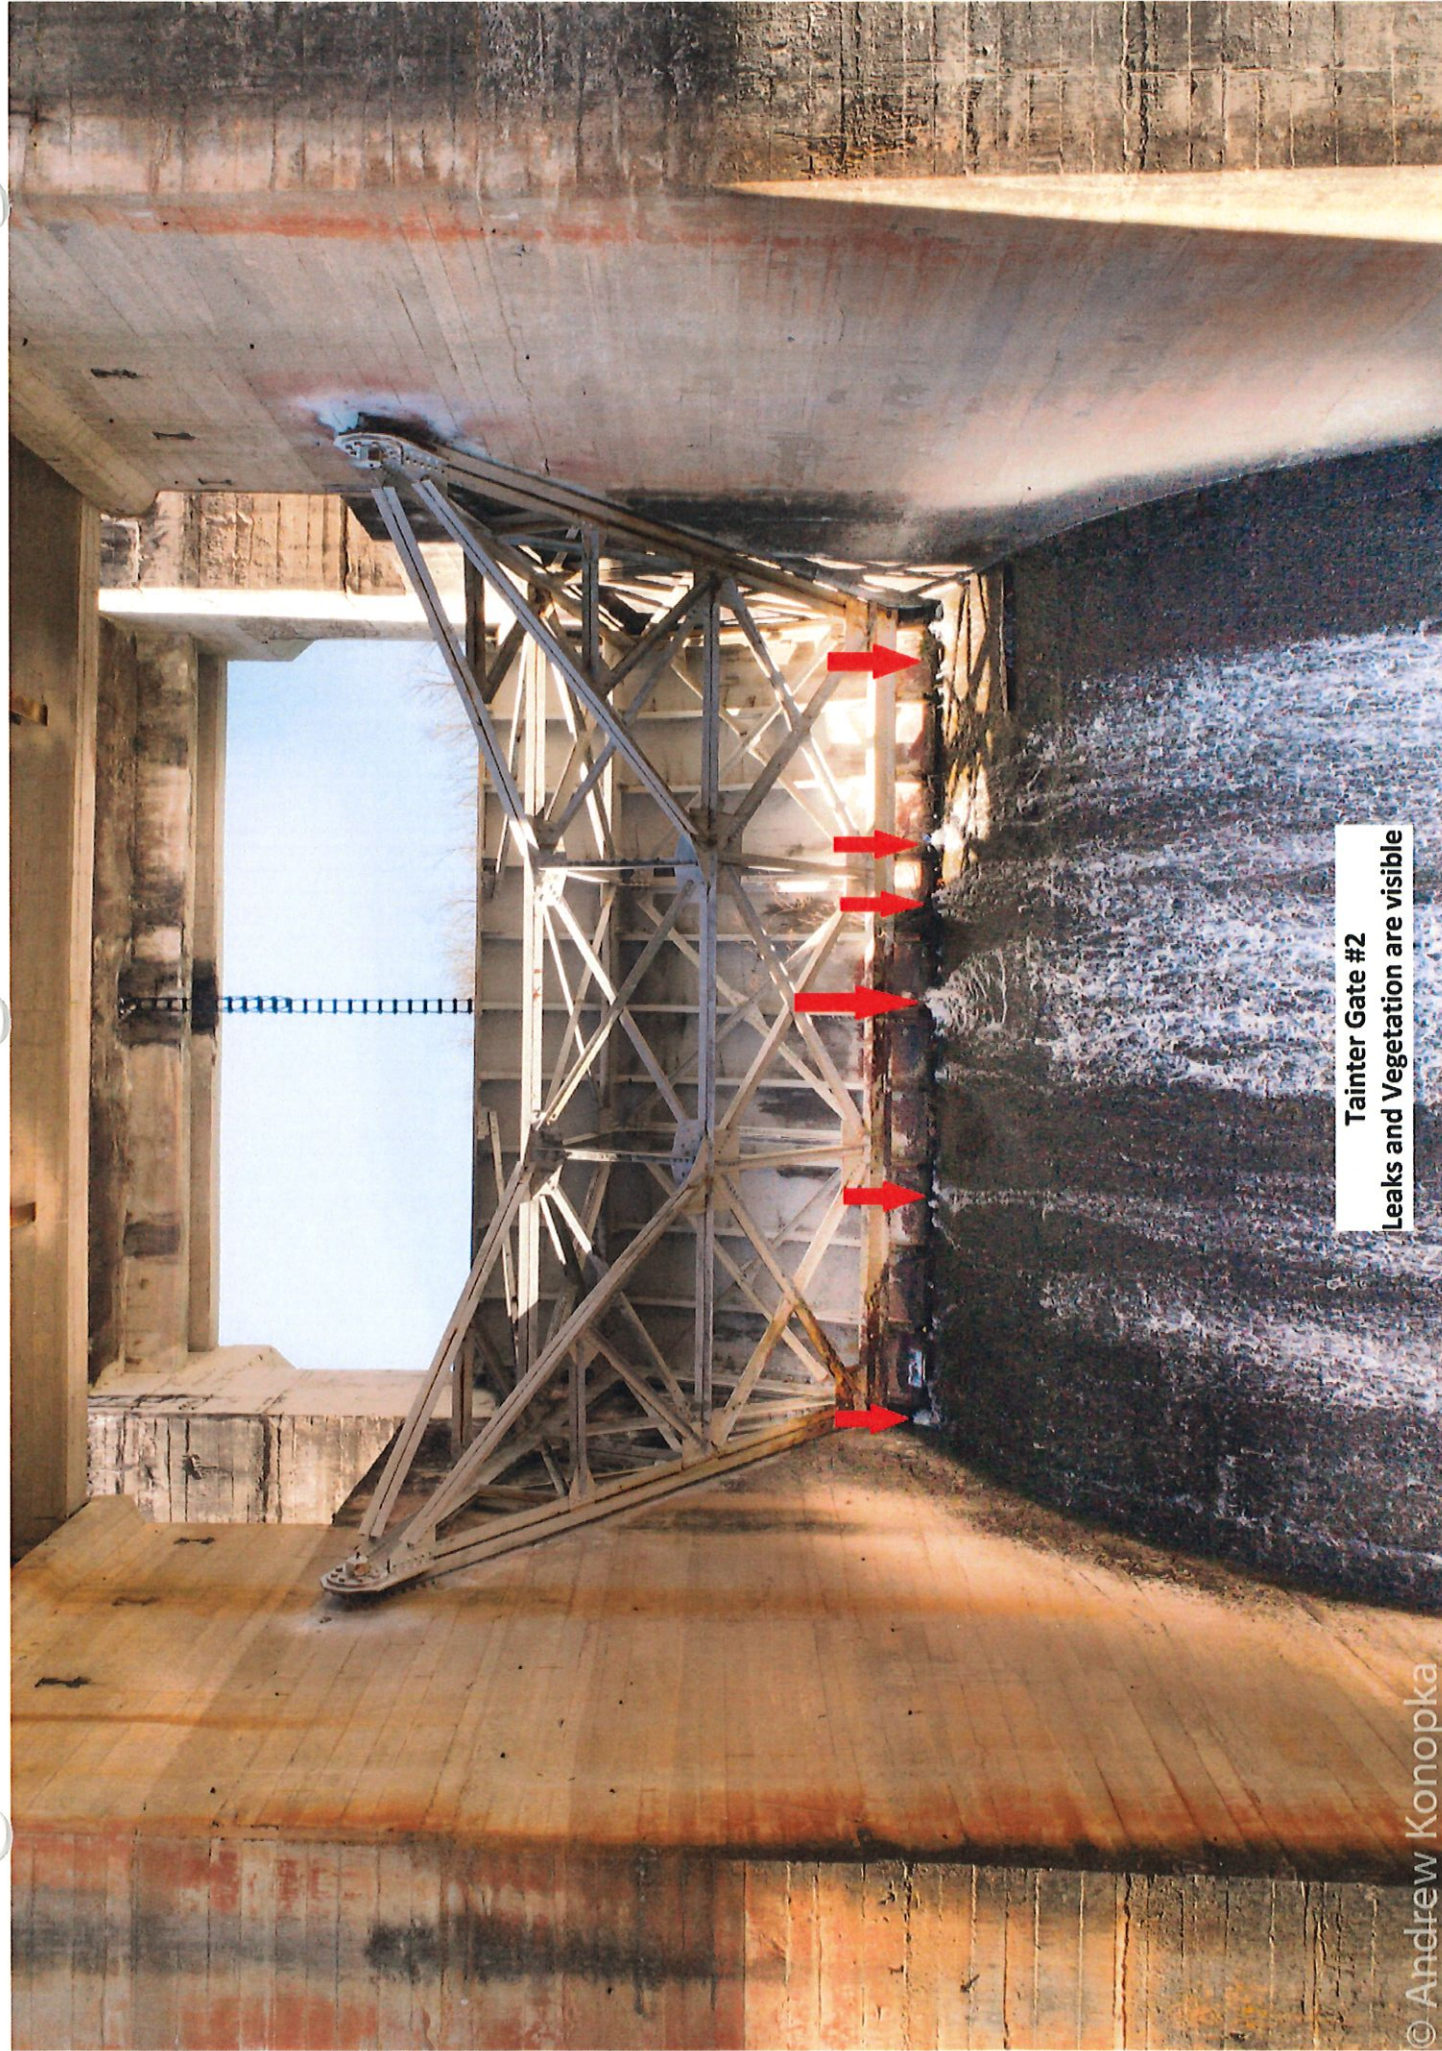
**Tainter Gate #2**  
**Leaks and Vegetation are visible**

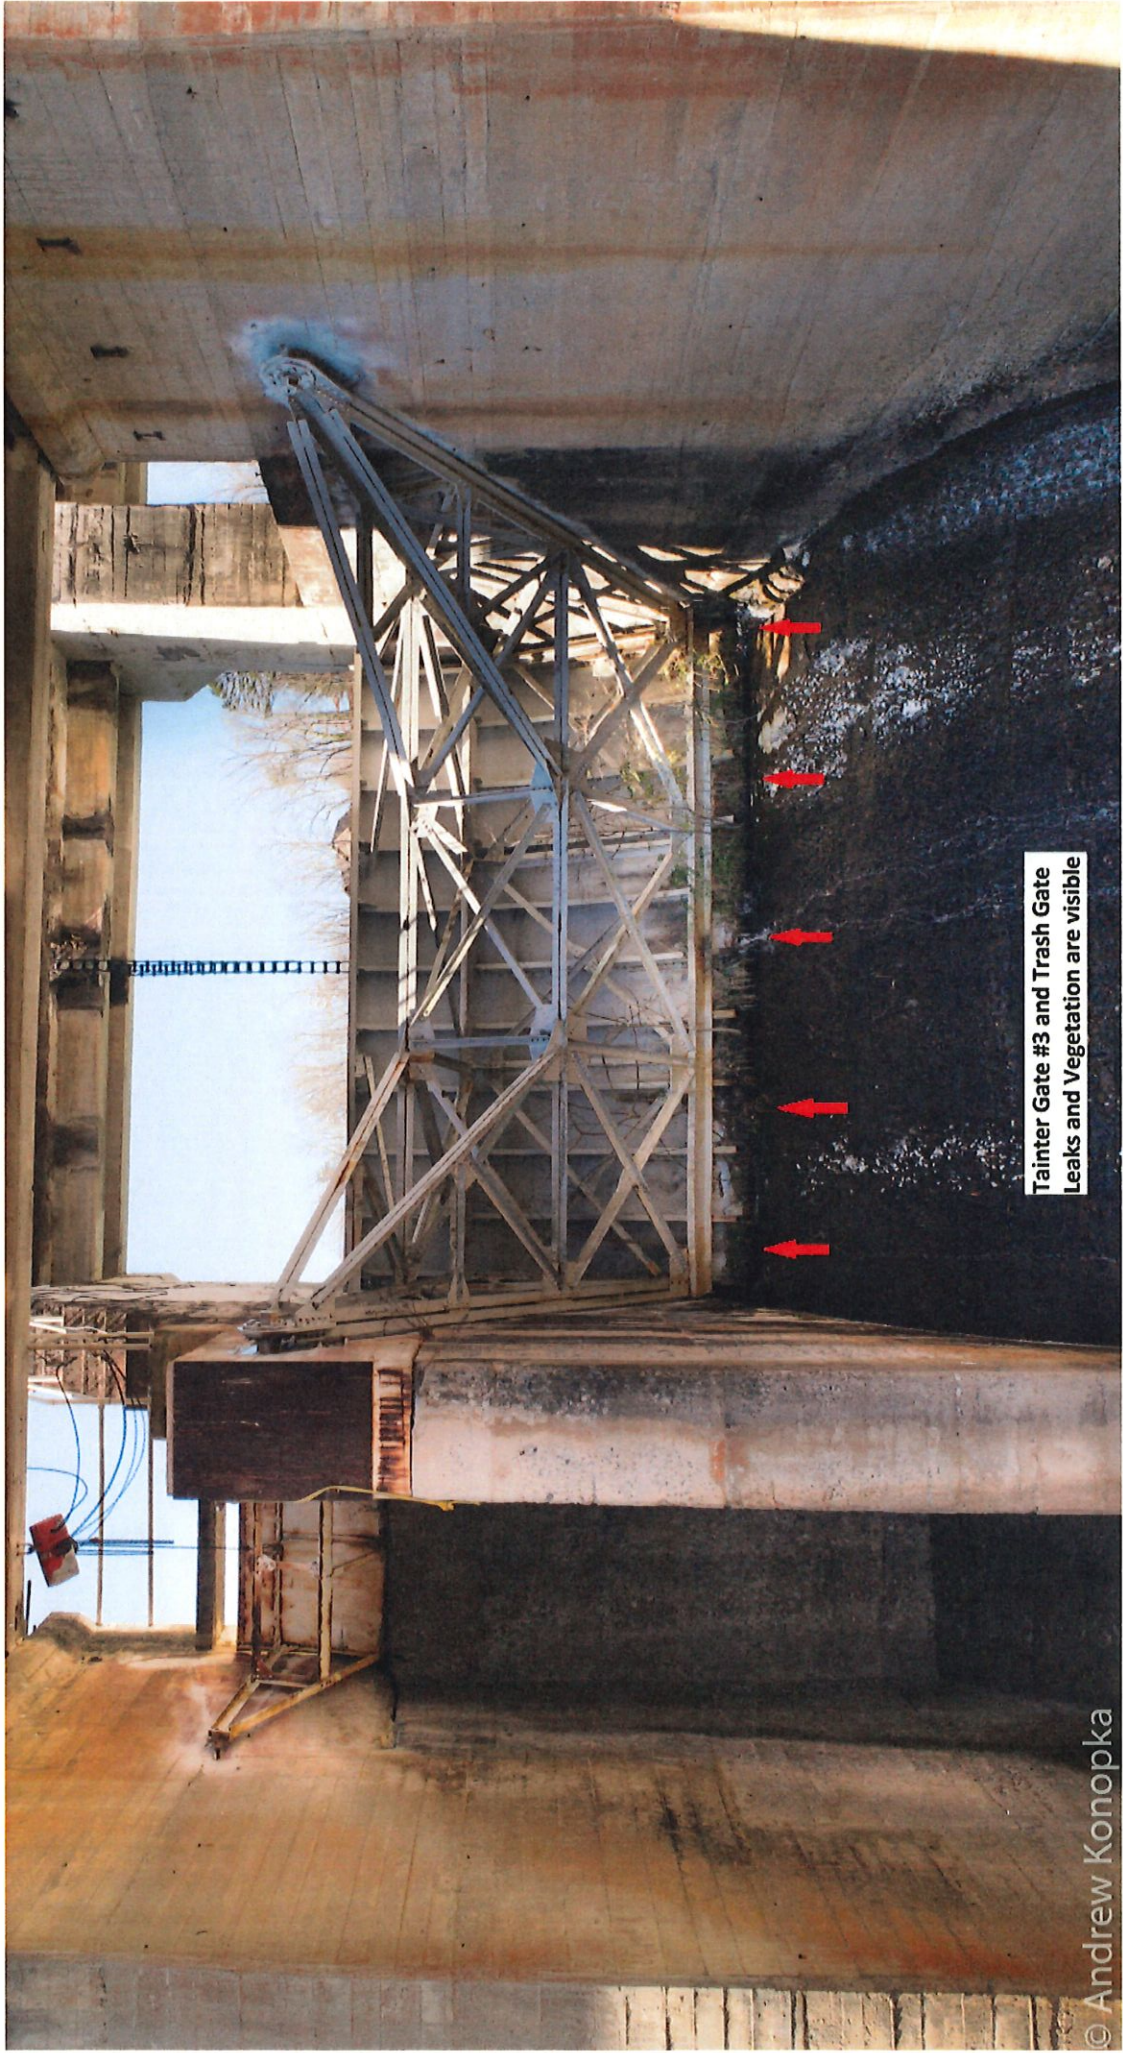
Tainter Gate #3 and Trash Gate  
Leaks and Vegetation are visible

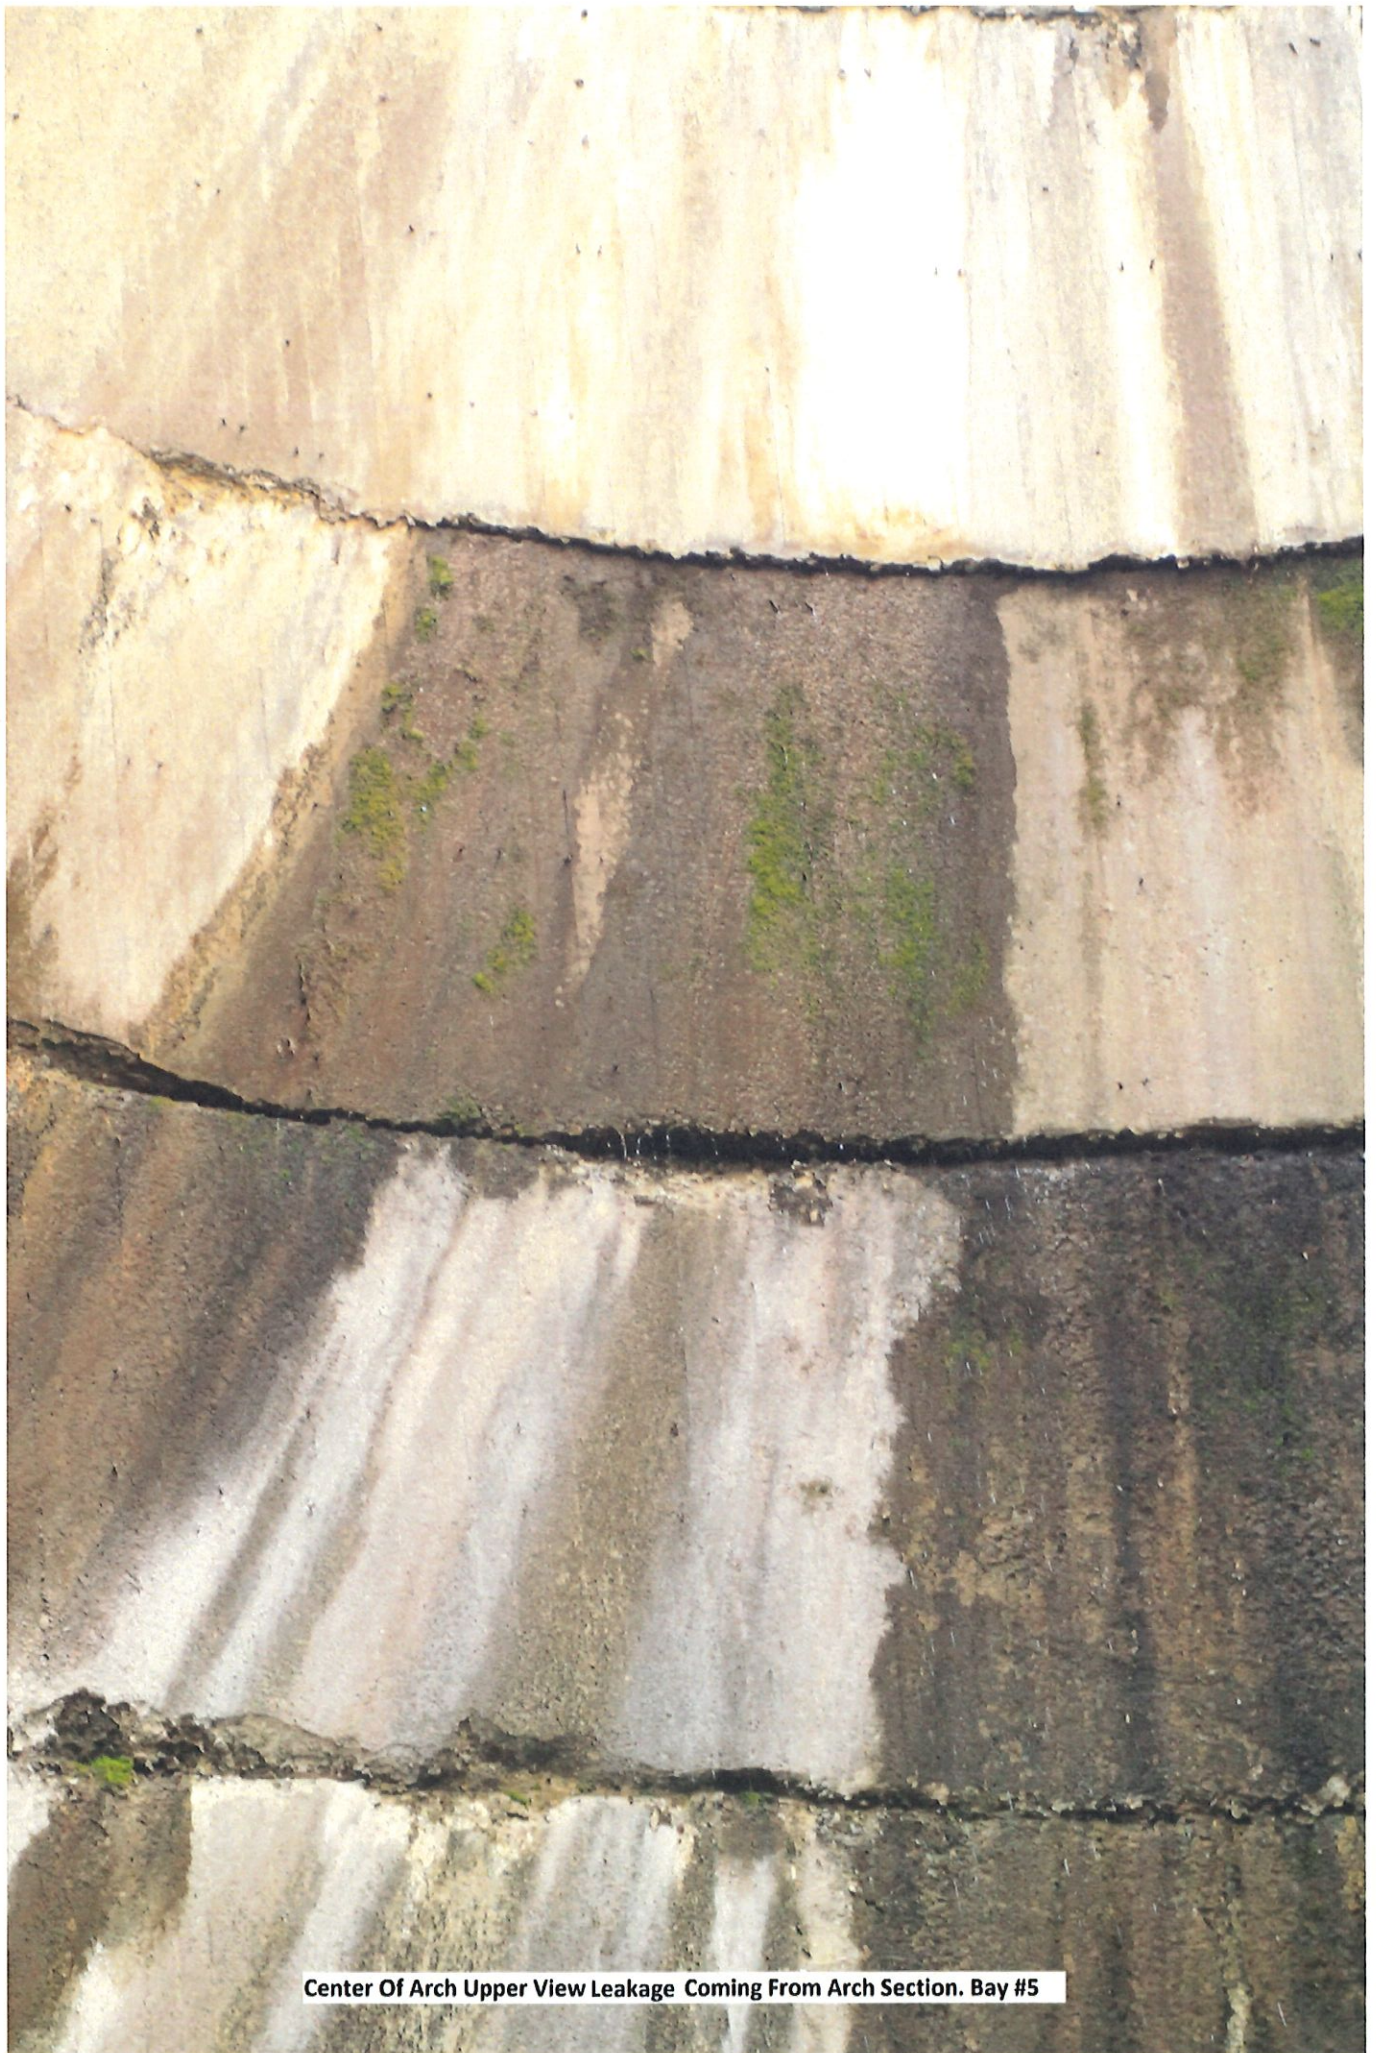
Center Of Arch Upper View Leakage Coming From Arch Section. Bay #5

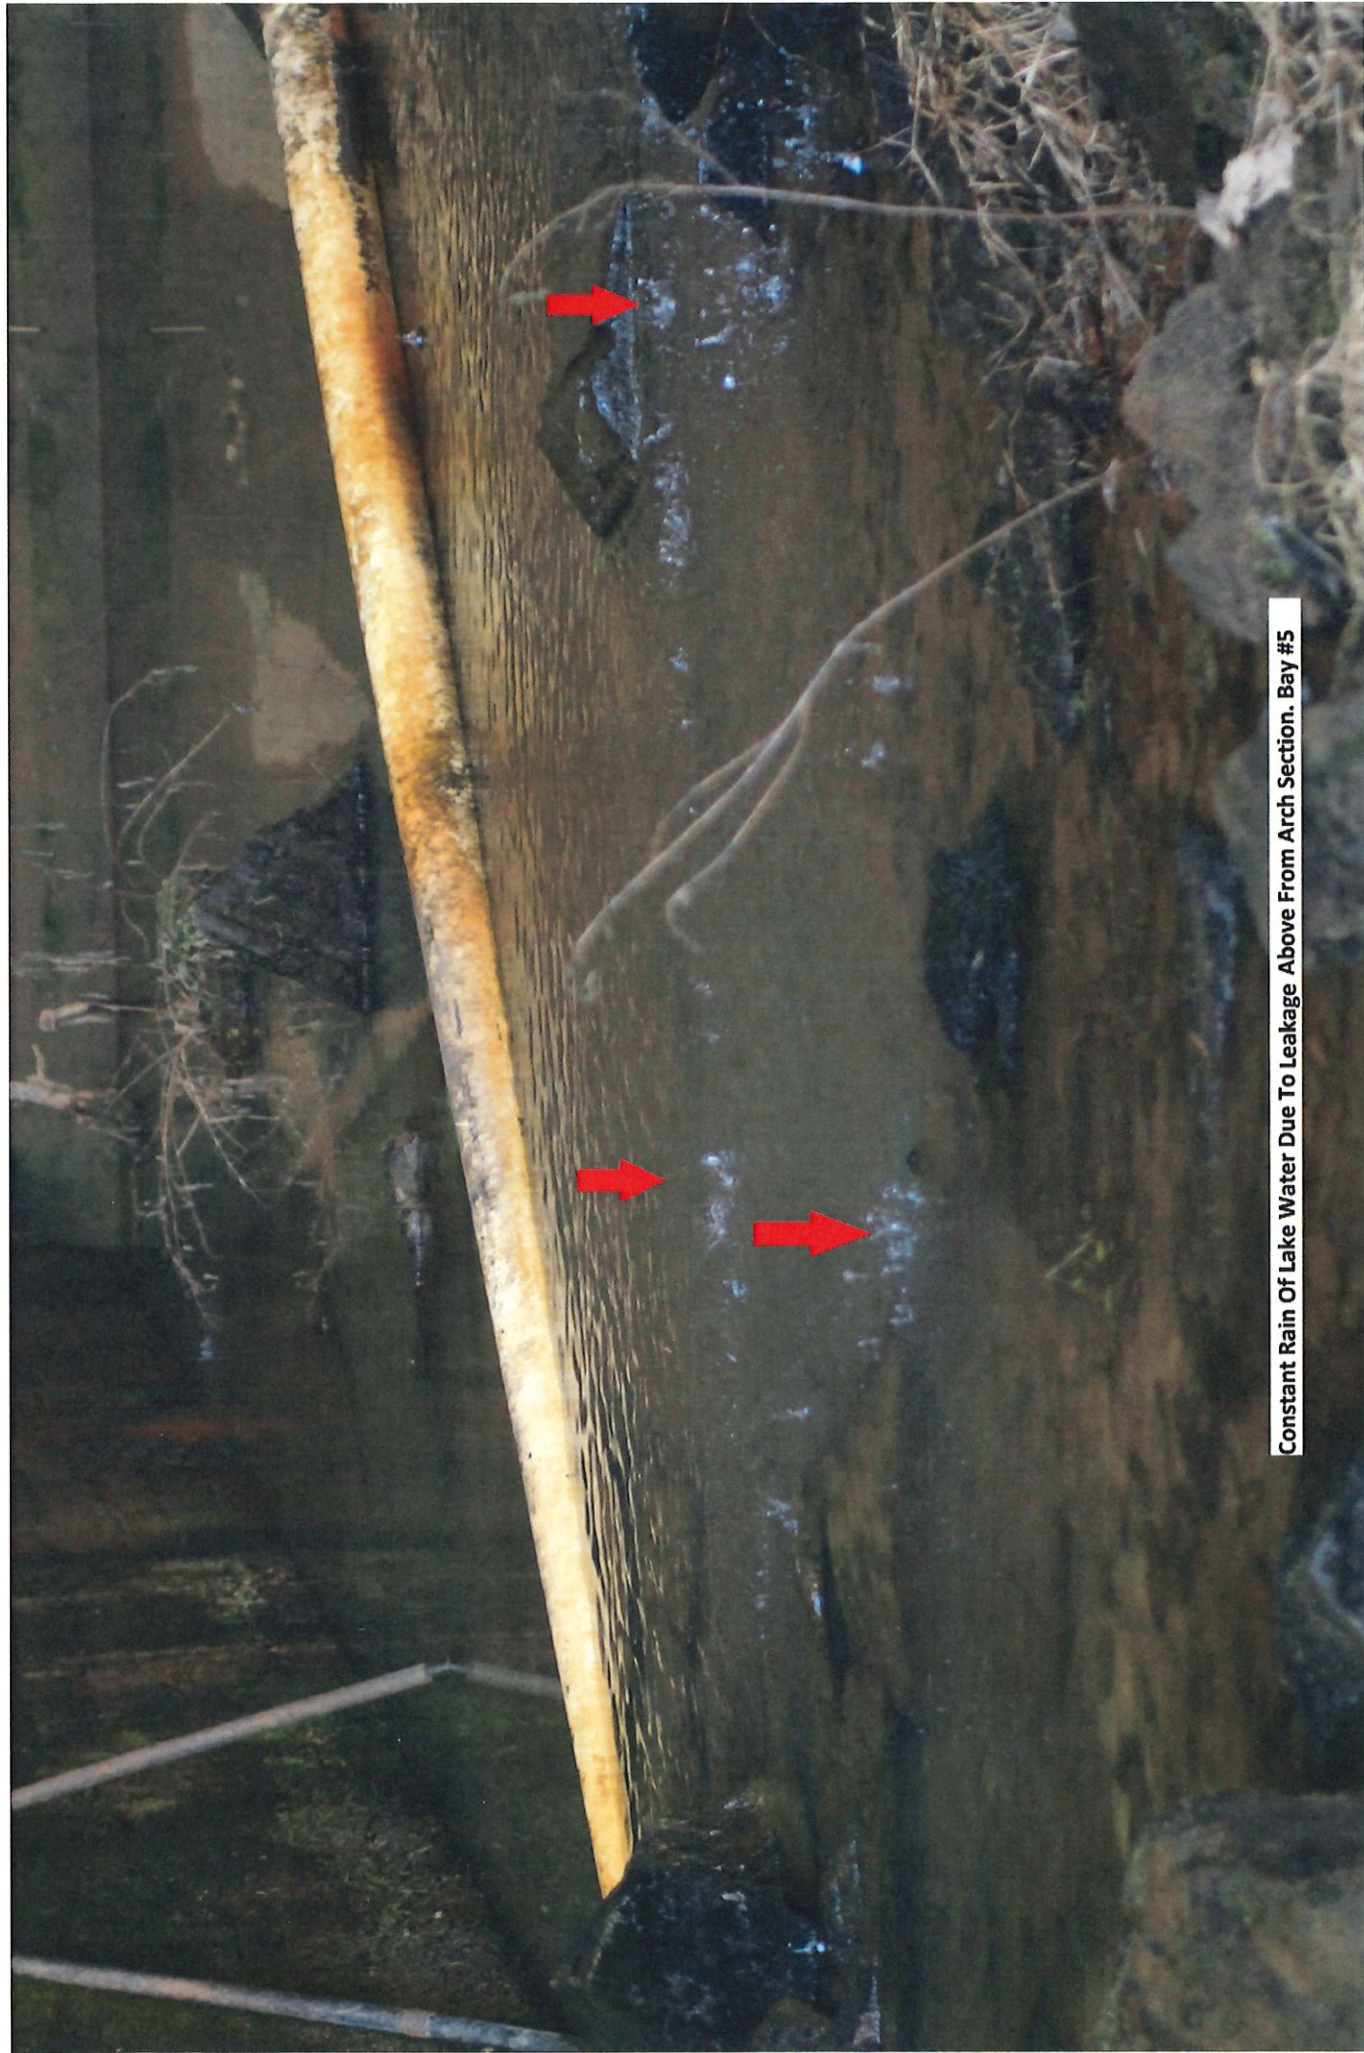
Constant Rain Of Lake Water Due To Leakage Above From Arch Section. Bay #5
