Bay #6 Center Arch View

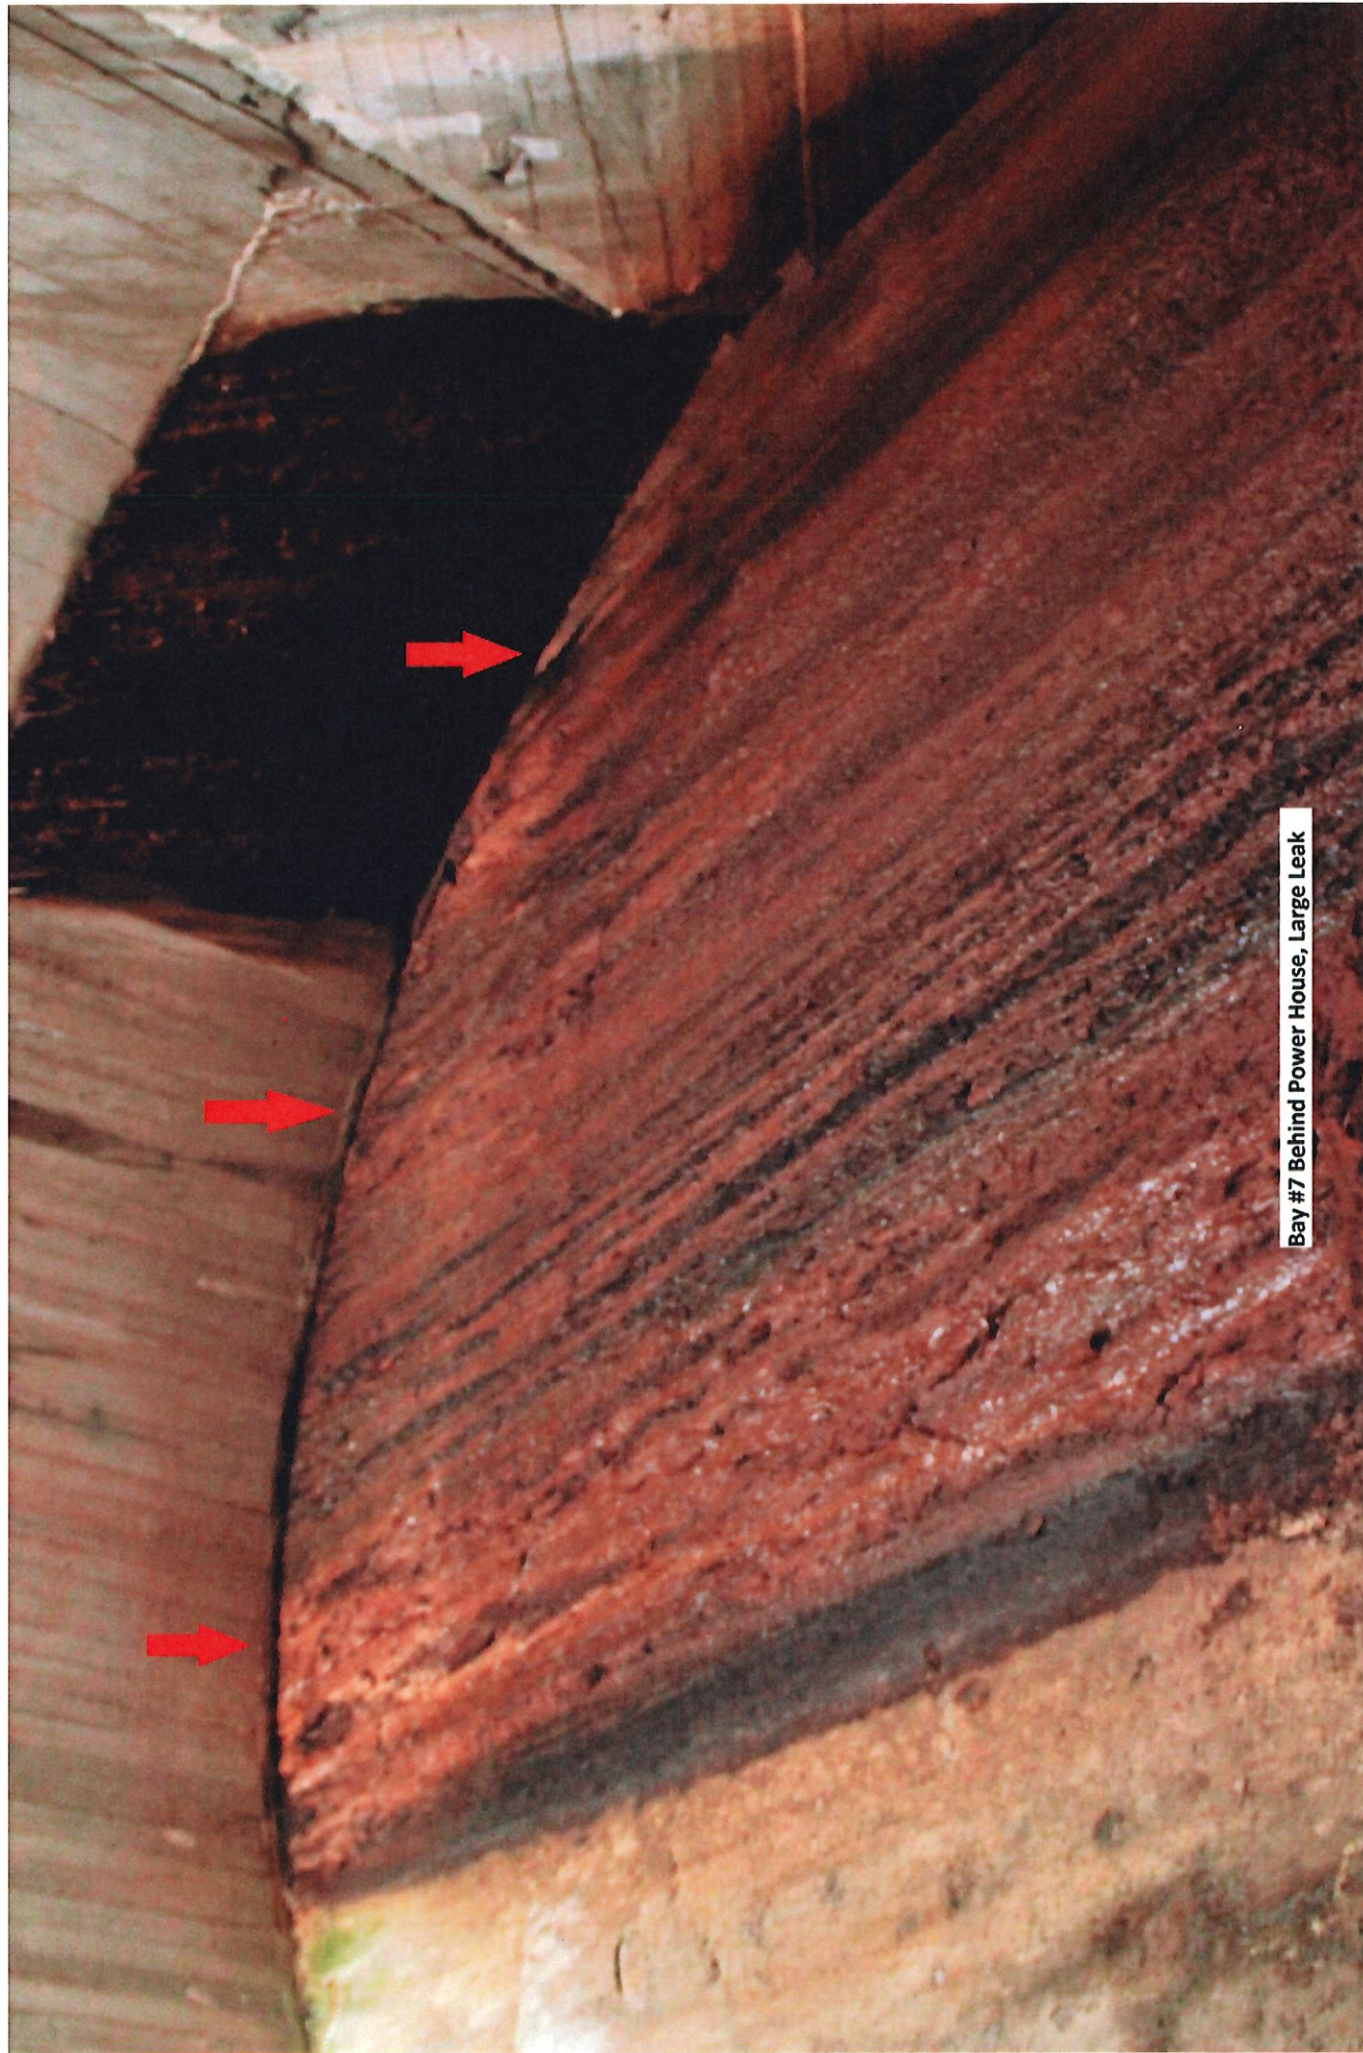
Bay #7 Behind Power House, Large Leak

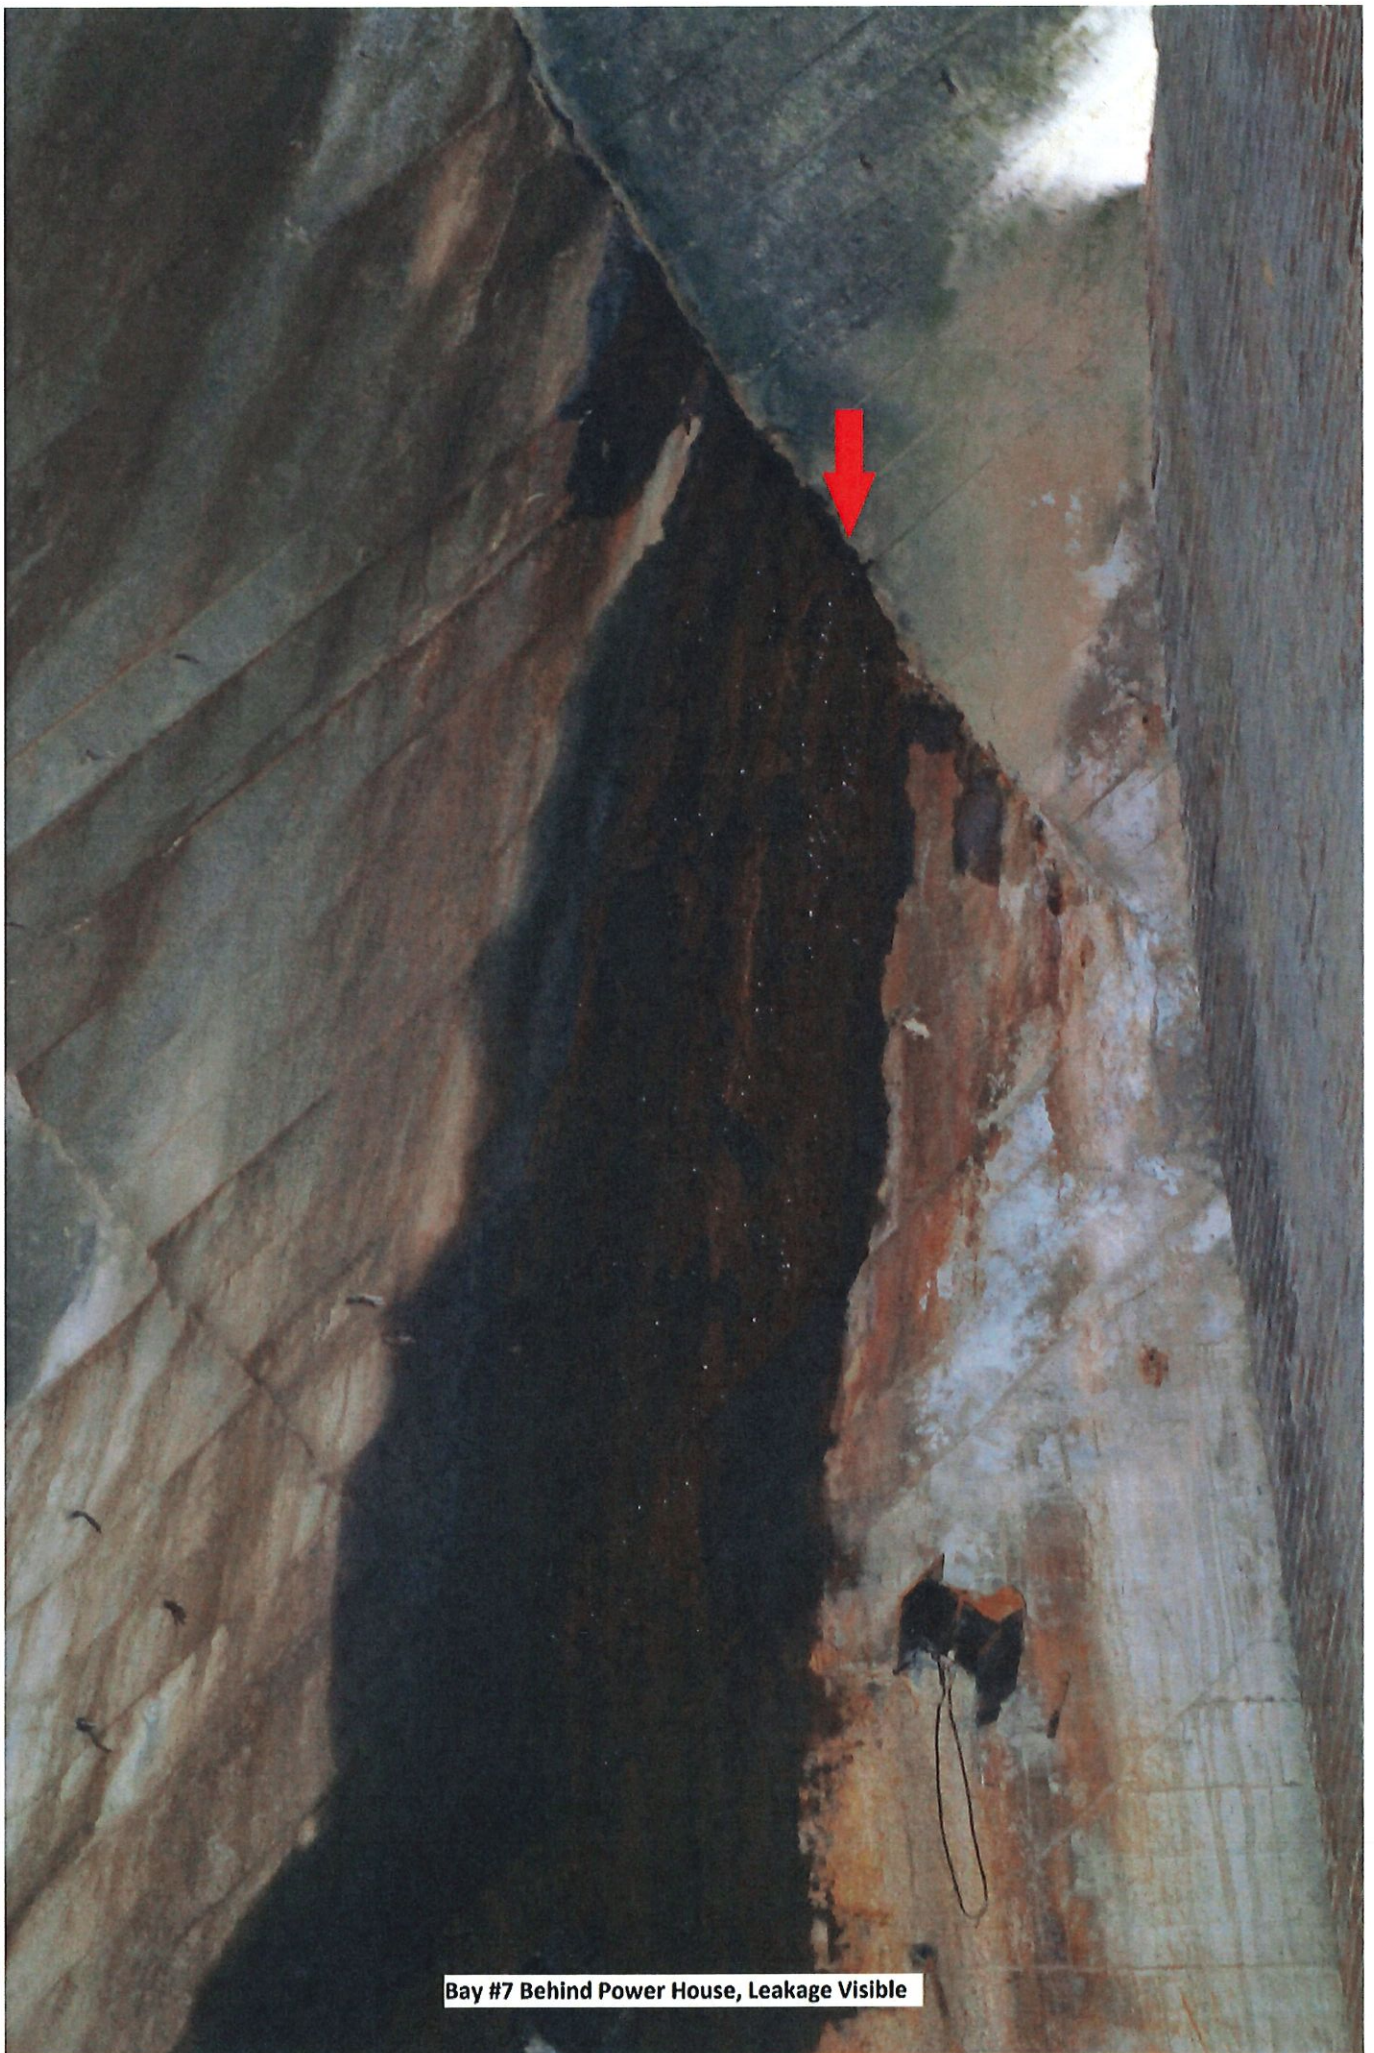
Bay #7 Behind Power House, Leakage Visible

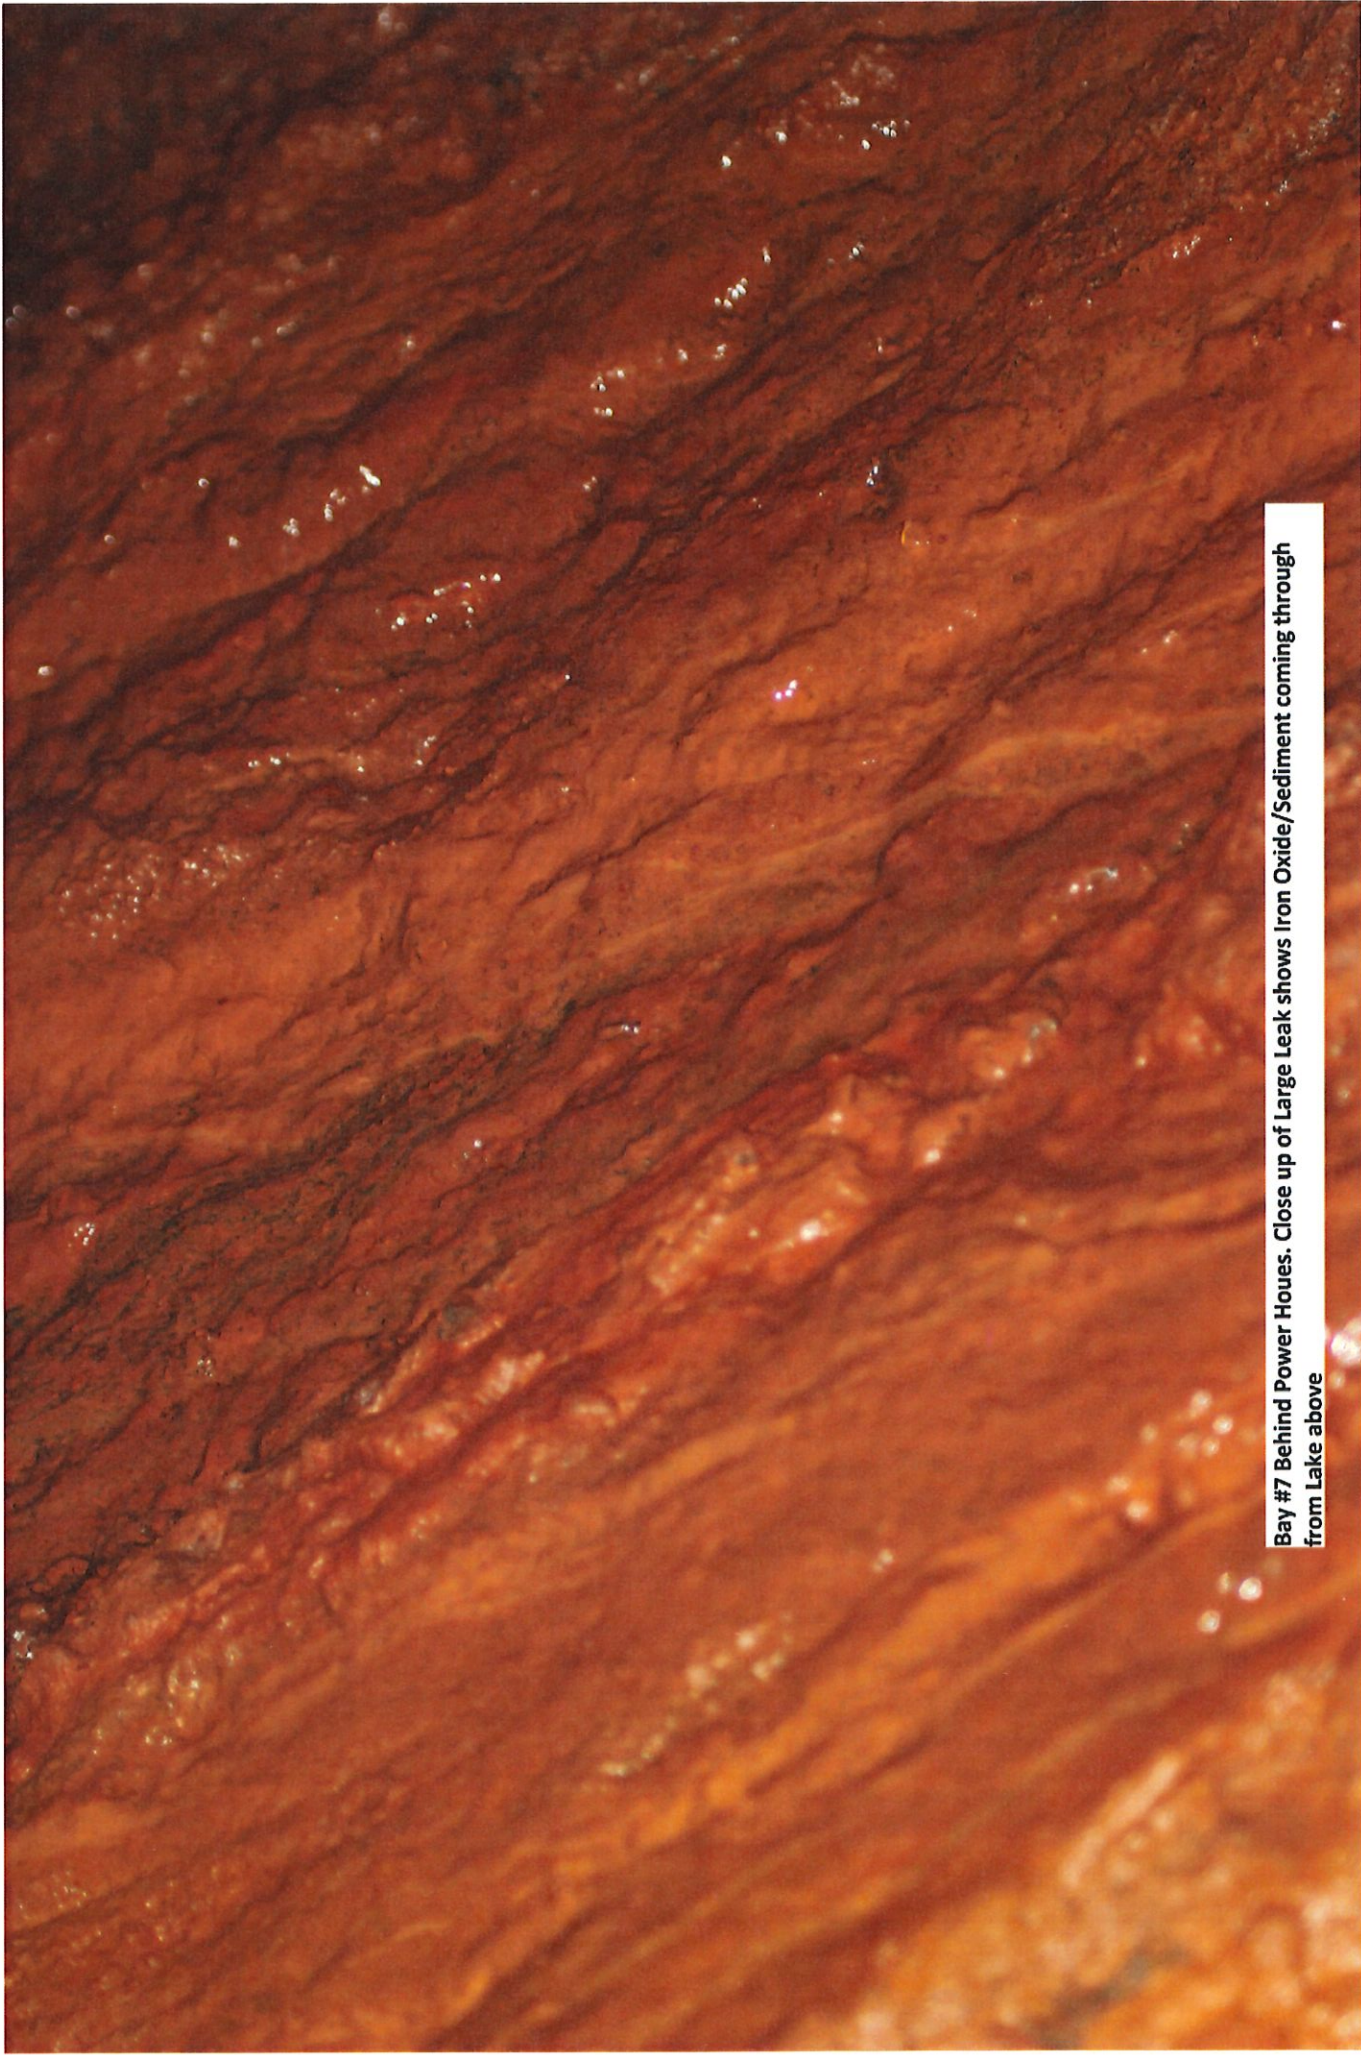
Bay #7 Behind Power Houes. Close up of Large Leak shows Iron Oxide/Sediment coming through from Lake above

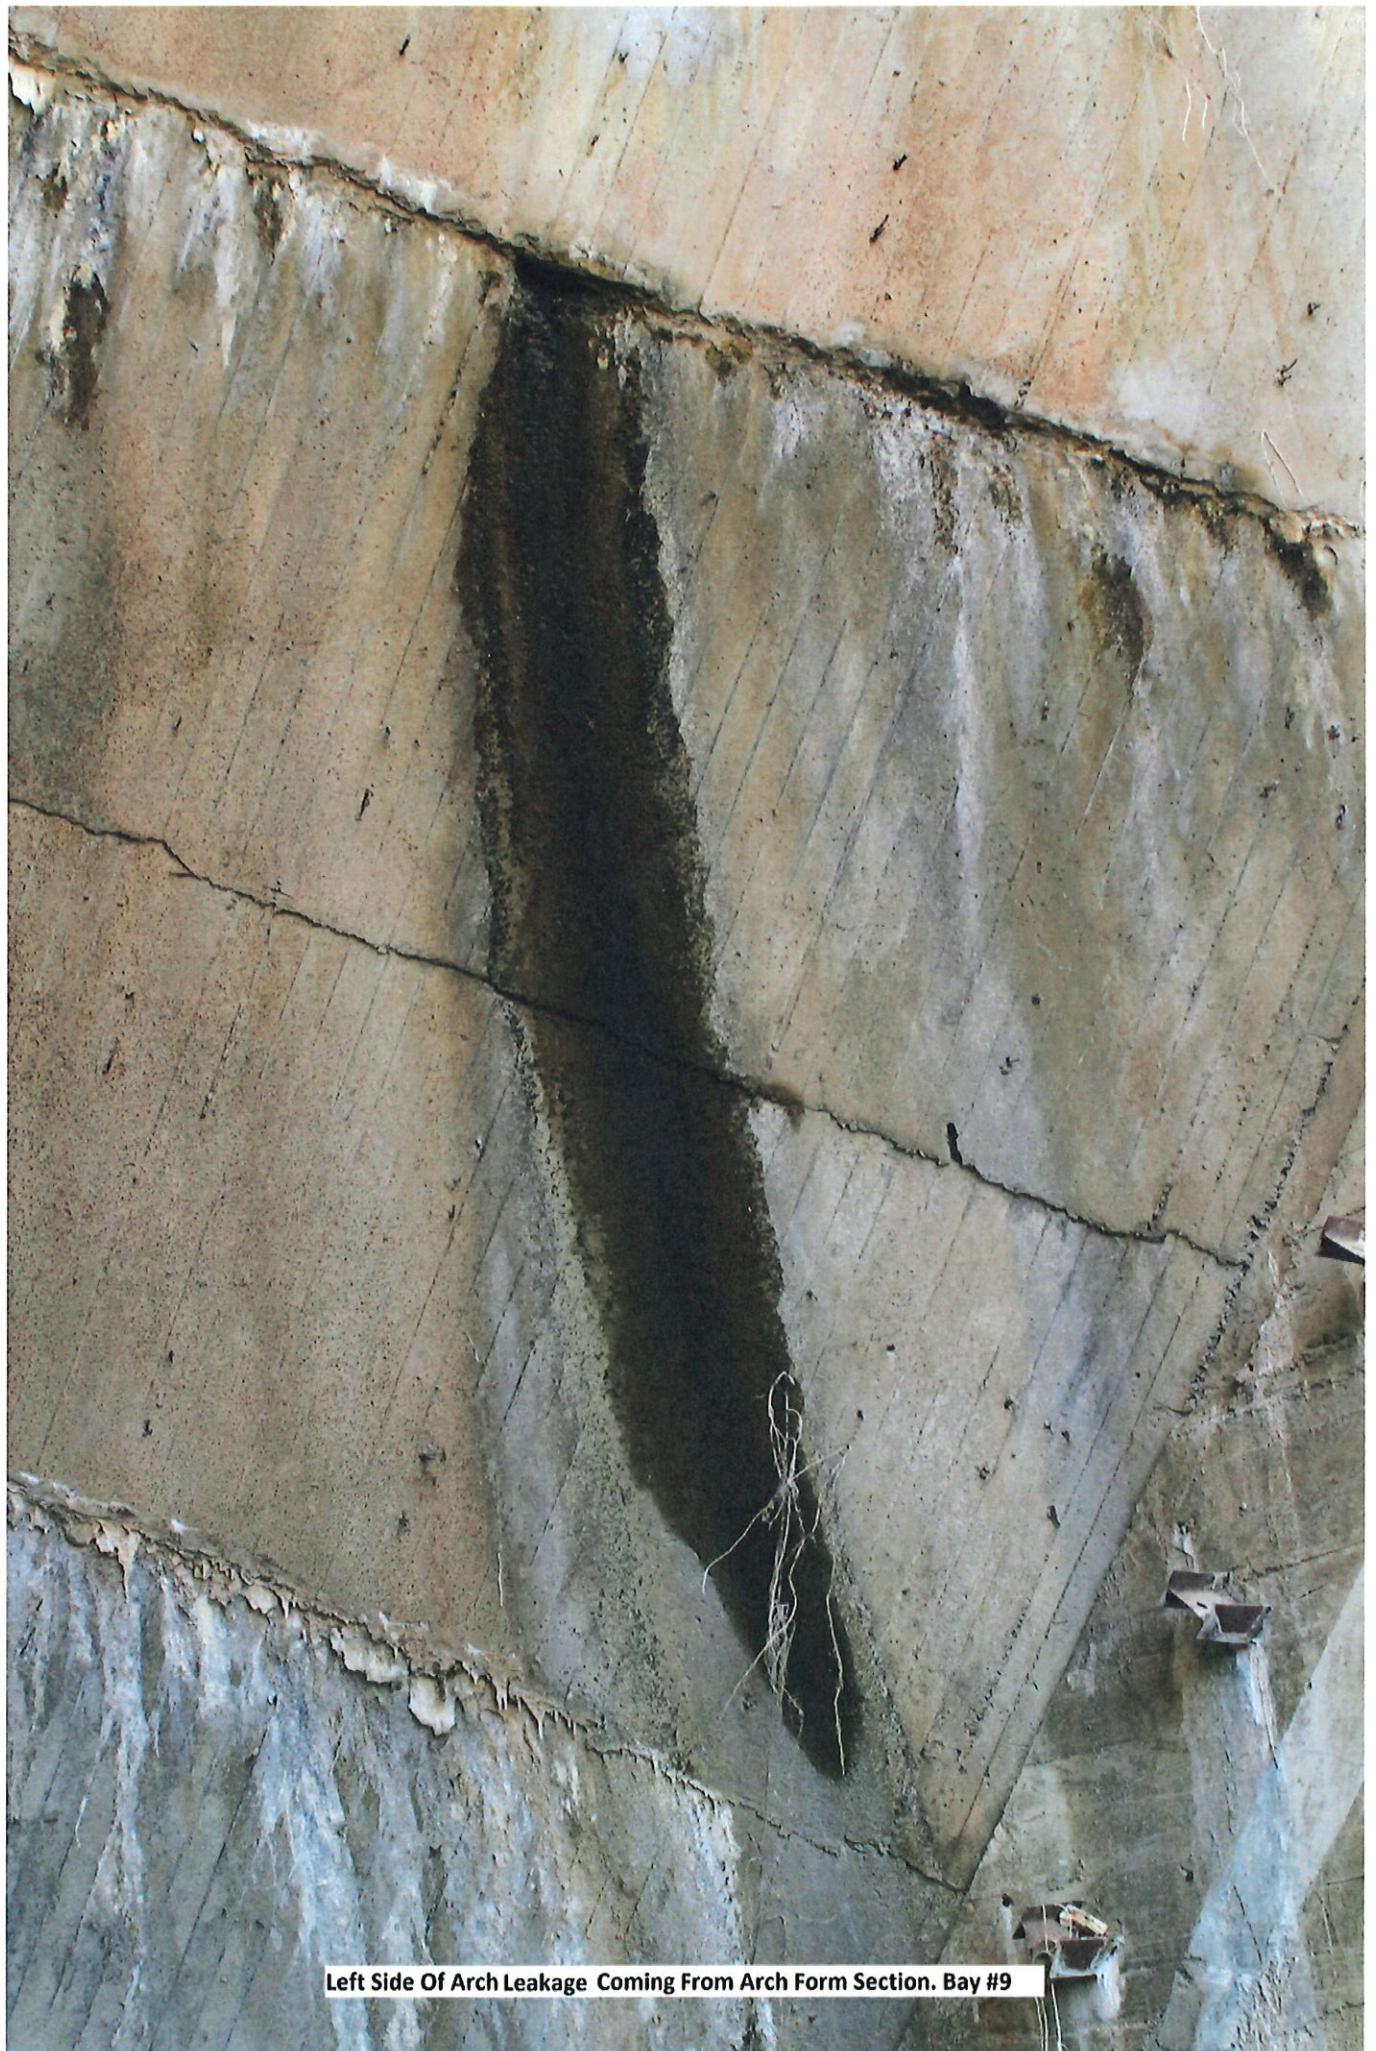
Left Side Of Arch Leakage Coming From Arch Form Section. Bay #9

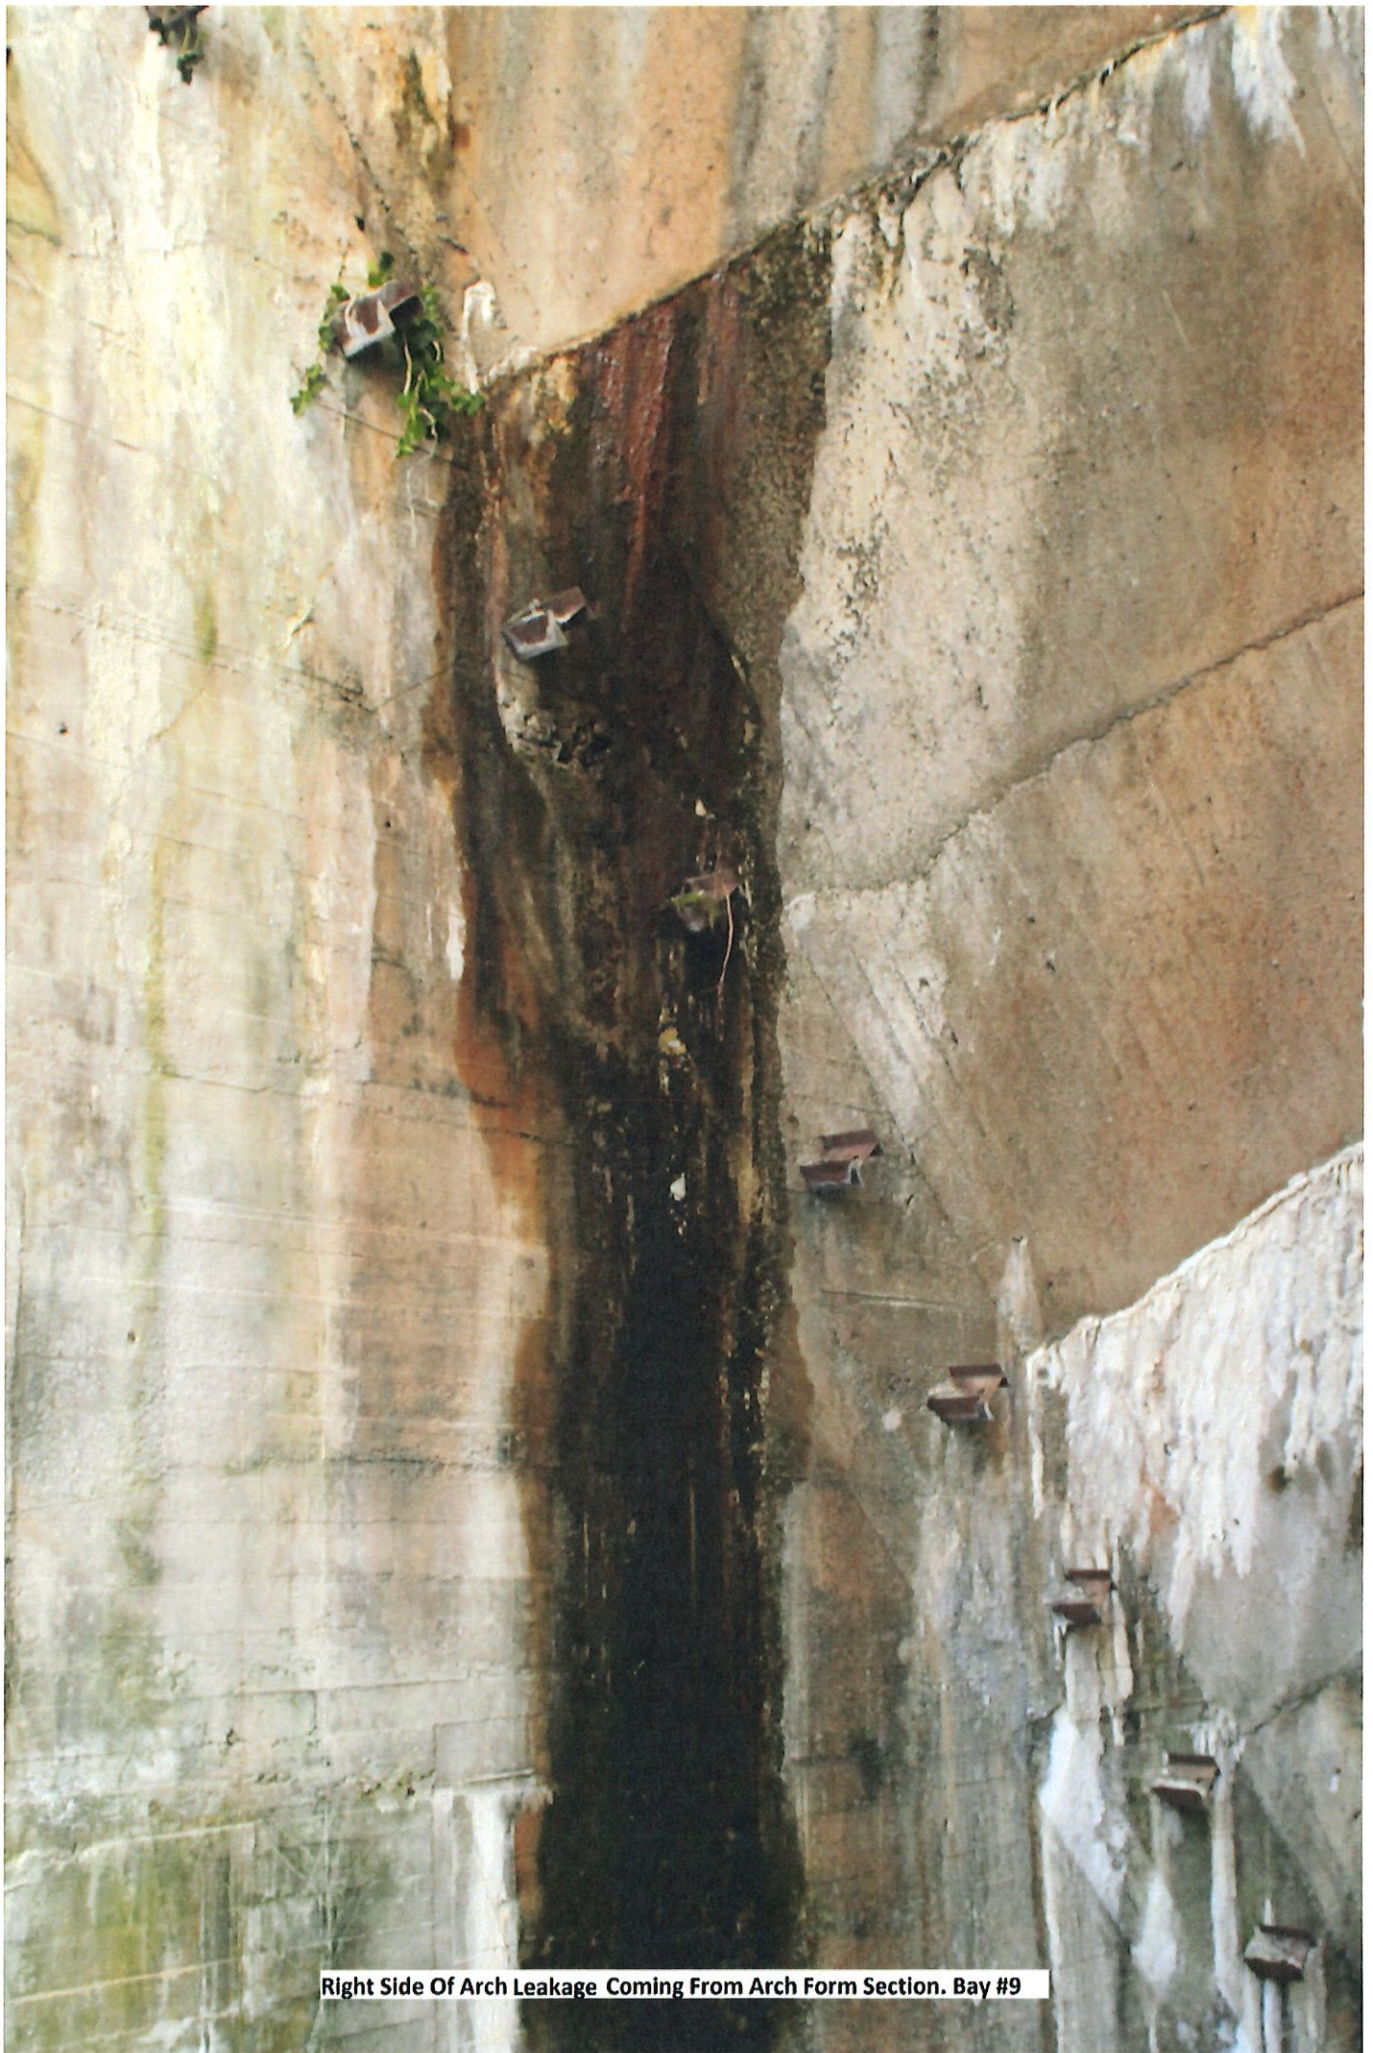
Right Side Of Arch Leakage Coming From Arch Form Section. Bay #9
