Front Of Power House. Bay #7

Aerial Overview of The Dam at Lake Lure

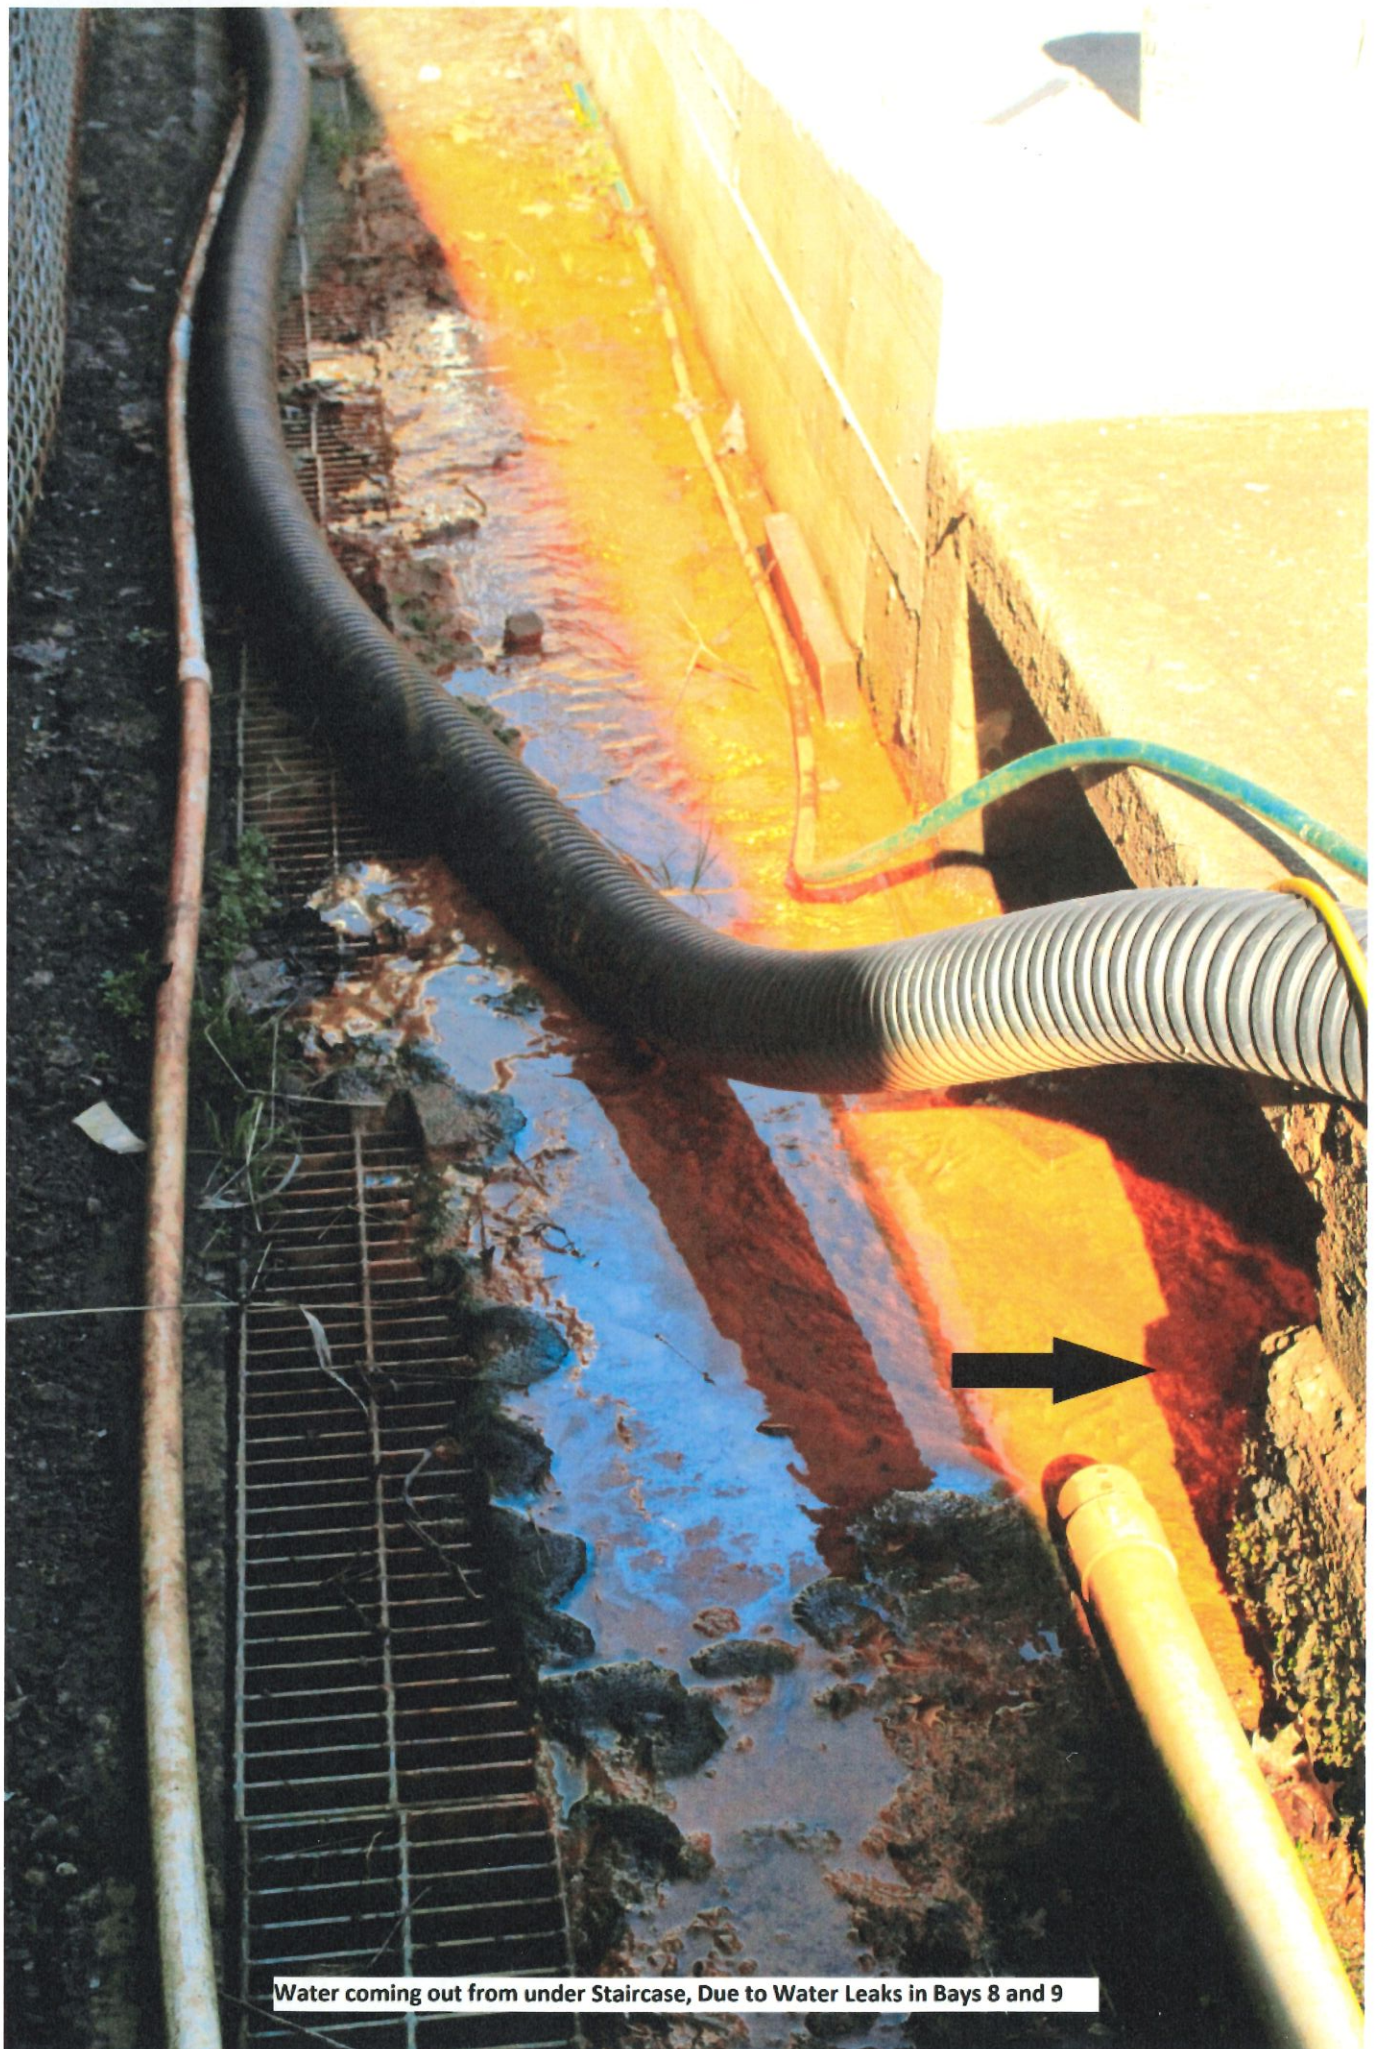
Water coming out from under Staircase, Due to Water Leaks in Bays 8 and 9

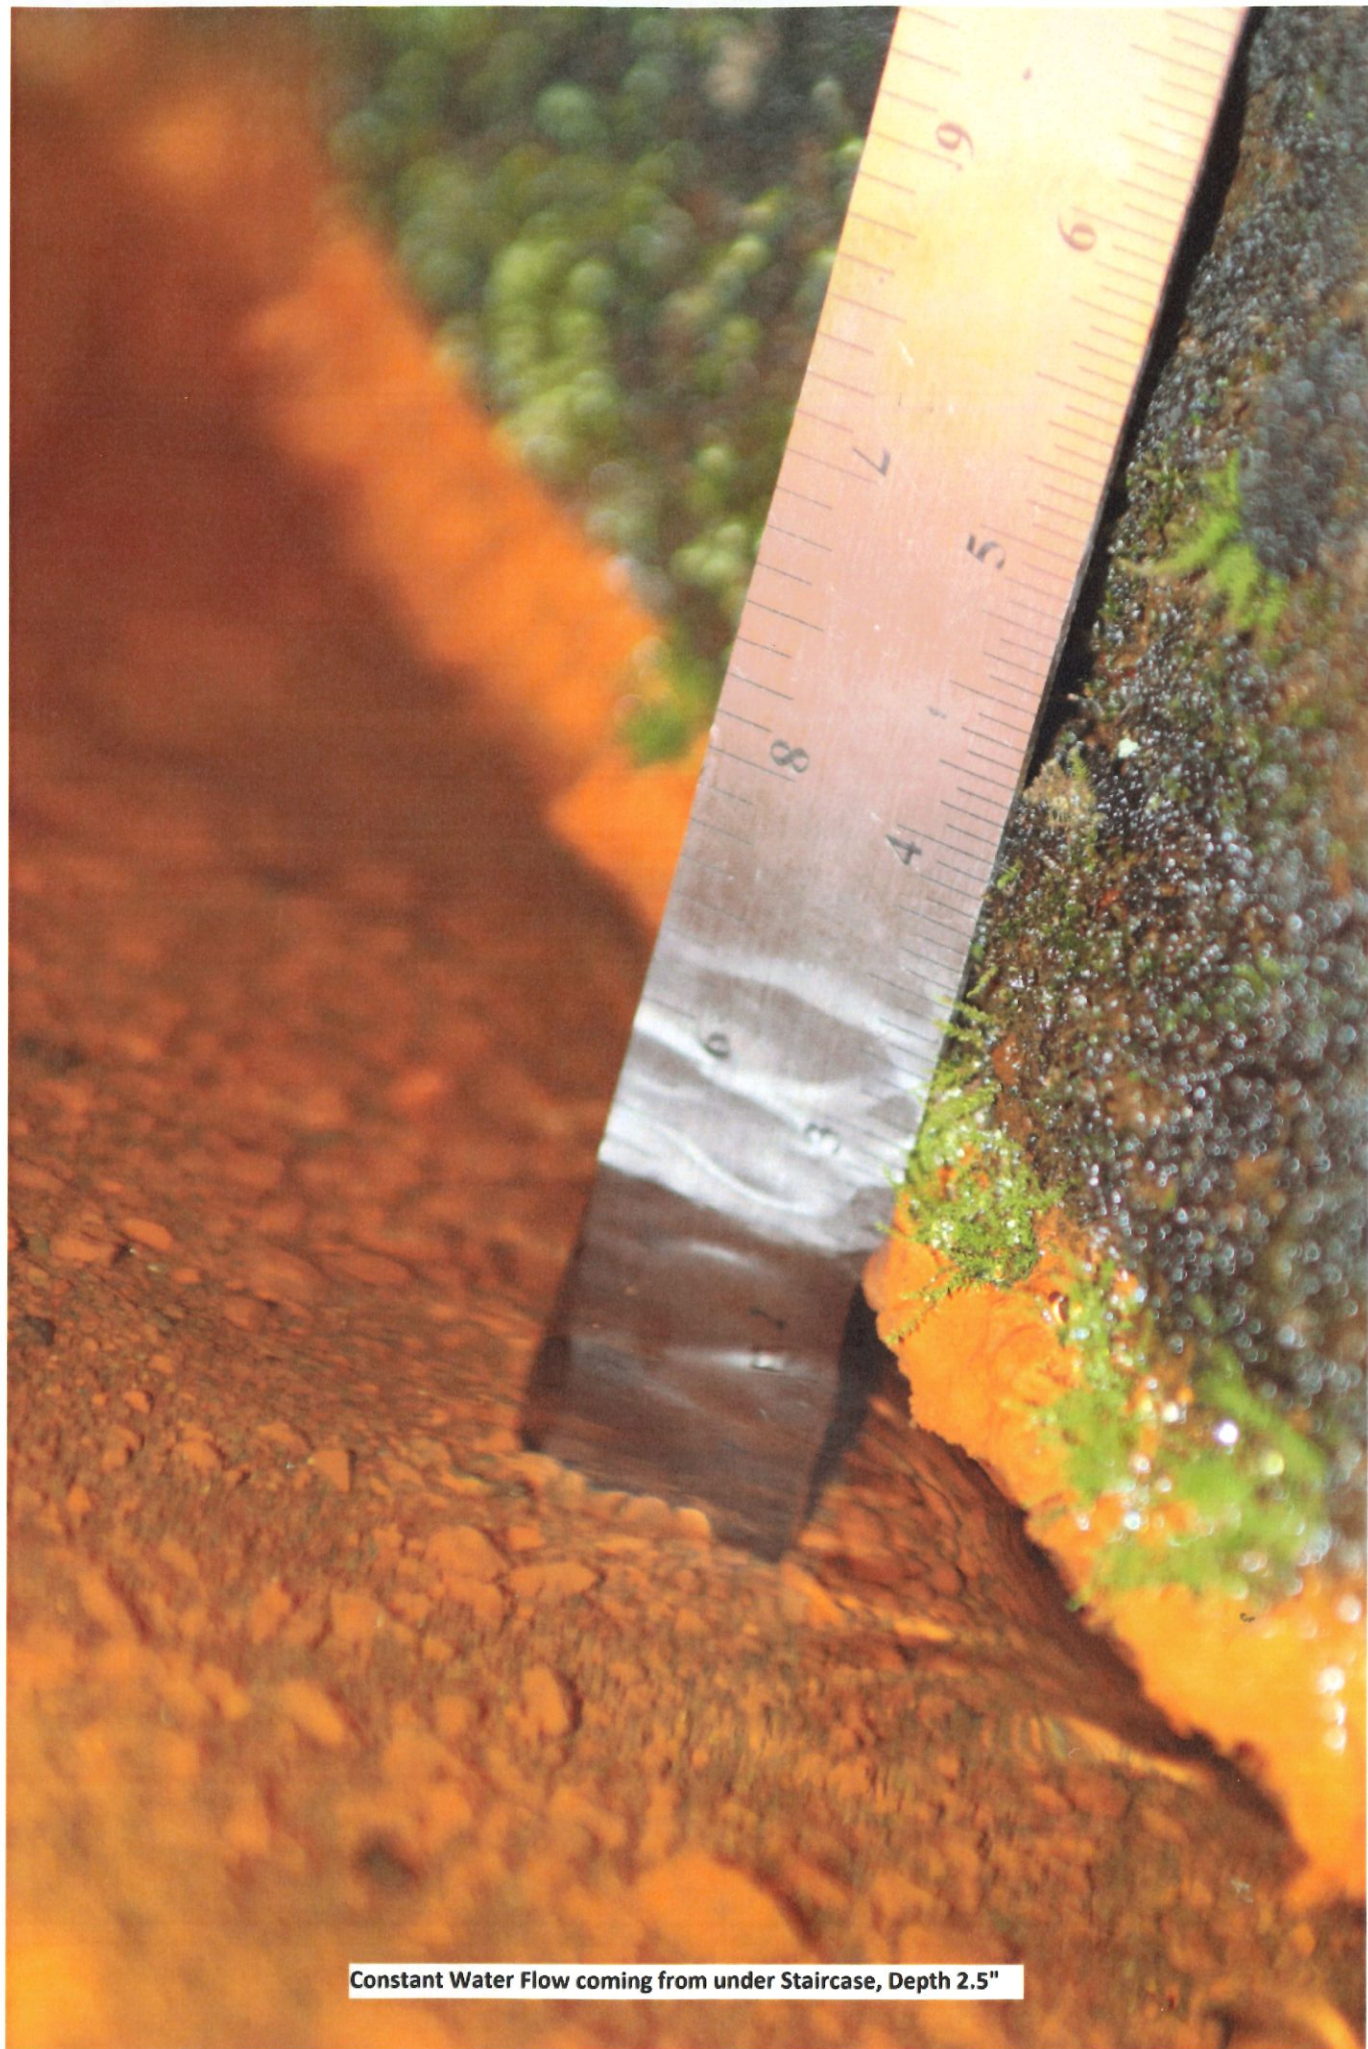
Constant Water Flow coming from under Staircase, Depth 2.5"
