# **POST-STORM EVENT EVALUATION REPORT**

**Lake Lure Dam and Hydroelectric Plant**

**NC Dam Identification No. RUTHE-003**

**Project No. ME – 18 – 005**

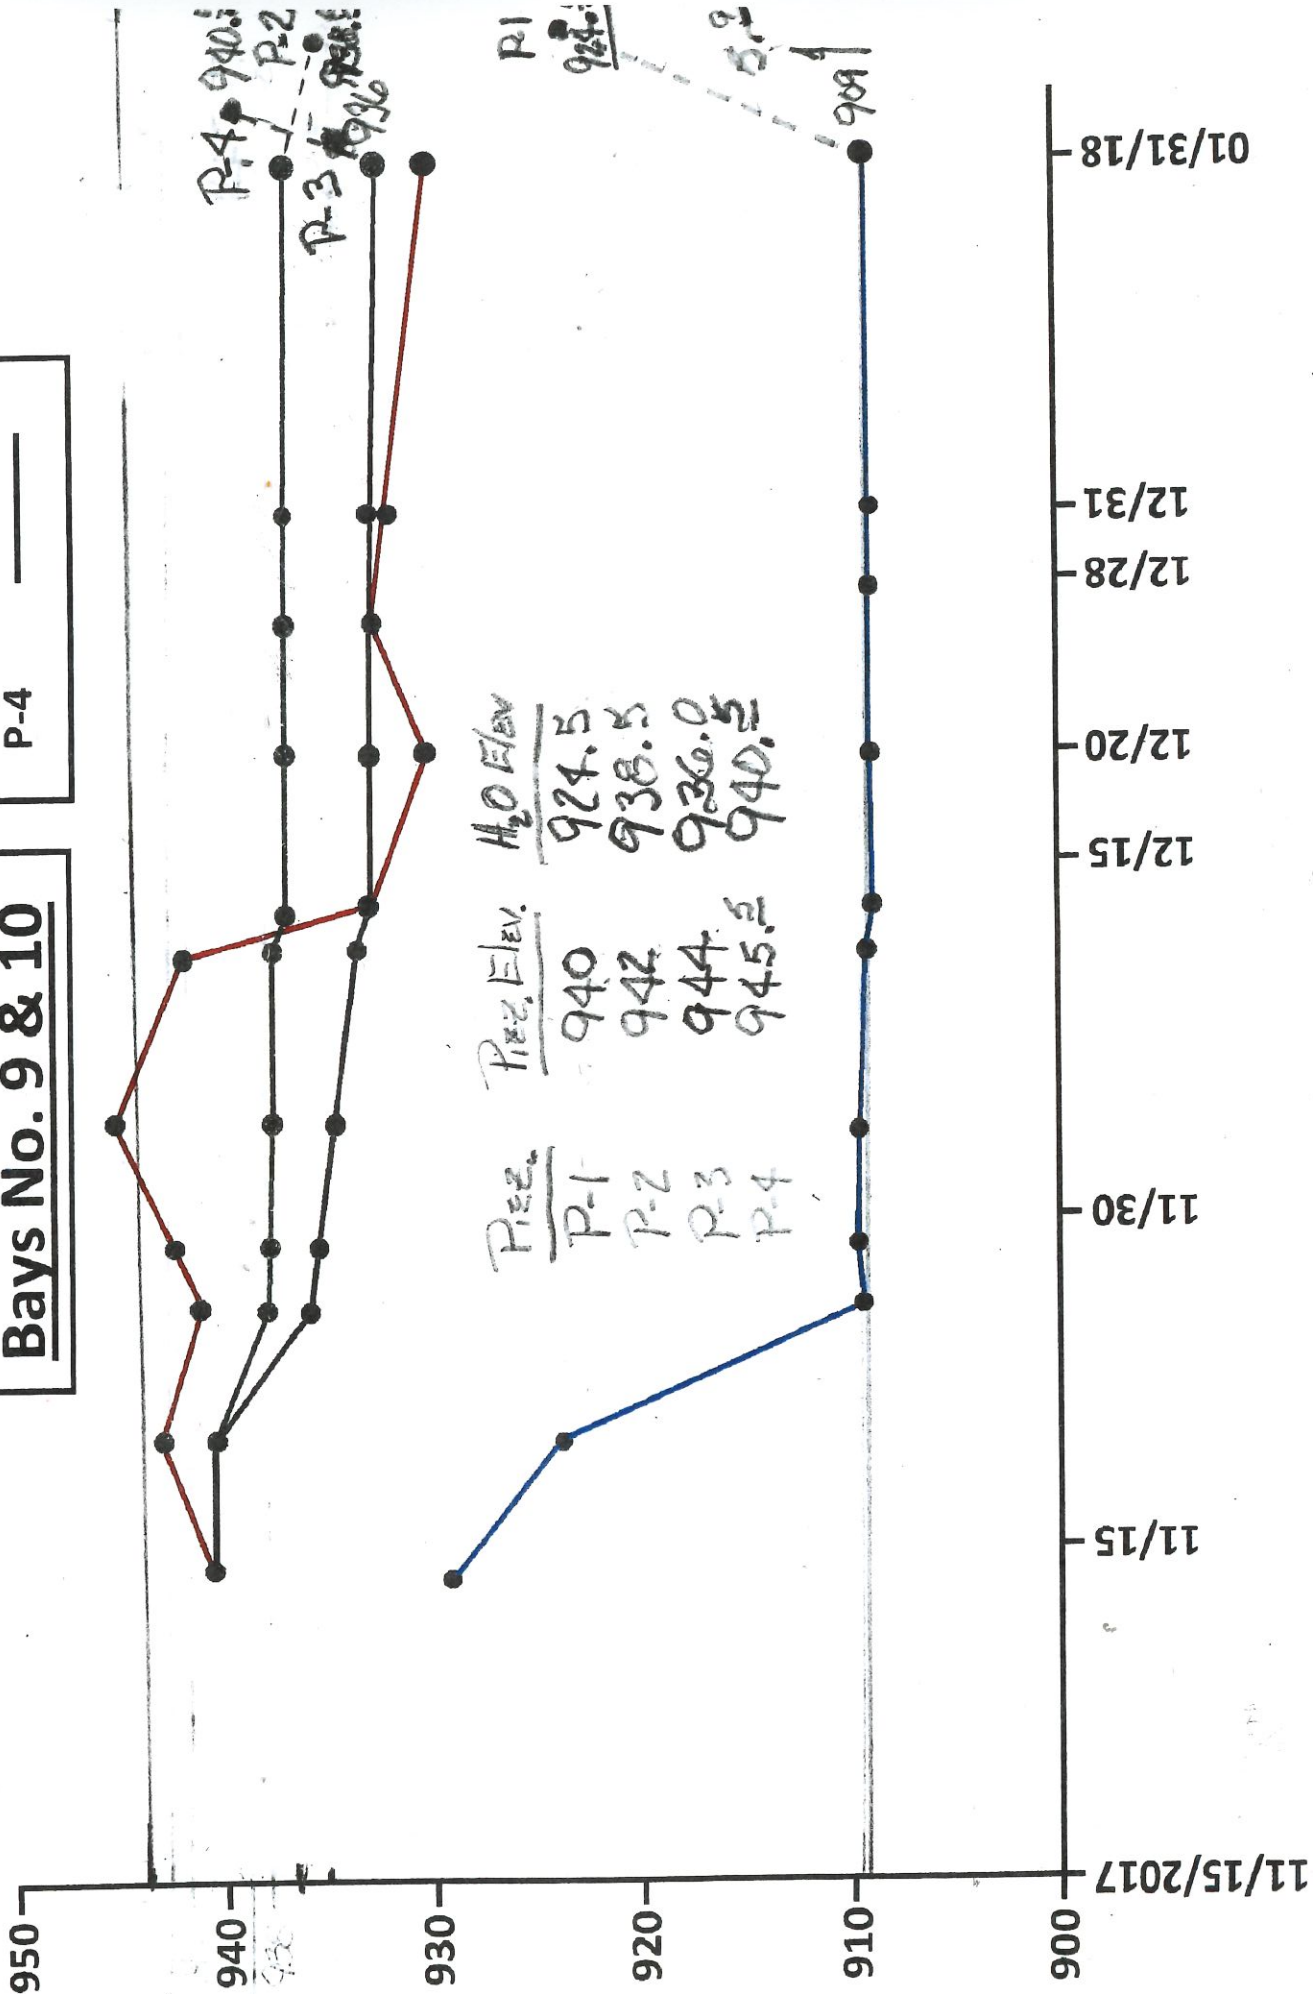
# Piezometer Data Lake Lure Dam Bays No. 9 & 10

Visual Observations (unusual or abnormal conditions):  
 BOF ~ 890 feet Uplift ~ 99.8 feet (100' x 62.4 pft = 6240 pft)  
 EXCESSIVE AMOUNT OF UPWARD SEEPAGE (PIPING) - 44' 62.4 pft  
 IN BAYS NO. 9, 10 & 11. EXCESS FLOW IS FLOODING CHANNEL TO WEIR & NOT BEING MEASURED (2746)  
 = 3494

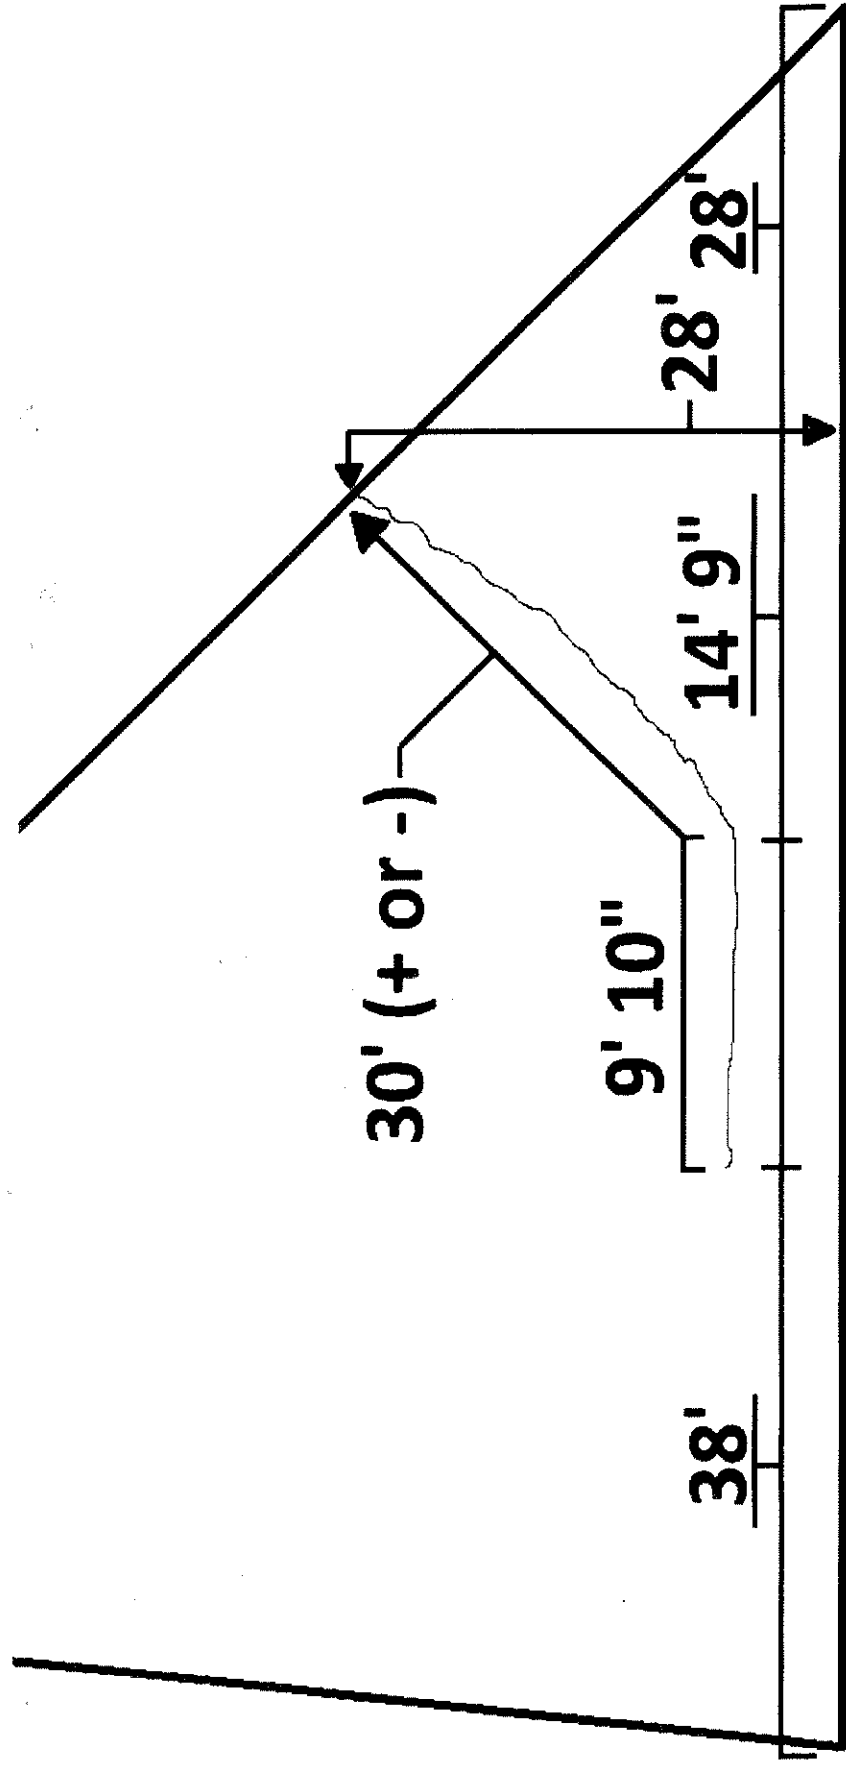
# Buttress #9 in Bay #8

The next most significant area of concern in the order of the inspection tour is the shear crack in Buttress No. 9 on the Bay No. 8 side of the buttress. The shear crack is thought to have been the result of the earthquake shock in December 2007. Remediation of this crack and stabilization of Buttress No. 9 is a portion of Task I of the remediation project for Lake Lure Dam. This item will be numbered as a situation that must remain under continual scrutiny until such time that it is addressed in the remediation construction.

Image Showing a large Stress Fracture

**8** Crack monitors capable of monitoring movement in two (2) planes will be installed within a month to begin numerical monitoring of any movement at the crack.

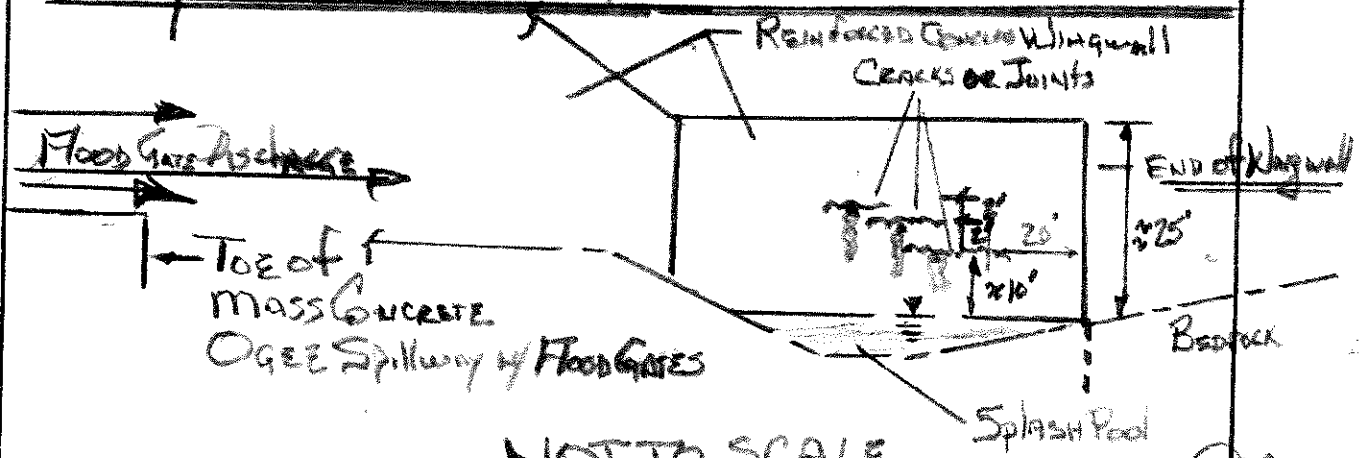
NEWLY IDENTIFIED LEAKAGE IN LEFT ABUTMENT WINGWALL
