## Town of Waynesville, NC

##### 4. McGill and Associates Engineering Report for the Waste Water Treatment Plant

# Table of Contents

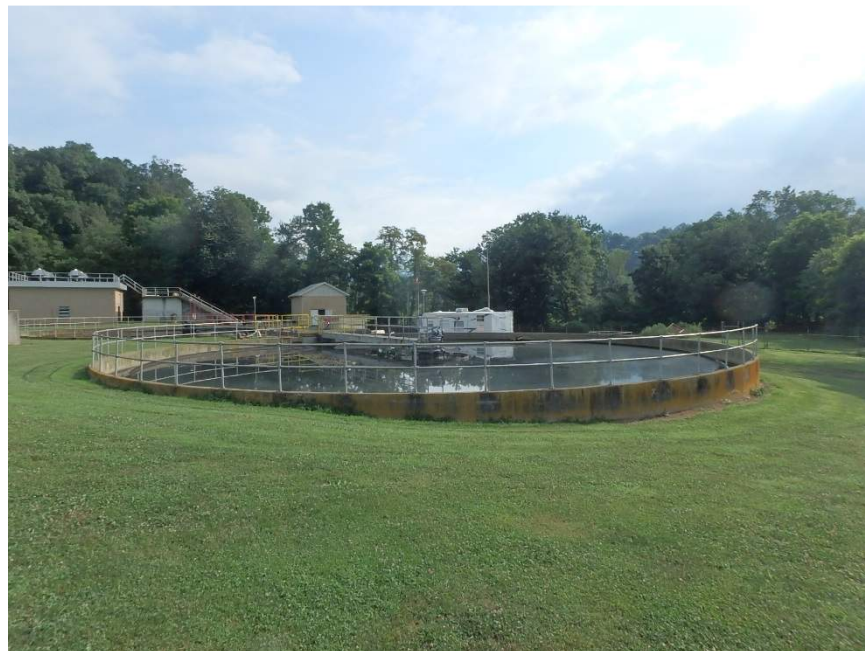
The concrete of the primary clarifiers was noted by Medlock & Associates to be in generally good condition. Vertical cracks in both clarifiers are likely due to shrinkage and not stress of the wall. However it was noted that while the south clarifier's cracks are typically dry and spaced approximately 6 feet apart, the north clarifier shows indicators of minor leakage, spalling, and delaminating concrete.

*Figure 2. Concrete at primary clarifier is stained but in generally good condition.*

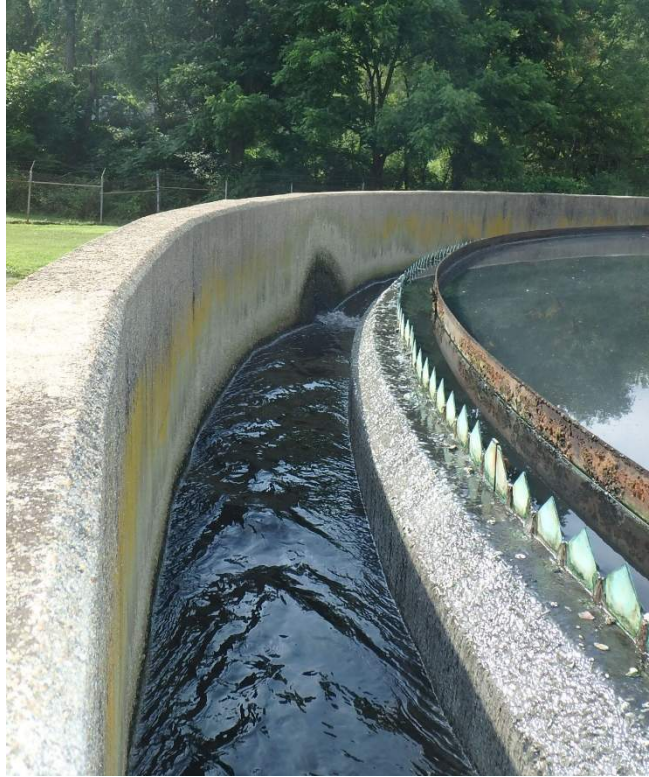
*Figure 3. Annular drainage trough at primary clarifier.*

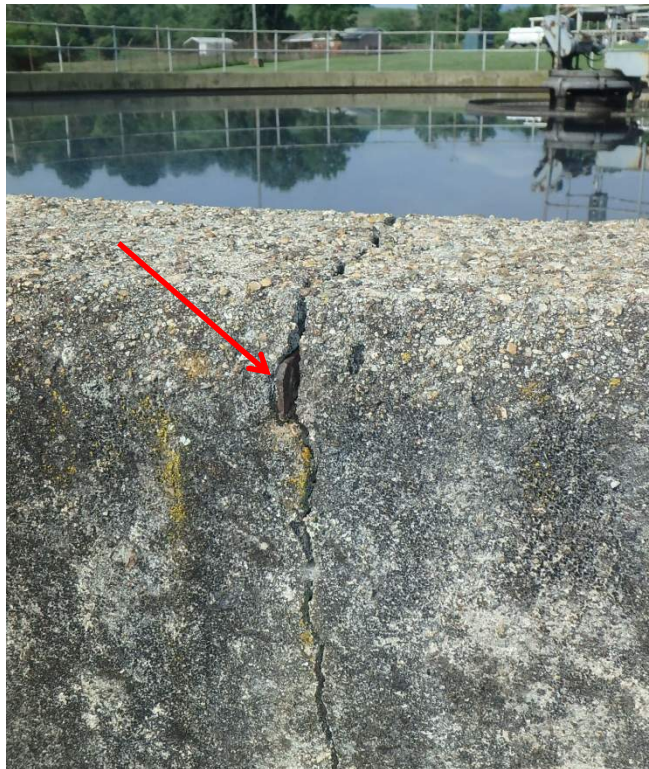
*Figure 4. Typical crack at primary clarifier. Red arrow indicates metal form tie.*

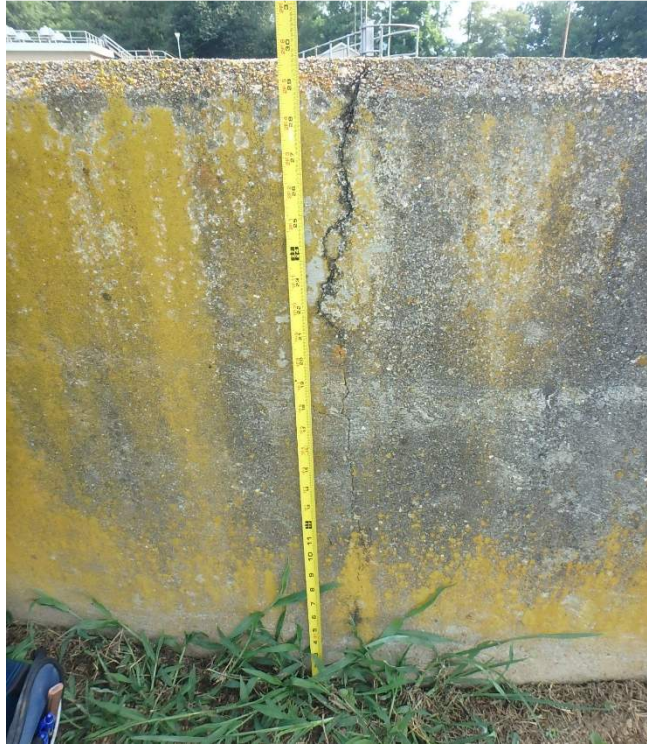
*Figure 5. Crack at primary clarifier with minor leakage.*

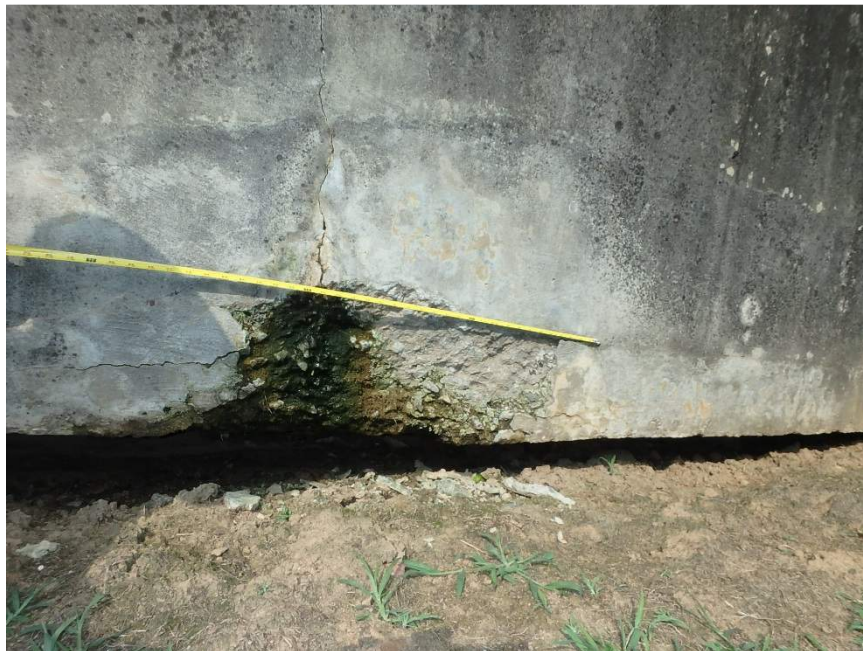
*Figure 6. Spalled concrete coincident with leaking crack at primary clarifier.*

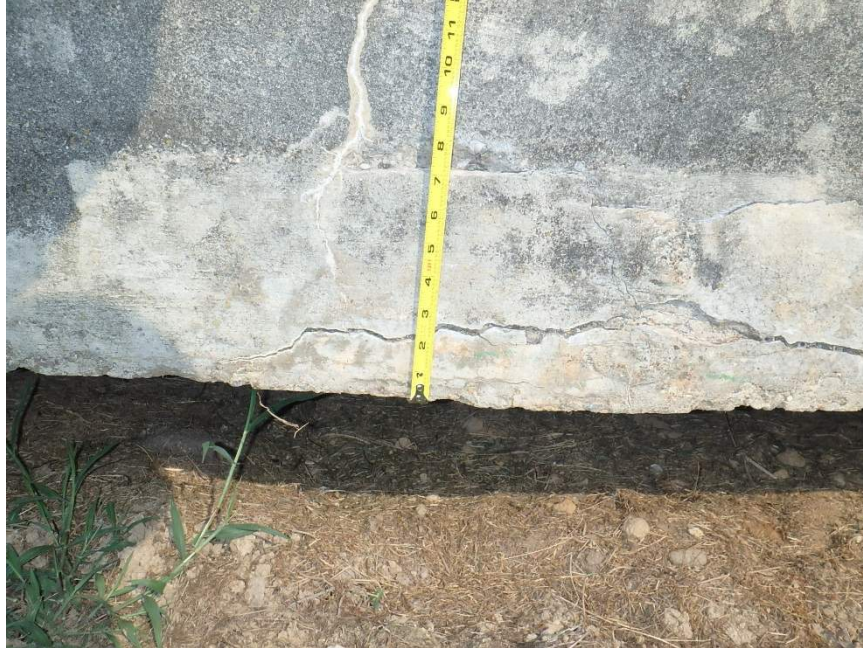
*Figure 7. Severely delaminated concrete at base of primary clarifier.*

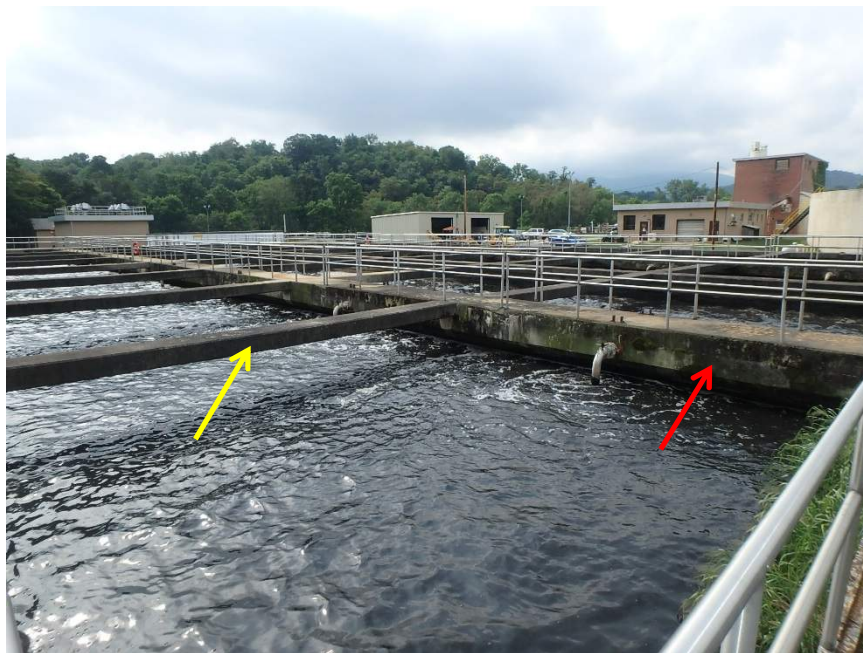
*Figure 8. Aeration basin. Walkway (red arrow) tops interior wall that separates chambers. Horizontal braces (yellow arrow) provide lateral stability to walls.*

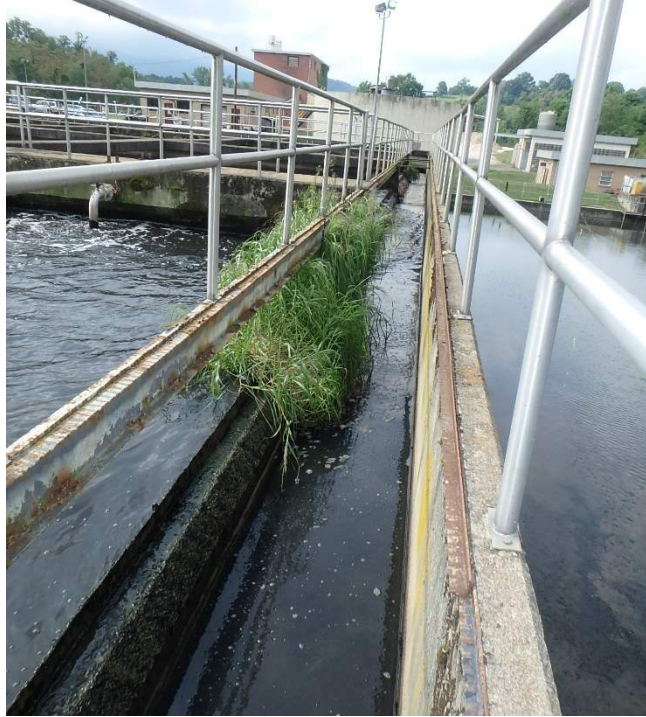
*Figure 9. Drainage trough at west end of aeration basin. Original steel grate used for walking surface has been removed. Note substantial vegetative growth.*

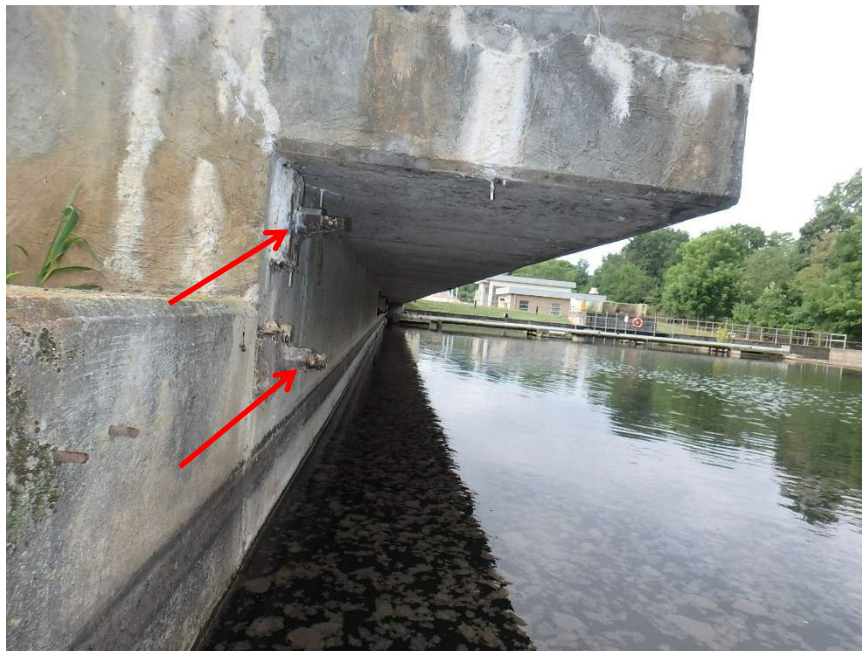
The end wall of the basin overhanging the secondary clarifiers appears to have shifted or moved in the past, and a supplemental wall was constructed against the inside face of the existing wall. The structural engineers' evaluation noted that the concrete of the aeration basin is in generally good condition, but exhibits greater deterioration than the concrete of the primary clarifiers. The basins exhibit some leakage at joints and inlet pipes. It was noted that deterioration of the concrete basins appears to be mostly due to the corrosive environment and freeze-thaw cycles, but that the basin is generally structurally sound, and that the interior walls have sufficient structural capacity to safely support hydraulic loads due to water level imbalances.

*Figure 10. Anchor rods (red arrows) installed as retrofit presumably intended to arrest excessive lateral movement of west perimeter wall of aeration basin.*

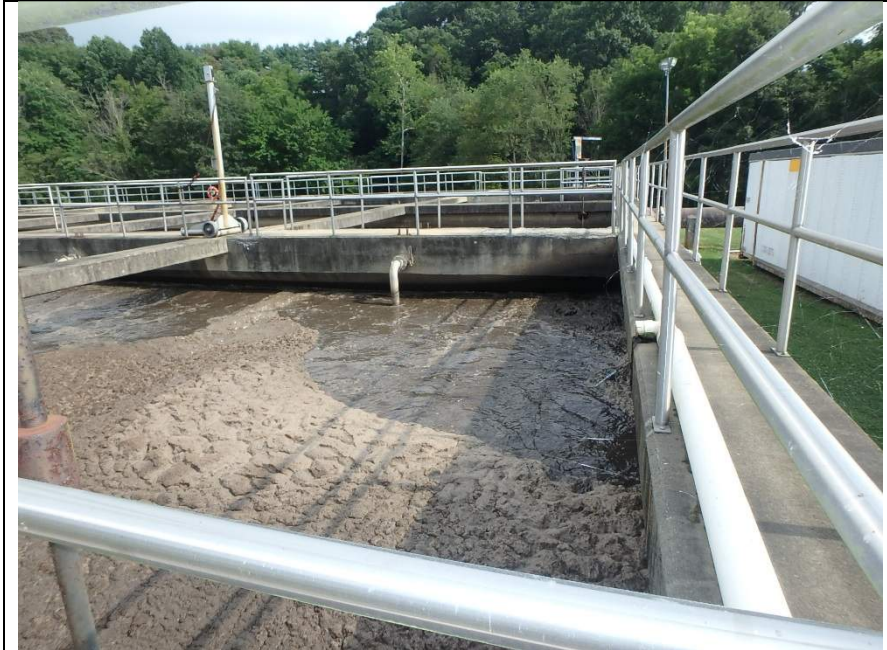
*Figure 11. Concrete at aeration basin is in generally good condition.*

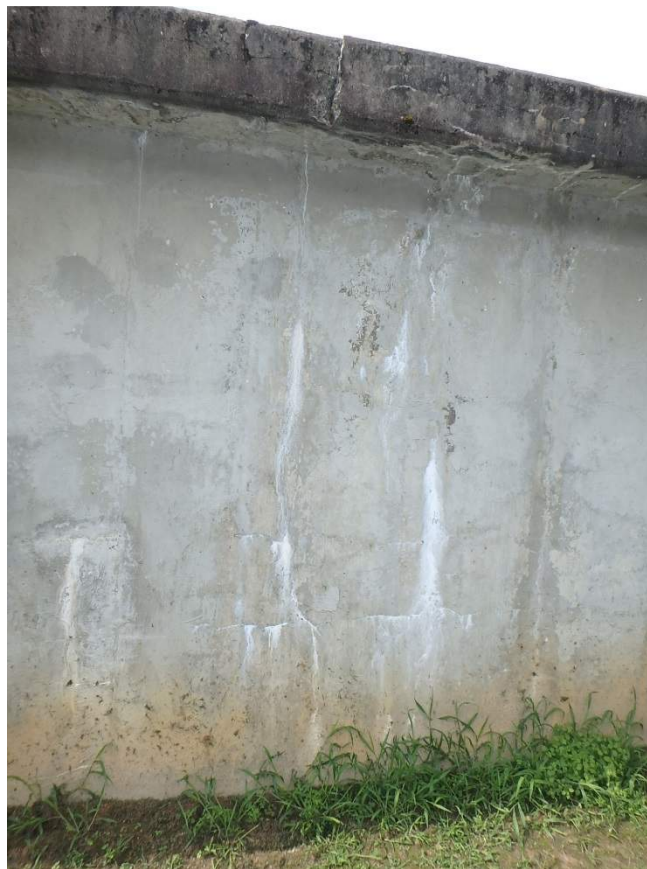
*Figure 12. Typical cracks with efflorescence at north perimeter wall of aeration basin*

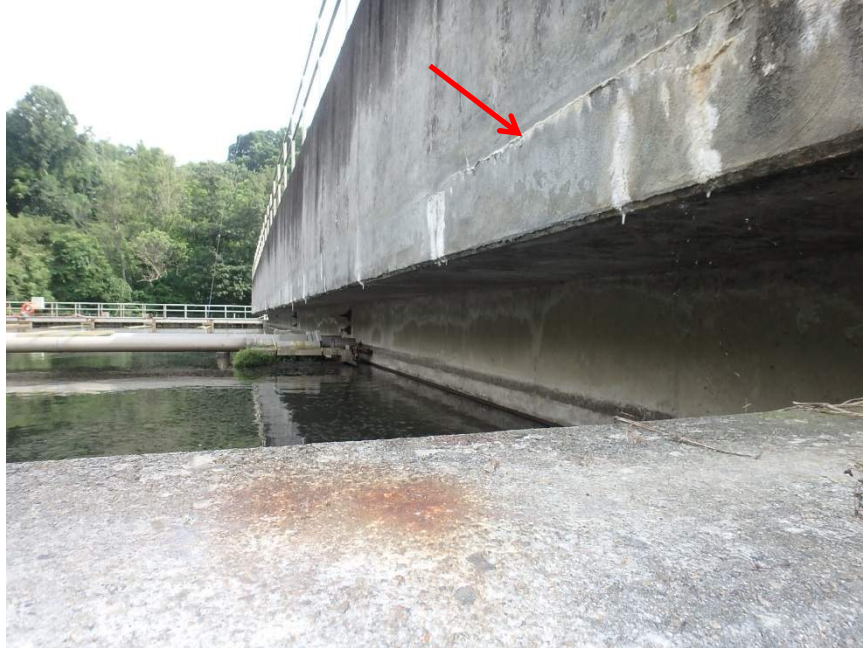
*Figure 13. Continuous horizontal crack and efflorescence (red arrow) indicate seepage through cold joist at drainage trough wall.*

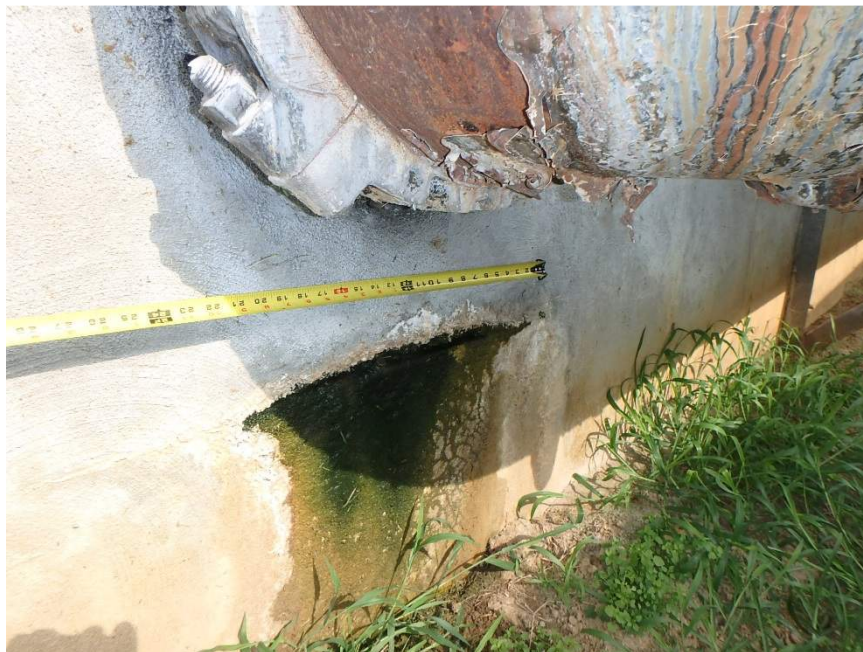
*Figure 14. Crack with substantial leakage at east perimeter wall of aeration basin.*

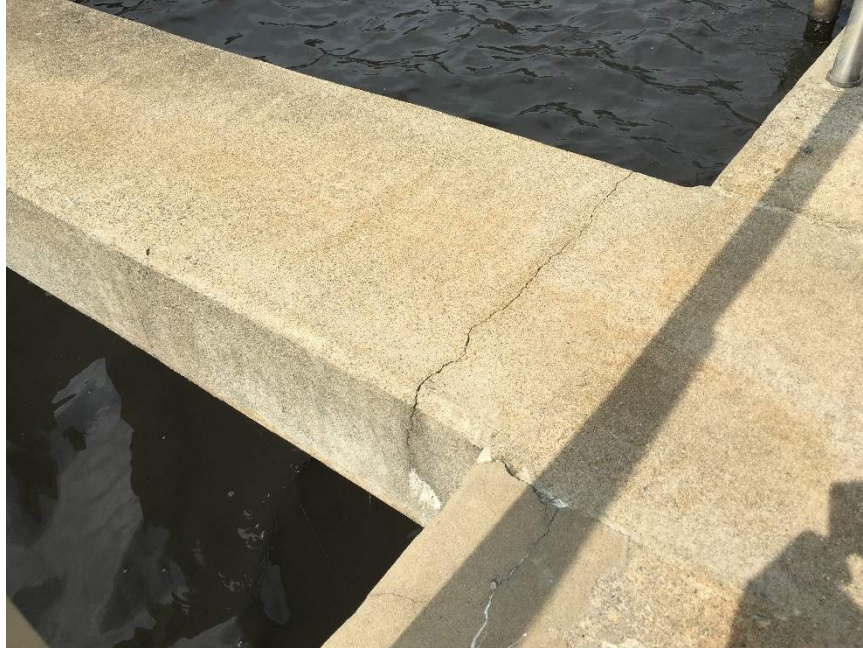
*Figure 15. Minor flexural crack and delaminating concrete at horizontal brace.*

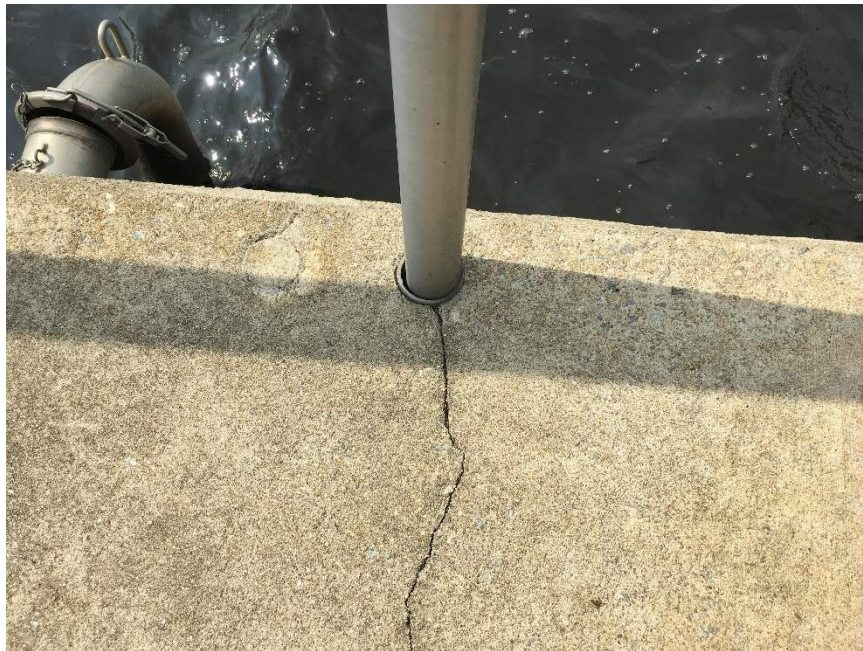
*Figure 16. Freeze-thaw cracking at guardrail post penetration.*

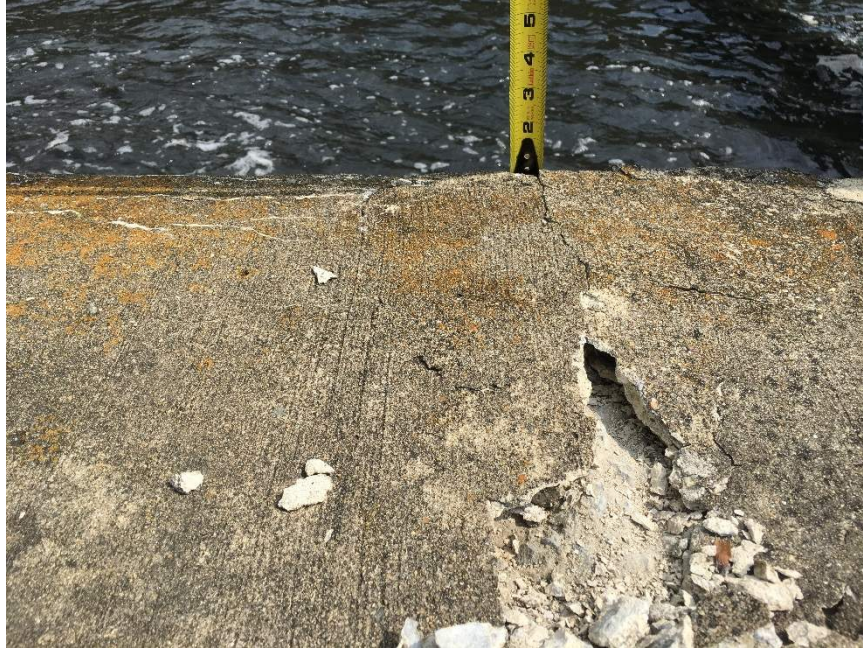
*Figure 17. Localized delaminations and spalling at aeration basin walkway.*

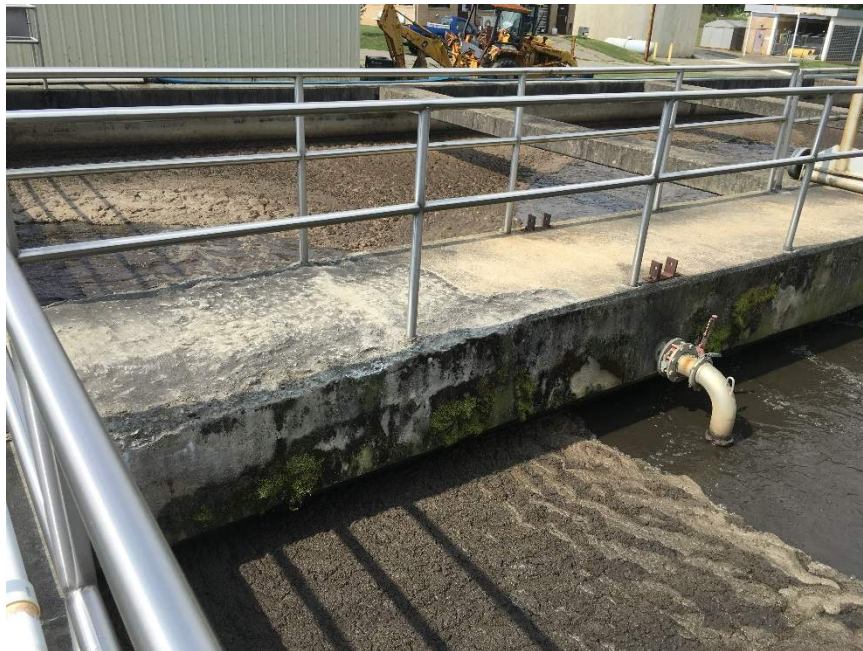
*Figure 18. Widespread spalling and raveling of concrete at aeration basin walkway.*

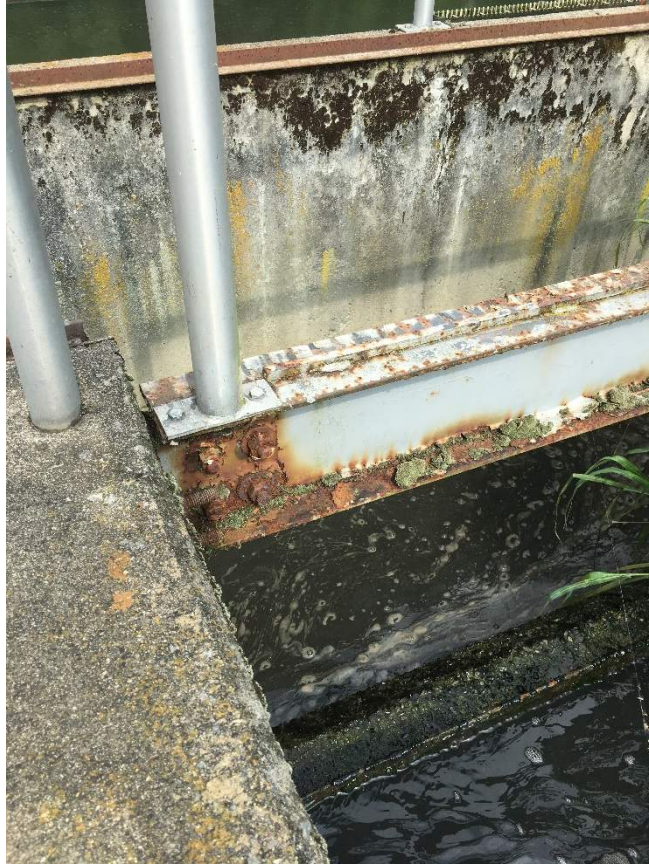
*Figure 19. Corrosion at steel beam at embedded plate connection.*

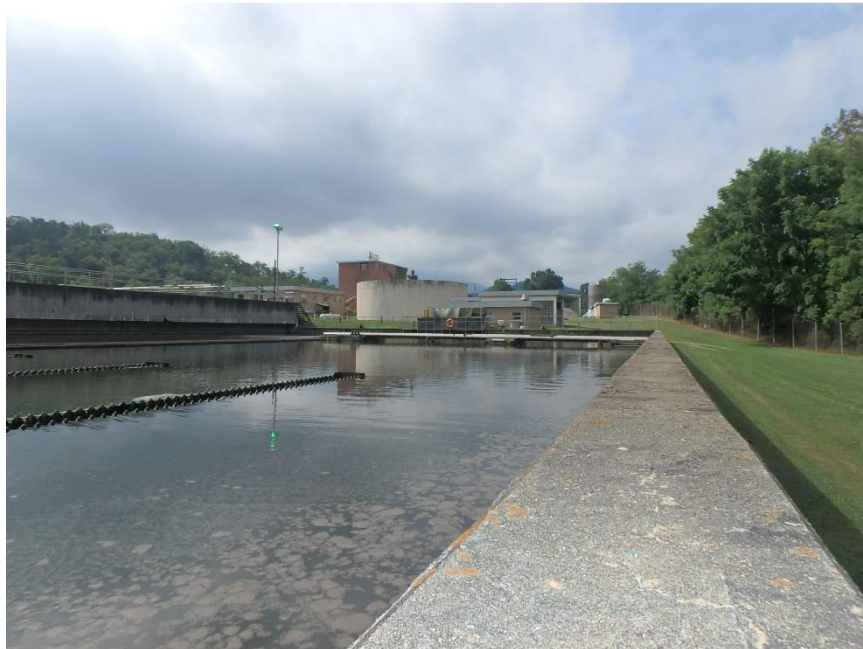
The structural engineers' evaluation noted that the concrete of the secondary clarifier is in generally good condition and typically sound, but shows regular vertical cracks similar to those observed on the primary clarifiers with areas of spalling and delamination. Seepage was observed at several locations.

*Figure 20. Concrete at secondary clarifier is in generally good condition.*

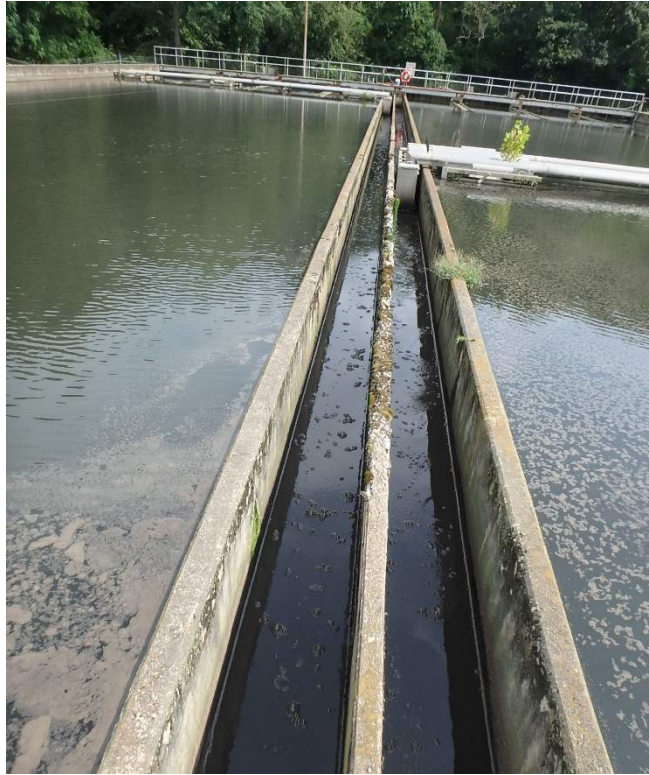
*Figure 21. Central rough at secondary clarifier.*

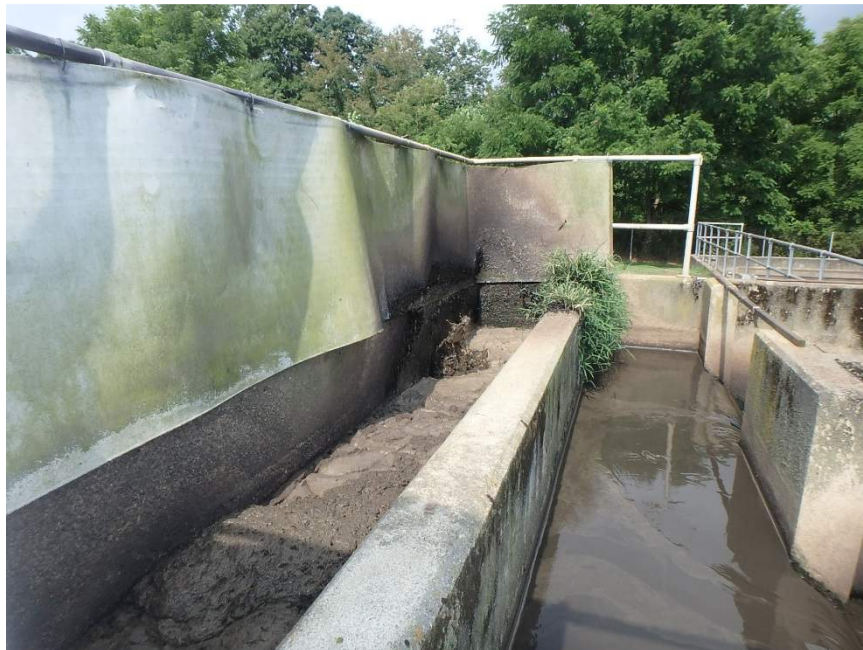
*Figure 22. Sludge diversion channel at west end of secondary clarifier. Note vegetative growth.*

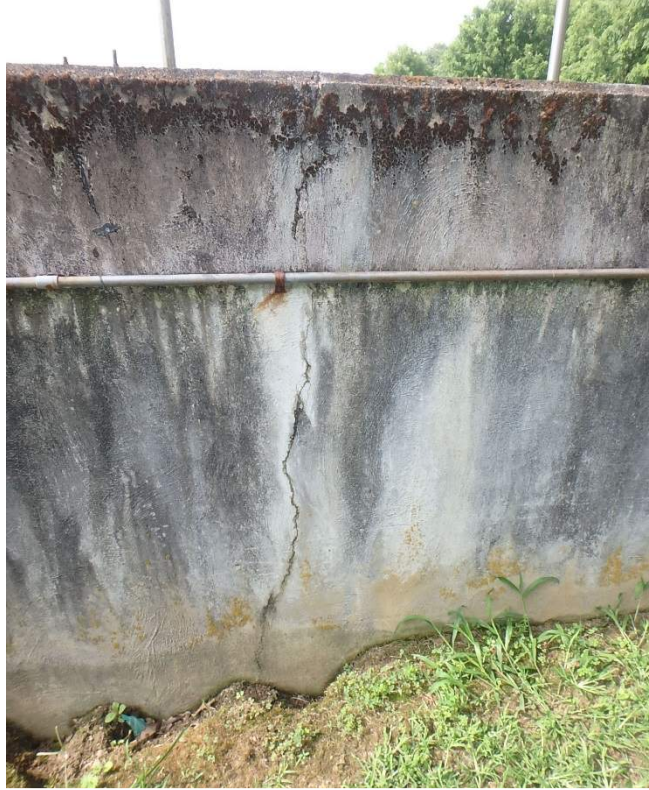
*Figure 23. Typical crack at secondary clarifier.*

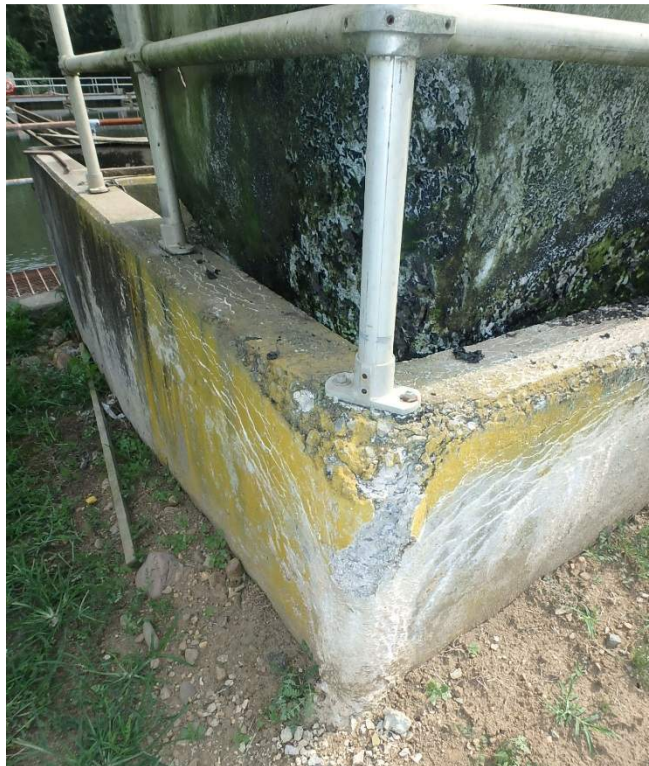
*Figure 24. Spalling concrete at guardrail anchorage at secondary clarifier.*

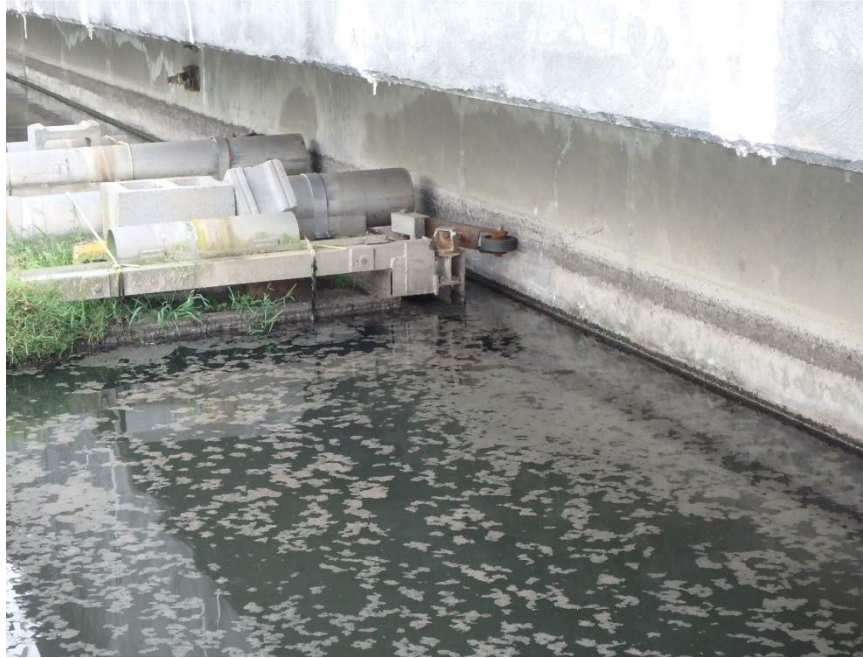
*Figure 25. Abraded concrete along path of skimmer arm guide wheel.*

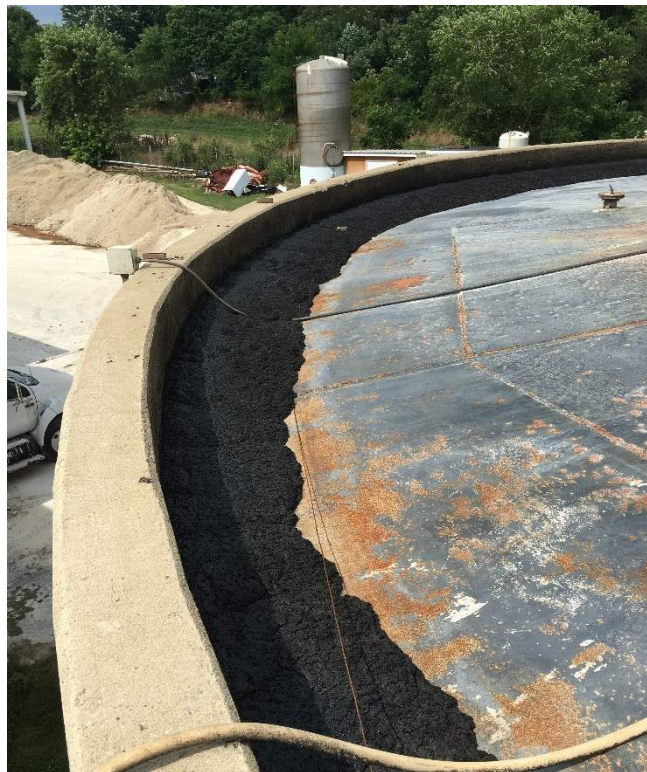
*Figure 26. Exterior concrete wall and steel-clad roof of digester.*

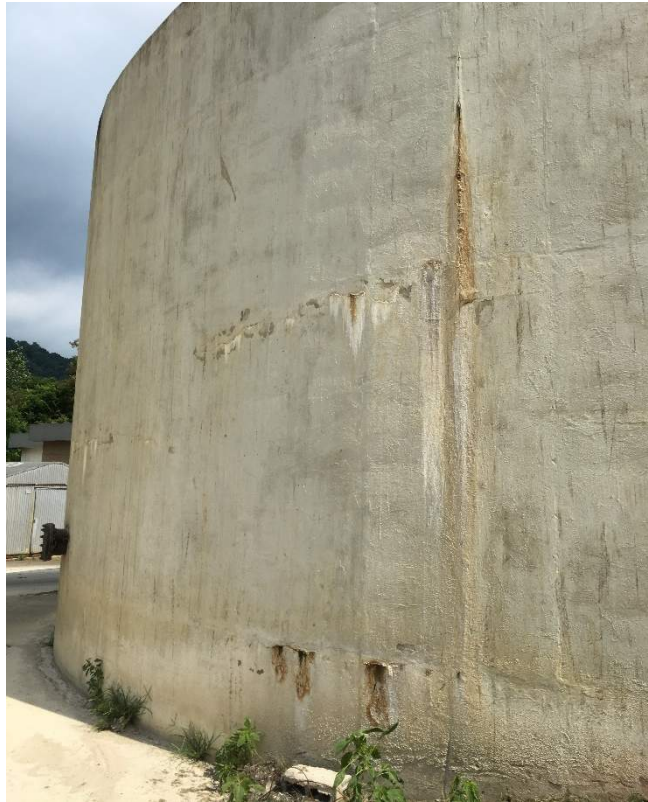
The sludge thickeners are typically structurally sound, but do have some leaks. The anaerobic digester is in generally good condition with minor seepage and cracks. Operations staff have noted that the location of the mechanical equipment on the roof of the digester makes maintenance difficult due to the lack of accessibility and the potential danger of operating welding equipment in close proximity to digester gas.

*Figure 27. Cracks with efflorescence and corrosion staining at digester.*

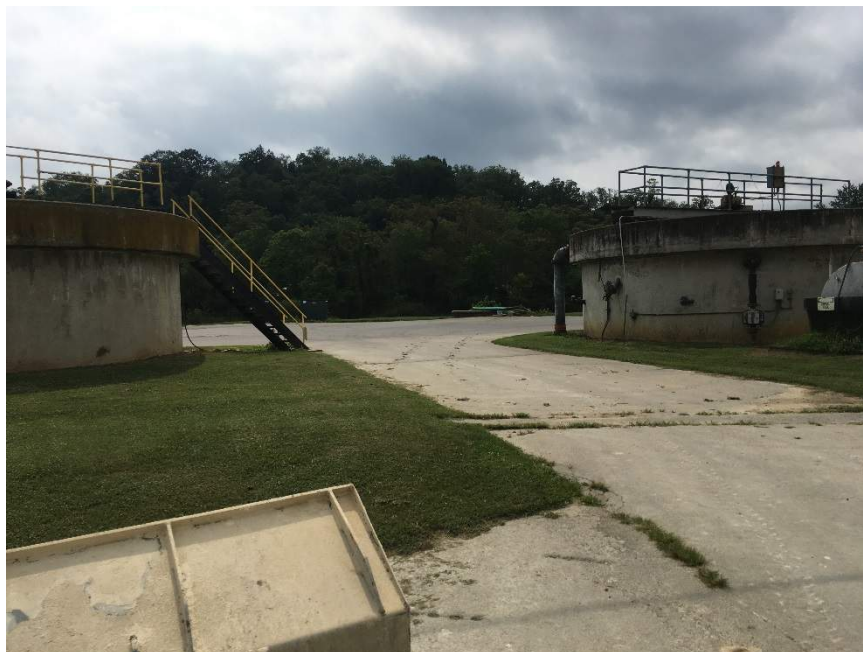
*Figure 28. Sludge thickener structures. Concrete is in generally good condition.*

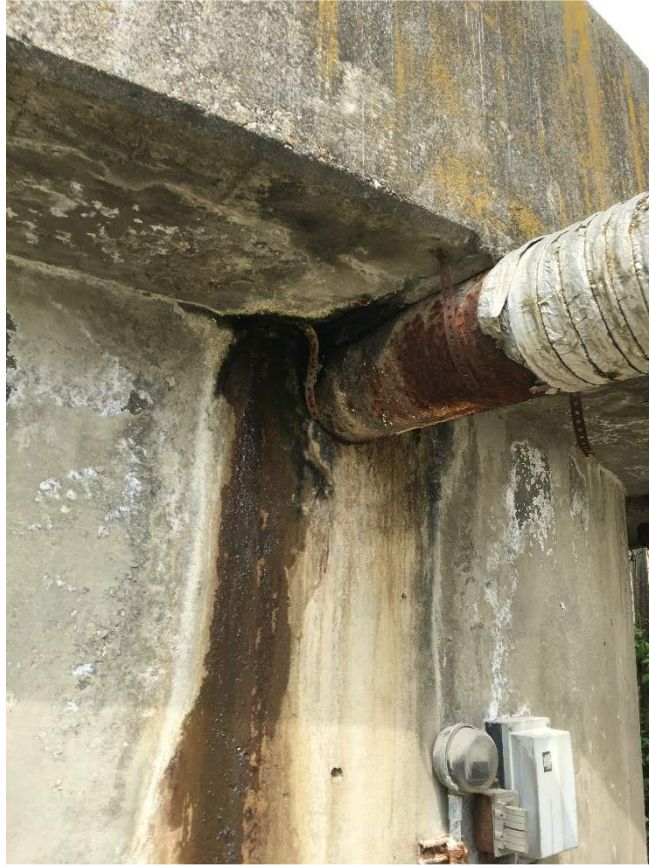
*Figure 29. Leaking pipe at north-most sludge thickener.*
