Field Investigation and Provisional Map of the Buffalo Creek Debris Slide Rutherford County, North Carolina

May 13, 2019

North Carolina Geological Survey

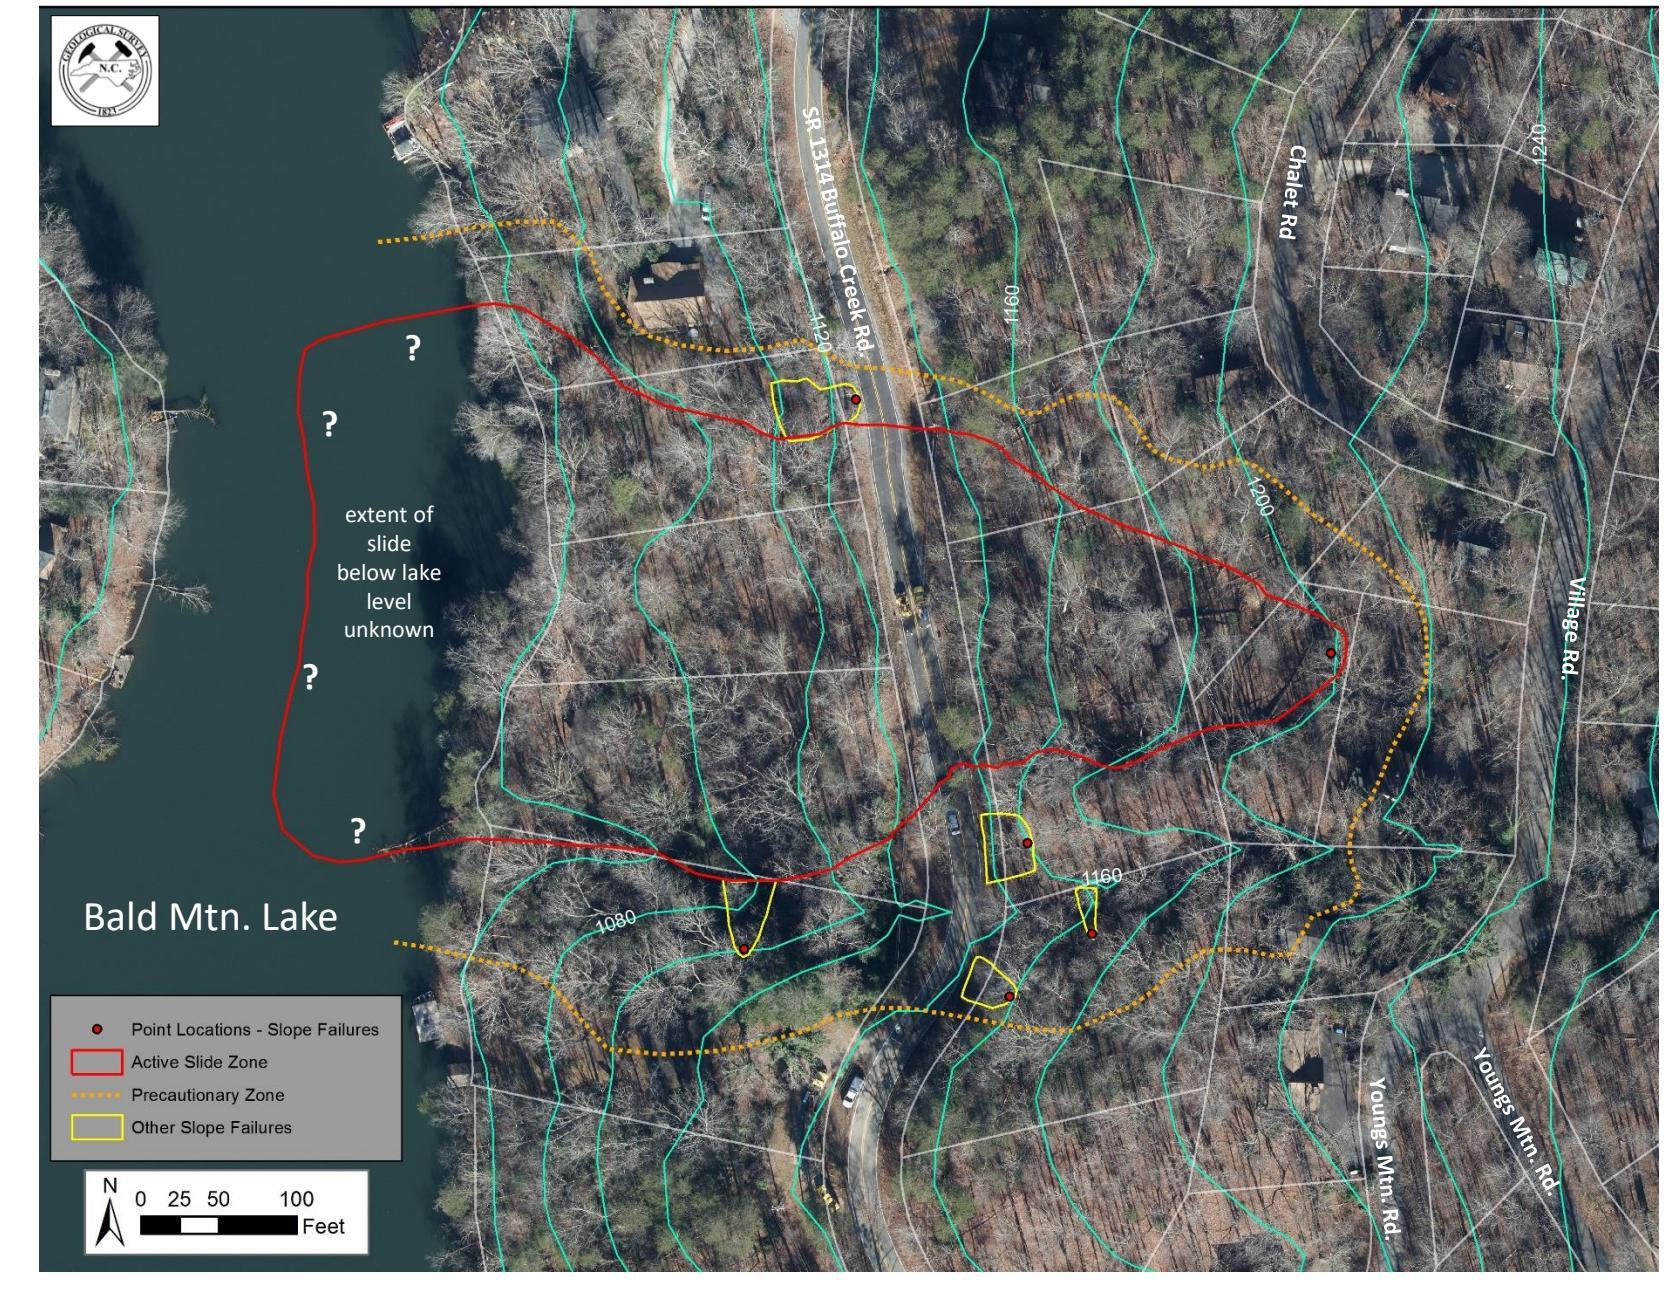
The active slide zone shown in Figure 2 encompasses the area with evidence of ground movement associated with the Buffalo Creek debris slide. The total area of the active zone is approximately 3.6 acres, which includes as much as 1 acre below lake level. Inclinometer data provided by the NCDOT indicate that slide movement is on the order of 42-55 feet below ground surface in portions of the slide. Depths and rates of movement within the slide mass vary. Rates of movement vary over time, and are probably on the order of inches/year to as much as feet/month.

Evidence of ground movement within the active slide zone includes the following:

- Ground rupture (i.e., scarps and tension cracks)
- Leaning and/or downed trees
- Bulging and/or subsidence of the ground surface
- Cracked and broken pavement on Buffalo Creek Road (SR 1314)
- Displacement of NCDOT survey monitoring points
- Deflection of NCDOT slope inclinometer casings.

The precautionary zone shown in Figure 2 delineates the area around the active slide zone that is potentially unstable, or could become unstable with enlargement of the active zone of the Buffalo Creek debris slide.

Slopes within the precautionary zone meet one or more of the following criteria:

- Deposits from past landslide activity are exposed at the ground surface and excavated slopes.
- Located within the area interpreted to be part of prehistoric and historic slope movements involving the present day Buffalo Creek debris slide.
- Ground cracks on the margins of the active slide area are present.
- Include small debris slides on steep slopes of adjacent drainage ways (flanks of related prehistoric-historic slope movements involving the present day Buffalo Creek slide).
- Ground slope is generally in excess of approximately 18-21 degrees (32%-38%) as estimated from a 20-foot pixel resolution LiDAR digital elevation model.

Figure 2. Provisional map of the Buffalo Creek debris slide area showing the active slide zone and precautionary zone and other slope movement features as of 2019/04/02. Topographic contours (20 foot contour interval) derived from a 20-foot pixel resolution LiDAR (Light Detecting And Ranging) digital elevation model. LiDAR data acquisition pre-dates recent slide movement. Approximate land parcel boundaries (white) courtesy of the Rutherford County GIS Department. Map base is 2019 unmanned aerial systems (UAS) ortho-mosaic provided by NCDOT. Data Sources: NCGS and NCDOT. **Notes:** 1. All locations and boundaries are approximate. 2. Areas of ground cracks within the active slide and precautionary zones are not shown. 3. Map unit boundaries are subject to change as slide conditions and extents may change. 4. This map is not a substitute for a map prepared by a licensed land surveyor.

Any new construction in the active slide zone is not recommended and should be done with extreme caution, and under the guidance of qualified geologists and/or engineers.

Siting new construction in the precautionary zone should be done by qualified geologists and/or geotechnical engineers.

It is recommended that foundation design in this zone should be done by a qualified geotechnical engineer.
