CCA
Water Treatment
Alternatives
Evaluation

Wells #5 & #8

March 16, 2011

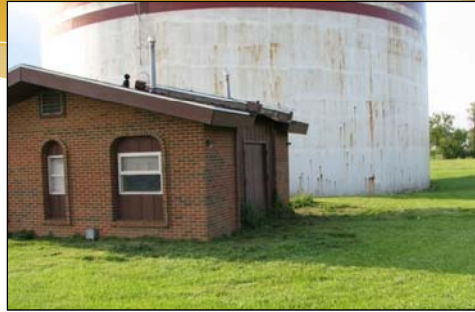
Well No. 5 Well House Building in foreground, 2.5 MG Ground Storage Tank in the background

- **Farrell Road Pump Station site**
 - Well #5 and Well House #5
 - Well #8
 - 2.5 MG Ground Storage Tank
 - Pump Station
- **Well #5**
 - Constructed in 1973
 - VFD pump rated at 600 gpm
- **Well #8**
 - Constructed in 2000
 - VFD pump rated at 400 gpm
- **Wells #5 & #8 combine and discharge into the 2.5 MG Ground Storage Tank**
- **Chlorine is added to the combined well line prior to entering the tank**

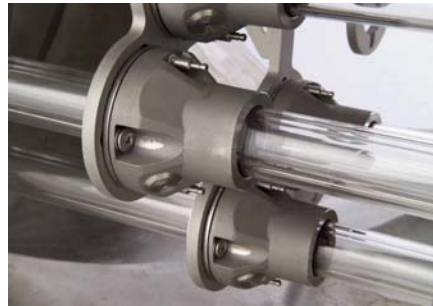
- Medium Pressure Lamps with electronic ballast
- Chemical/mechanical cleaning system

UV Disinfection lamp photo provided by Trojan UV

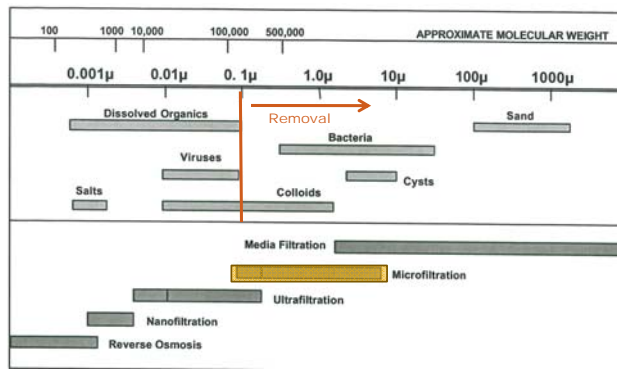
Figure 1. Membrane Process Classification

- 0.1 micron pore size
- Absolute Filtration

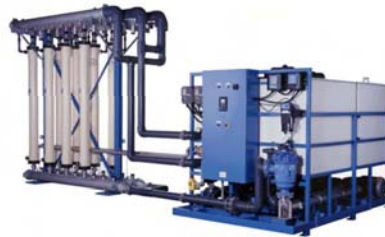
- Pressurized system consisting of hollow fiber modules mounted on a skid

Microfiltration membrane photo provided by Pall Corporation

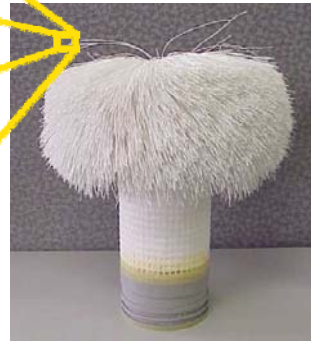
- Hollow center fiber
- Outside-in flow

Microfiltration membrane unit photo provided by Siemens

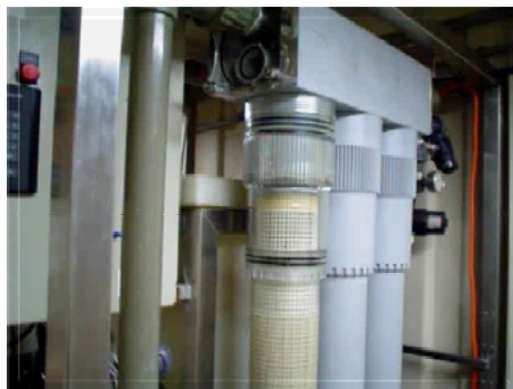
Membrane
backwash
video provided
by Siemens

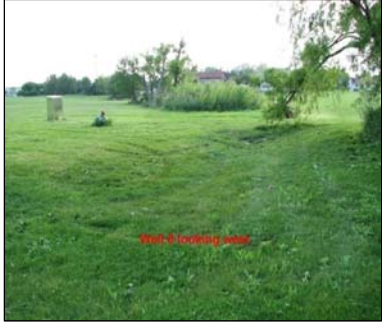
Well #8 location

The drainage ditch has a small berm obstructing the natural surface water flow north of Well #8.

- **Site Grading**
 - Finished grade should be at least 6" below tank foundation
 - Site has several areas of ponding
- **Driveway to Well #8**
 - For maintenance of well
- **Site Fencing**
 - For water system security

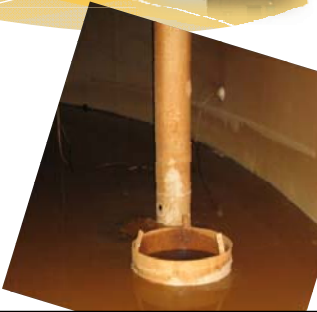
Inlet and outlet pipes inside the 2.5 MG Ground Storage Tank

- **Tank Recoating**
 - Tank inspection performed 2-3 years ago
 - Including tank inlet piping modifications
- **Well #5/Well House #5 Upgrade**
 - Building replacement
 - Well motor replacement with variable frequency drive
 - Electrical upgrade
- **Standby Generator**
 - To have fire protection upon loss of power
