The College Street Corridor

Intersection of College Street and North Street

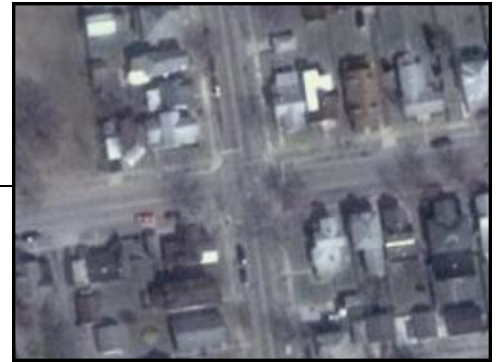
Aerial Photo:

The intersection of College Street with North Street is signal controlled and has four approaches intersecting at a 90-degree angle. There is a single lane on each approach. The intersection is located in a residential area. The pretimed signal has a 70-second cycle length with two phases. Parking restrictions vary near the intersection and are provided in detail on the existing conditions diagram. Shrubbery in the southwest corner partially obstructs sight distance at the intersection. The primary concern at this intersection is the warrant status of the existing traffic signal. This signal may have been installed initially to control traffic and pedestrian crossings associated with a school that used to be located near this intersection.

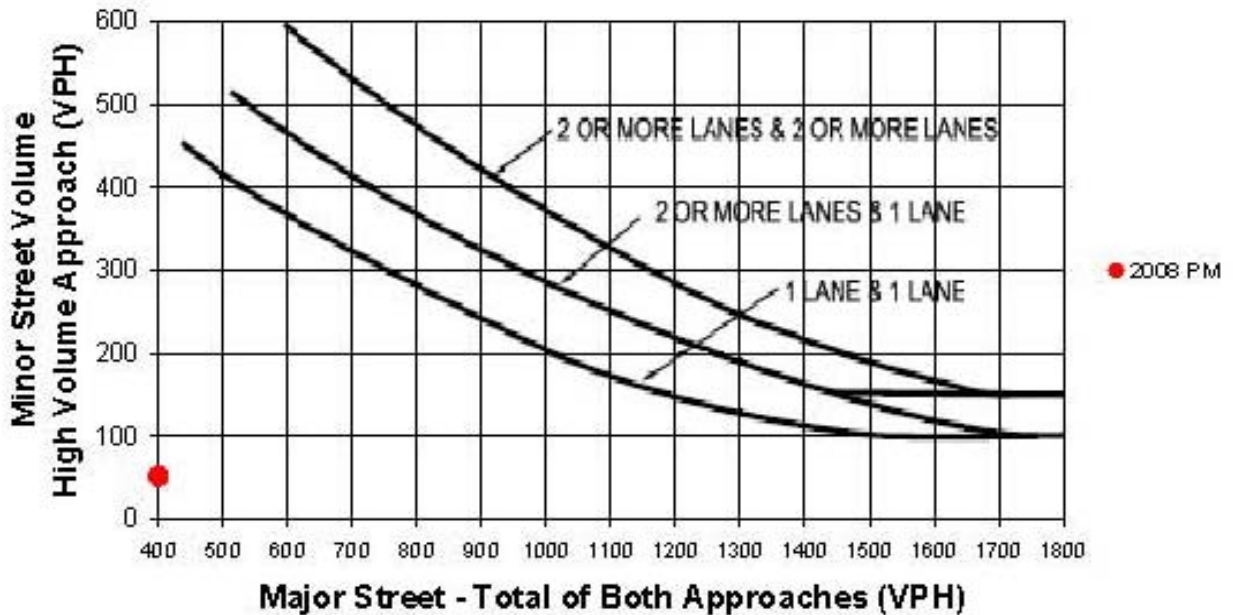
Warrant 3, Peak Hour

The counted PM peak hour volumes were plotted on the Warrant 3 Table (attached). The plotted point is below the warrant threshold line for “1 lane & 1 lane”.

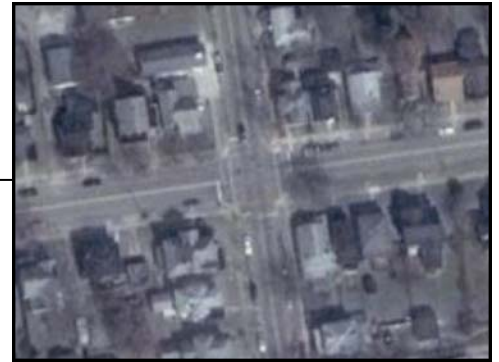
Aerial Photo:

The intersection of College Street with Greene Street is signal controlled and has four approaches intersecting at a 90-degree angle. There is a single lane on each approach. The intersection is located in a residential area. The pretimed signal has a 70-second cycle length with two phases. Parking restrictions vary near the intersection and are provided in detail on the existing conditions diagram. Shrubbery in the northeast corner partially obstructs sight distance at the intersection. The primary concern at this intersection is the warrant status of the existing traffic signal. This signal may have been installed initially to control traffic and pedestrian crossings associated with a school that used to be located near this intersection.

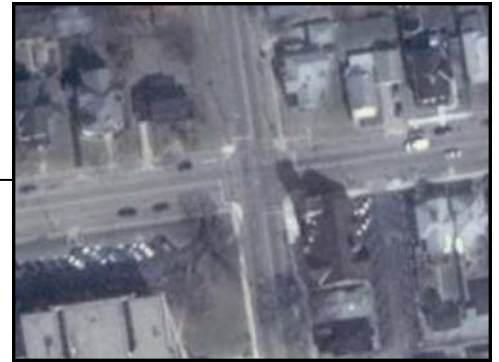
Aerial Photo:

The intersection of College Street with Ash Street is signal controlled and has four approaches intersecting at a 90-degree angle. There is a single lane on each approach. The intersection is located in a residential area. The pretimed signal has a 70-second cycle length with two phases. Parking restrictions vary near the intersection and are provided in detail on the existing conditions diagram. Church building on southeast corner restricts visibility due to its close proximity to the intersection. The primary concern at this intersection is the warrant status of the existing traffic signal. This signal may have been installed initially to control traffic and pedestrian crossings associated with a school that used to be located near this intersection.

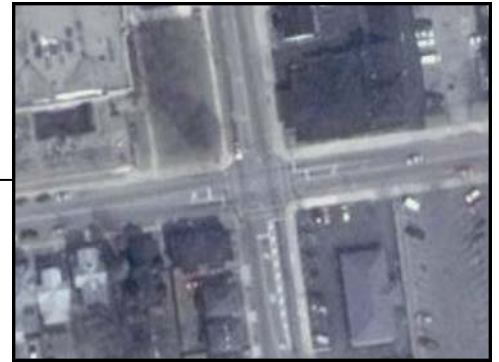
Aerial Photo:

The intersection of High Street with College Street has four approaches intersecting at a 90-degree angle and is currently signal controlled. Each approach has two lanes - one left-turn only lane and one through-right shared lane. The pretimed signal has a 70-second cycle length with four phases: (1) an 11-second east-west protected left turn phase, (2) a 24-second east-west permitted phase, (3) an 11-second north-south protected left-turn phase, and (4) a 24-second north-south permitted phase. Parking restrictions vary near the intersection and are provided in detail on the existing conditions diagram. The traffic signals along College Street between Water Street and North Street are currently time-base coordinated. The primary concern at this intersection is with the timing and/or operation of the existing traffic signal and whether the signal should be coordinated with adjacent traffic signals.

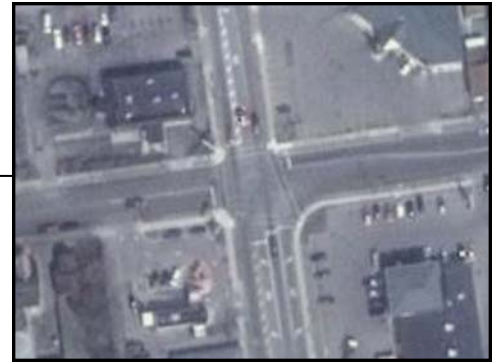
Aerial Photo:

The intersection of College Street with Water Street has four approaches intersecting at a 90-degree angle and is currently signal controlled. The eastbound and westbound approaches of Water Street are single lane approaches. The northbound approach of College Street has three lanes - one left-turn only lane, one through only lane, and one right-turn only lane. The southbound approach of College Street has two lanes - one left turn only lane and one through-right shared lane. The south and east legs of this intersection are designated as US Route 36. The pretimed signal has a 70-second cycle length with two phases. Parking restrictions vary near the intersection and are provided in detail on the existing conditions diagram. The traffic signals along College Street between Water Street and North Street are currently time-base coordinated. The primary concern at this intersection is with the timing and/or operation of the existing traffic signal and whether the signal should be coordinated with adjacent traffic signals.
