# The Greene Street Corridor

- Intersection of Greene Street and Downing Street
- Intersection of Greene Street and Wayne Street
- Intersection of Greene Street and Main Street

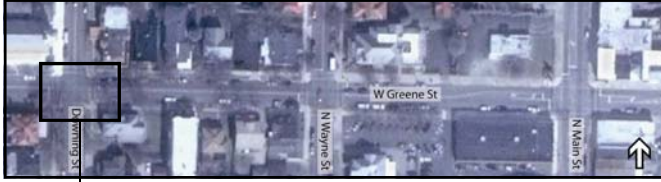
**Aerial Photo:**

The intersection of Greene Street with Downing Street is signal controlled and has four approaches intersecting at a 90-degree angle. There is a single lane on each approach. The intersection is located in a residential area. The pretimed signal has a 70-second cycle length with two phases. Parking restrictions vary near the intersection and are provided in detail on the existing conditions diagram. Vegetation, fencing, and a portion of a building partially obstruct sight distance at the intersection. The primary concern at this intersection is the warrant status of the existing traffic signal. This signal may have been installed initially due to its proximity to the central business district and may have been warranted when it was installed.

It is recommended that consideration be given to the removal of the traffic signal at this intersection. Based on the relatively balanced traffic volumes on the intersection approaches, four-way stop control is recommended. Also, curb bump-outs should be considered to provide adequate locations for stop sign visibility. Four-way stop control is consistent with the surrounding development and with traffic control at similar adjacent intersections.

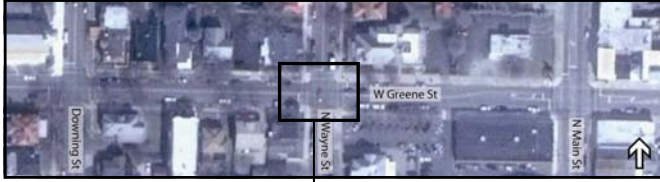
**Aerial Photo:**

The intersection of Greene Street with Wayne Street is signal controlled and has four approaches intersecting at a 90-degree angle. There is a single lane on each approach. The intersection is located in a residential area. The pretimed signal has a 70-second cycle length with two phases. Parking restrictions vary near the intersection and are provided in detail on the existing conditions diagram. A building on the southwest corner of the intersection restricts sight distance. The primary concern at this intersection is the warrant status of the existing traffic signal. This signal may have been installed initially due to its proximity to the central business district and may have been warranted when it was installed.

It is recommended that consideration be given to the removal of the traffic signal at this intersection. Based on the relatively balanced traffic volumes on the intersection approaches, four-way stop control is recommended. Also, curb bump-outs should be considered to provide adequate locations for stop sign visibility. Four-way stop control is consistent with the surrounding development and with traffic control at similar adjacent intersections.

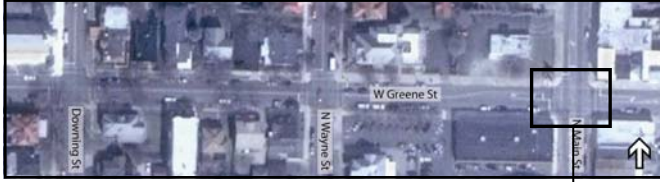
**Aerial Photo:**

The intersection of Greene Street with Main Street has four approaches intersecting at a 90-degree angle and is currently signal controlled. Each approach has two lanes - one left-turn only lane and one through-right shared lane. The pretimed signal has a 70-second cycle length with two phases. Parking restrictions vary near the intersection and are provided in detail on the existing conditions diagram. This intersection is located in the central business district. The primary concerns at this intersection are whether or not the existing traffic signal is warranted, to determine if there is an appropriate balance between the use of turn lanes and on-street parking in the area of this intersection, and to determine if the on-street parking layout interferes with the operation of the intersection. This traffic signal was likely installed initially due to its location in the central business district.

Due to the potential for future growth in traffic volumes and the intersection's location in the central business district, it is recommended that the traffic signal be retained. If additional on-street parking is desired along Greene Street, the left turn lanes on Greene Street may be removed to obtain the necessary road width. It is recommended that the left turn lanes on Main Street be retained to accommodate vehicles that would otherwise turn left at the intersection of Main Street and Ash Street, where left turns are currently prohibited.

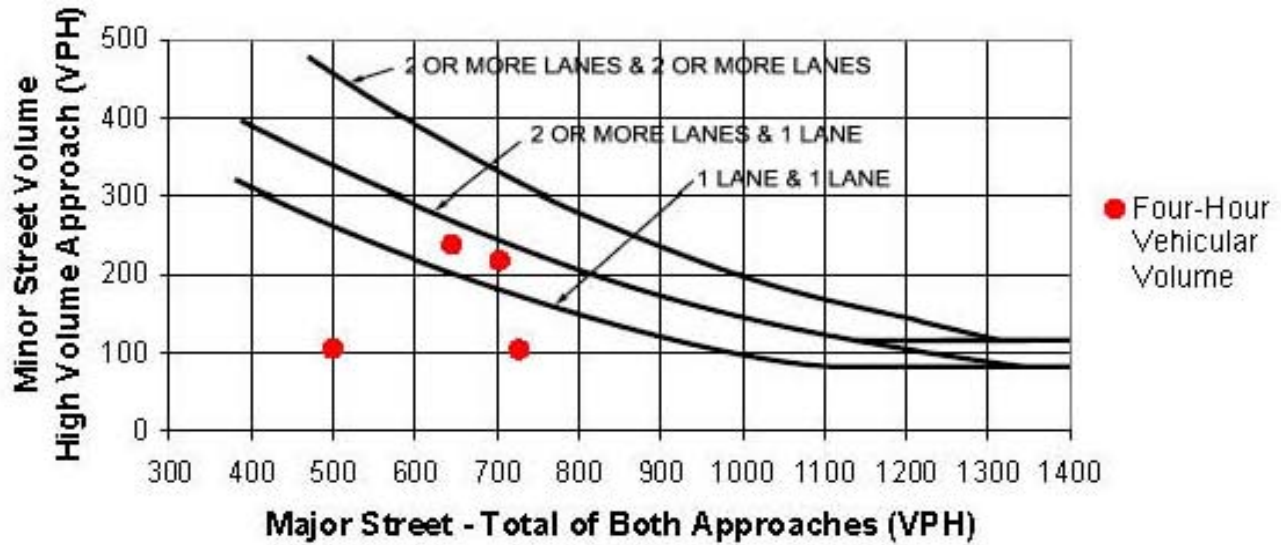
Warrant 2, Four-Hour Vehicular Volume

Counted volumes from the four hours with the highest counted volumes were plotted on the Warrant 2 Table (attached). Two of the four plotted points are above the warrant threshold line for “1 lane & 1 lane”.
