# The SR 185 Corridor

- Intersection of Park Avenue and College Street/Nicklin Avenue
- Intersection of Park Avenue and Broadway Street
- Intersection of Broadway Street and North Street
- Intersection of Ash Street and Broadway Street
- Intersection of Ash Street and Downing Street
- Intersection of Ash Street and Main Street

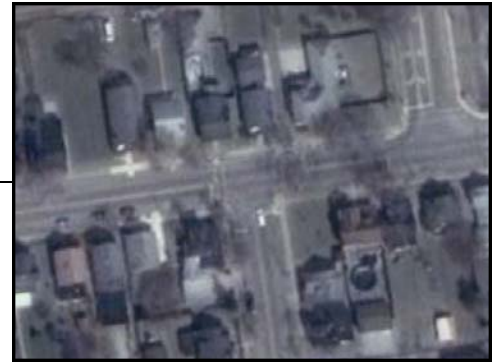
**Aerial Photo:**

The intersection of Park Avenue with College Street and Nicklin Avenue is a combination of two signalized “tee” type intersections controlled by one traffic signal controller. Nicklin Avenue is the north leg of the intersection and is located approximately 190 feet east of College Street, which is the south leg of the intersection. Each approach has a single lane. The actuated signal has a 70-second cycle length and has left turn signals on the westbound approach of Park Avenue at College Street and on the eastbound approach of Park Avenue at Nicklin Avenue. Parking restrictions vary near the intersection and are provided in detail on the existing conditions diagram. The Nicklin Learning Center is located just north of this intersection. The primary concern at this intersection is the warrant status of the existing traffic signal. This signal may have been installed initially due to its location between a school and a residential area and likely provided for school traffic capacity and pedestrian crossings.

Due to the proximity of this intersection to the Nicklin Learning Center, the number of pedestrians observed during school times, and the unusual intersection configuration, it is recommended that this traffic signal be retained.

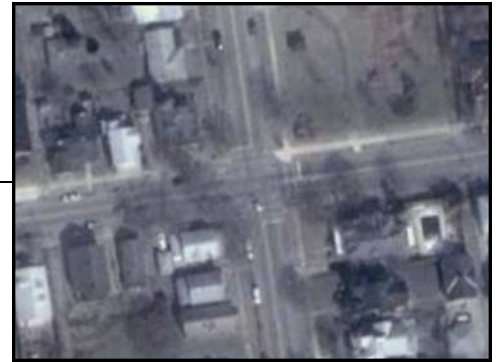
**Aerial Photo:**

The intersection of Park Avenue with Broadway Street is signal controlled and has four approaches intersecting at a 90-degree angle. There is a single lane on each approach. The intersection is located in a residential area. Ann Mira Das Park is located in the northeast corner of the intersection. The pretimed signal has a 70-second cycle length with two phases. Parking restrictions vary near the intersection and are provided in detail on the existing conditions diagram. The west and south legs of the intersection are designated as SR 185. The primary concern at this intersection is the warrant status of the existing traffic signal. This signal may have been installed initially due to its location on the State Route.

Due to the fact that SR 185 is routed through this intersection and that the existing traffic signals at the Broadway Street intersections with North Street and Ash Street are recommended to remain in operation, it is recommended that the traffic signal at this intersection remain in operation as well. Keeping this traffic signal in operation will provide consistency in the traffic control along Broadway Street. However, in order to reduce unnecessary stopping and delays, particularly for motorists on Park Avenue, it is recommended that the traffic signal be converted to actuated operation with pedestrian pushbuttons and pedestrian signal indications. The signal should rest in green on the Park Avenue phase.

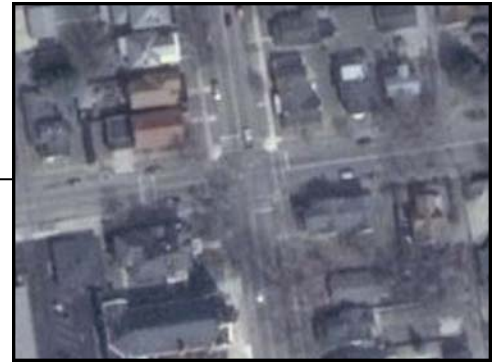
**Aerial Photo:**

The intersection of Broadway Street with North Street is signal controlled and has four approaches intersecting at a 90-degree angle. There is a single lane on each approach. The intersection is located in a residential area. The pretimed signal has a 70-second cycle length with two phases. Parking restrictions vary near the intersection and are provided in detail on the existing conditions diagram. Broadway Street is designated as SR 185 through this intersection. Piqua Catholic School is located just west of this intersection. A number of pedestrians were observed crossing the roadway at this intersection during school arrival and dismissal periods. The primary concern at this intersection is the warrant status of the existing traffic signal. This signal may have been installed initially due to its location on the State Route.

Due to the pedestrian crossings observed at this intersection during the school arrival and dismissal periods, it is recommended that the traffic signal at this intersection be retained. However, in order to reduce unnecessary stopping and delays, particularly for motorists on Broadway Street, it is recommended that the traffic signal be converted to actuated operation with pedestrian pushbuttons and pedestrian signal indications. The signal should rest in green on the Broadway Street phase.

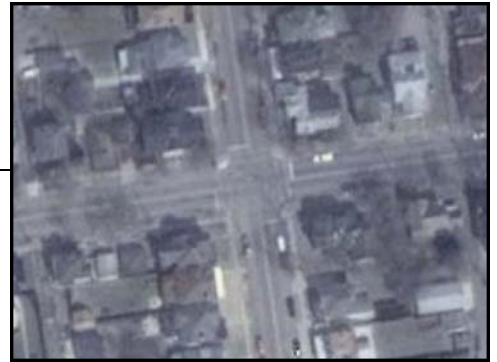
**Aerial Photo:**

The intersection of Ash Street with Broadway Street is signal controlled and has four approaches intersecting at a 90-degree angle. There is a single lane on each approach. The intersection is located in a residential area. The pretimed signal has a 60-second cycle length with two phases. Parking restrictions vary near the intersection and are provided in detail on the existing conditions diagram. The north and east legs of the intersection are designated as SR 185. Shrubbery in the southwest corner and part of a home and a tree in the northeast corner partially restrict visibility at the intersection. The primary concern at this intersection is the warrant status of the existing traffic signal. This signal may have been installed initially due to its location on the State Route.

Due to the fact that SR 185 is routed through this intersection and that this intersection is conveniently located for motorists that want to divert from Ash Street to High Street and vice-versa, it is recommended that the traffic signal at this intersection remain in operation. However, in order to reduce unnecessary stopping and delays, particularly for motorists on Broadway Street, it is recommended that the traffic signal be converted to actuated operation with pedestrian pushbuttons and pedestrian signal indications. The signal should rest in green on the Ash Street phase.

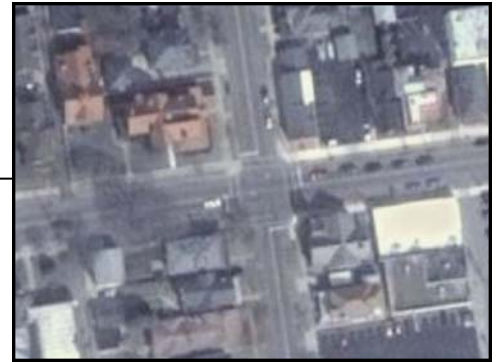
**Aerial Photo:**

The intersection of Ash Street with Downing Street is signal controlled and has four approaches intersecting at a 90-degree angle. There is a single lane on each approach. The intersection is located in a residential area. The pretimed signal has a 70-second cycle length with two phases. Parking restrictions vary near the intersection and are provided in detail on the existing conditions diagram. Ash Street is designated as SR 185 through this intersection. A church building on the southeast corner of the intersection partially restricts sight distance at the intersection; however, visibility is adequate if motorists stop beyond the stop bar closer to the intersection. The primary concerns at this intersection are the warrant status of the existing traffic signal as well as the timing and/or operation of the existing traffic signal and whether the signal should be coordinated with adjacent traffic signals. This signal may have been installed initially due to its location on the State Route and its proximity to the central business district.

It is recommended that consideration be given to the removal of the traffic signal at this intersection. Based on the traffic volumes entering the intersection on each roadway, two-way stop control with stop signs on Downing Street is recommended. Also, curb bump-outs should be considered to provide adequate locations for stop sign visibility. These modifications could be performed in conjunction with the potential future re-routing of SR 185.

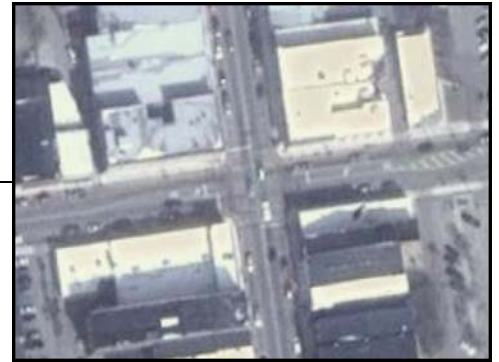
**Aerial Photo:**

The intersection of Ash Street with Main Street has four approaches intersecting at a 90-degree angle and is currently signal controlled. The Ash Street approaches each have two lanes - one left-turn only lane and one through-right shared lane. Both directions of Main Street have single lane approaches. Left-turns from Main Street are prohibited at this intersection. The actuated signal has a 70-second cycle length with two phases. Parking restrictions vary near the intersection and are provided in detail on the existing conditions diagram. Ash Street is designated as SR 185 through this intersection. This intersection is located in the central business district. The primary concerns at this intersection are whether or not the existing traffic signal is warranted, to determine if there is an appropriate balance between the use of turn lanes and on-street parking in the area of this intersection, and to determine if the on-street parking layout interferes with the operation of the intersection. This traffic signal was likely installed initially due to its location in the central business district.

Due to the potential for future growth in traffic volumes, the fact that Signal Warrant 8 is met, and the intersection's location along SR 185 in the central business district, it is recommended that the traffic signal and the existing lane configuration be retained.
