### 4.8. Lake Hartridge

### Water Quality Restoration Project Selection and Priorities

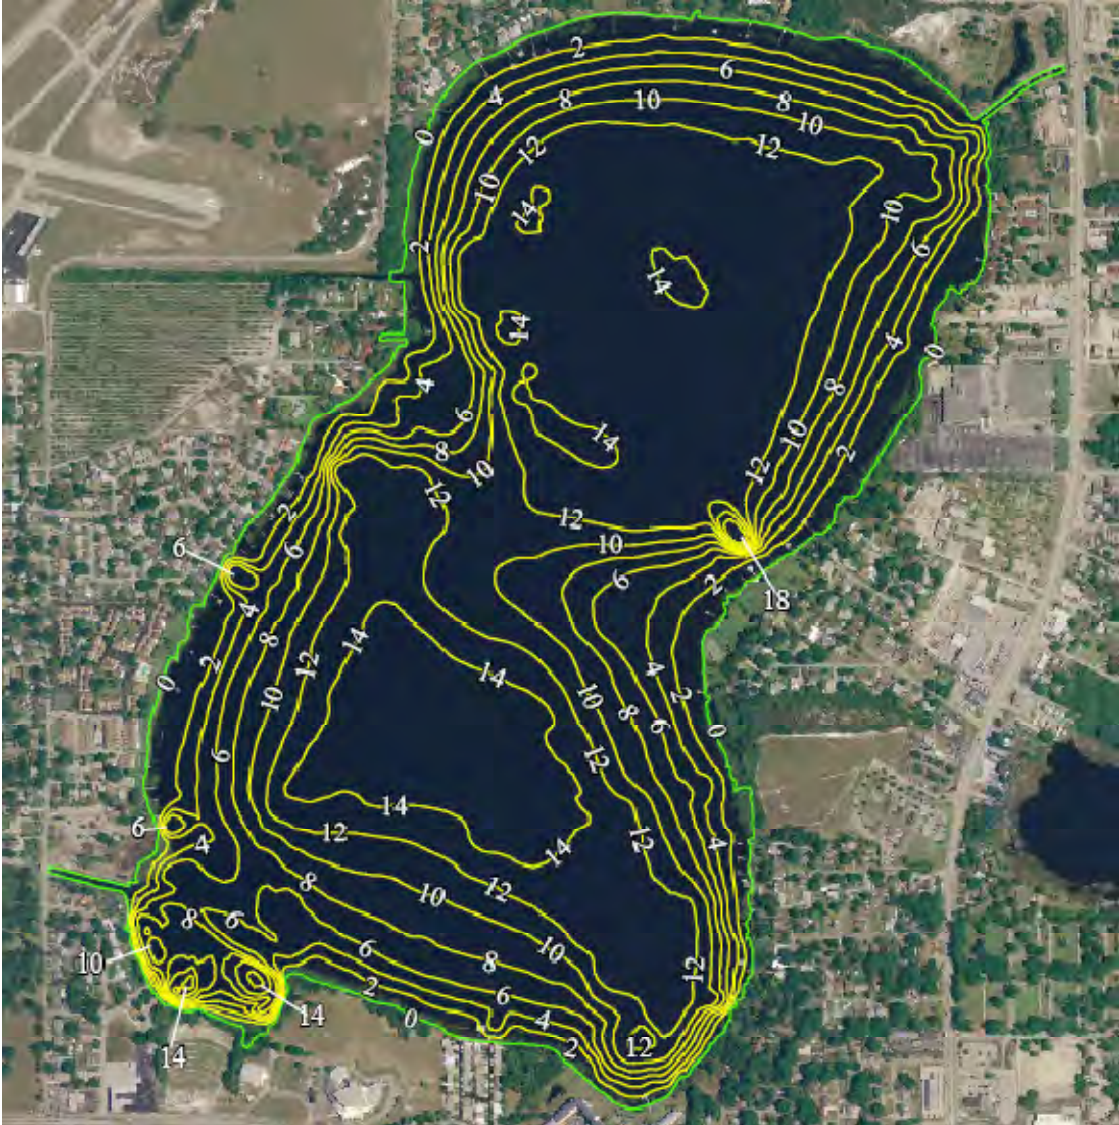
Figure 4-32. Lake Hartridge bathymetry (October 2006) at water level elevation = 131 feet (Polk County Water Atlas).

The 1997-2007 median secchi depth for Lake Hartridge was 3.3 feet indicating that SAV plants should not be planted in water depths greater than 4 feet. The maximum planting effort could result in vegetation cover of approximately 18 percent of the lake bottom (83 acres).
