RE: Lake Lure Hydro Project  
Rutherford County  
Project Number 92-0499

# DAM SAFETY INSPECTION REPORT

| NAME<br><b>LAKE LUKE DAM</b> | | COUNTY<br><b>Rutherford</b> | NO.<br><b>003</b> | INSPECTED BY<br><b>JCA</b> | DATE<br><b>4/9/91</b> |

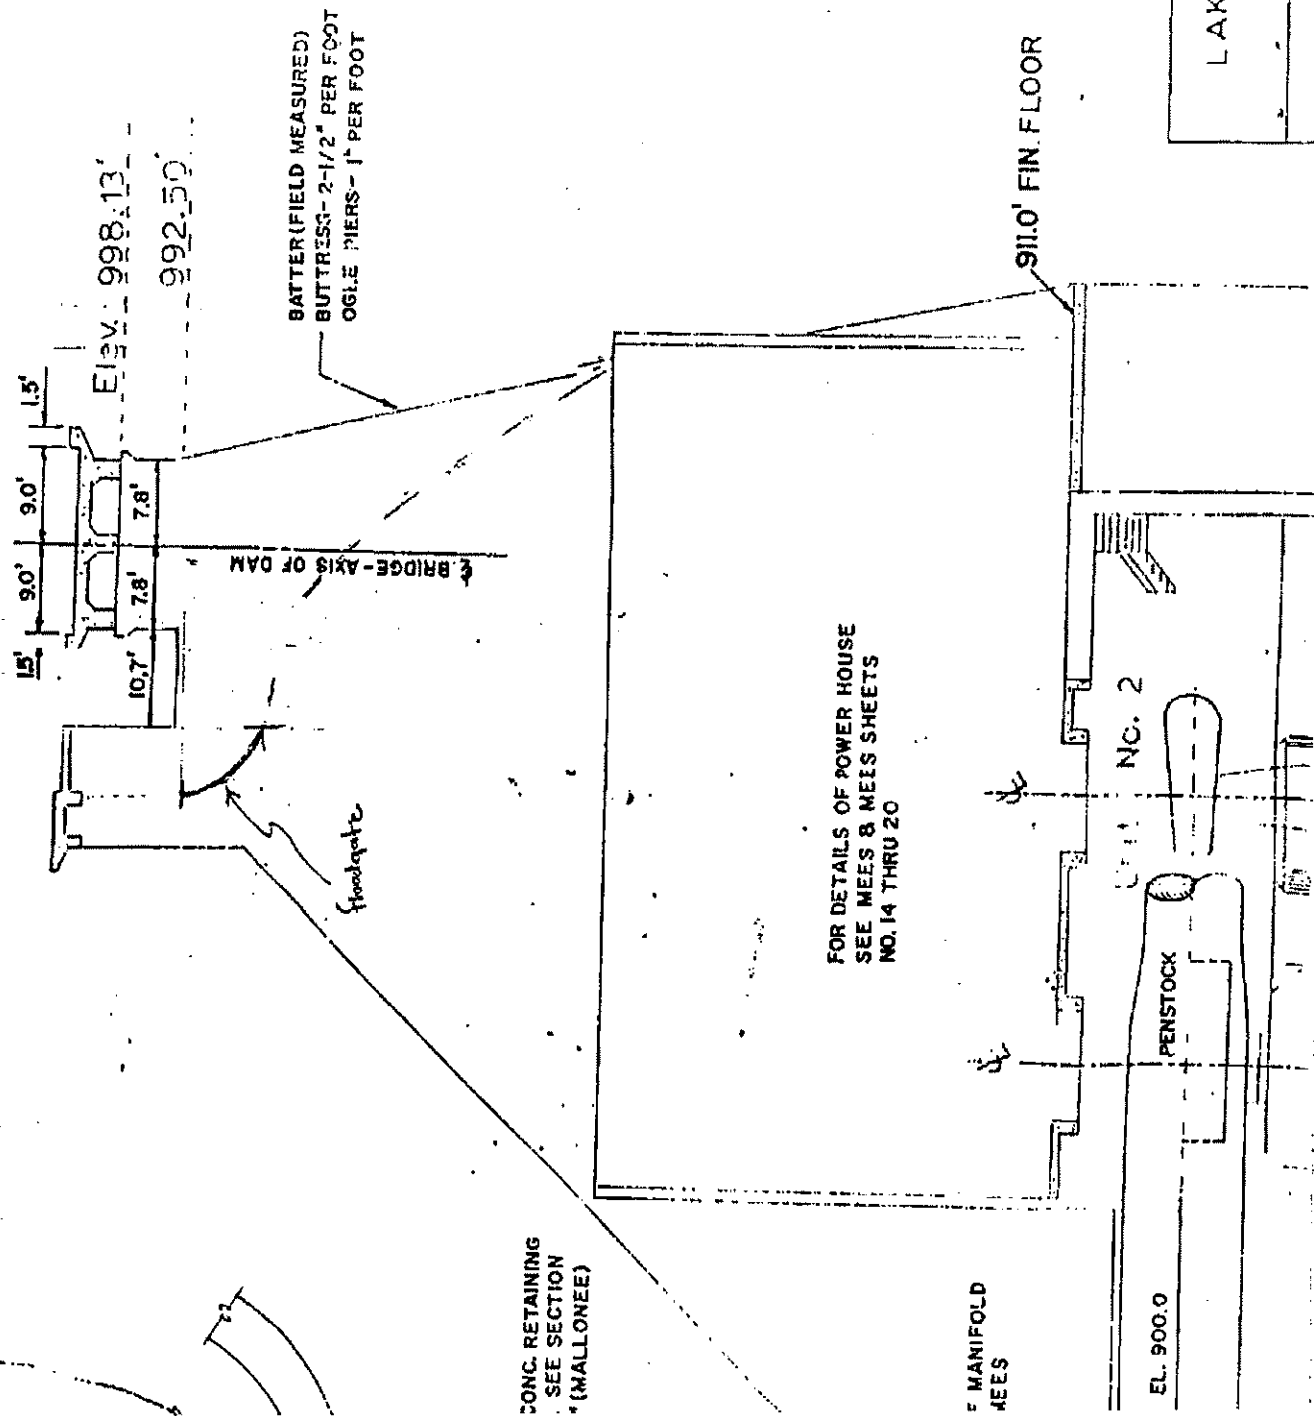
# REAR SIDE OF DAM.

| NAME<br><b>Lake Lure Dam</b> | | COUNTY<br><b>Rutherford</b> | NO.<br><b>003</b> | INSPECTED BY<br><b>Larry Adair</b> | DATE<br><b>02-13-89</b> |
|---|---|---|---|---|---|
| DOWNSTREAM SLOPE / FACE | <input checked="" type="checkbox"/> 1. None <input type="checkbox"/> 11. Seepage<br><input type="checkbox"/> 2. Trees <input type="checkbox"/> 12. Bolls<br><input type="checkbox"/> 3. High bushes <input type="checkbox"/> 13. Cracks<br><input type="checkbox"/> 4. Burrows <input type="checkbox"/> 14. Holes<br><input type="checkbox"/> 5. Erosion <input type="checkbox"/> 15. Spalling<br><input type="checkbox"/> 6. Livestock damage <input type="checkbox"/> 16. Displaced joints<br><input type="checkbox"/> 7. Slides <input type="checkbox"/> 17. Deteriorated joints<br><input type="checkbox"/> 8. Depressions <input type="checkbox"/> 18. Exposed reinforcement<br><input type="checkbox"/> 9. Bulges <input type="checkbox"/> 19. Other<br><input type="checkbox"/> 10. Wetness | | COVER: <input checked="" type="checkbox"/> Vegetation <input type="checkbox"/> Rip rap <input checked="" type="checkbox"/> Concrete <input type="checkbox"/> Other<br><br><b>KUDZU IS PRESENT ON THE <del>ROCK</del> ABUTMENTS.</b><br><b>SPALLING OF CONCRETE IS PRESENT ON THE (E. DETERIORATION) BACKSLOPE OF THE DAM.</b> | | |
