## Town of Waynesville, NC

##### 4. McGill and Associates Engineering Report for the Waste Water Treatment Plant

# Table of Contents

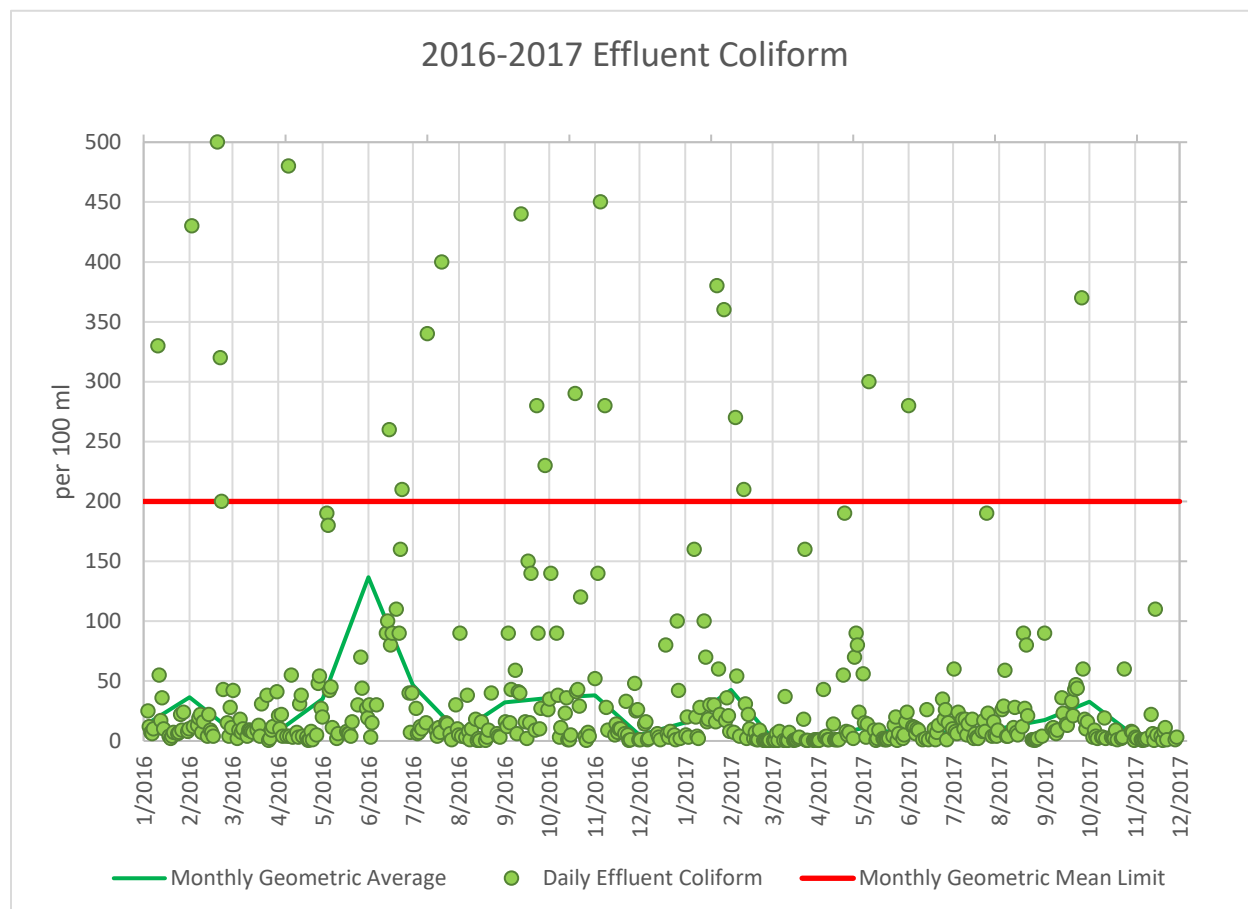
Figure 4. Effluent Coliform Counts

Individual daily fecal coliform counts exceeded the 200/100 ml monthly average discharge limit on 10.3% of the days on which effluent values were measured, and exceeded the 400/100 ml weekly geometric mean discharge limit on 6.8% of days.

Effluent fecal coliform count varies greatly, ranging from a maximum of 9,400/100 ml in November of 2016 to a minimum below the detection limit.

The single coliform violation, which occurred in one week of June 2016, was for a weekly geometric mean coliform count of 838/100 ml, over two times the weekly limit of 400/100 ml. The Town's investigations of its larger customers and industrial users led Town staff to conclude that the event was likely due to end of year cleaning at local schools, where unknown cleaning chemicals were discharged to the collection system.

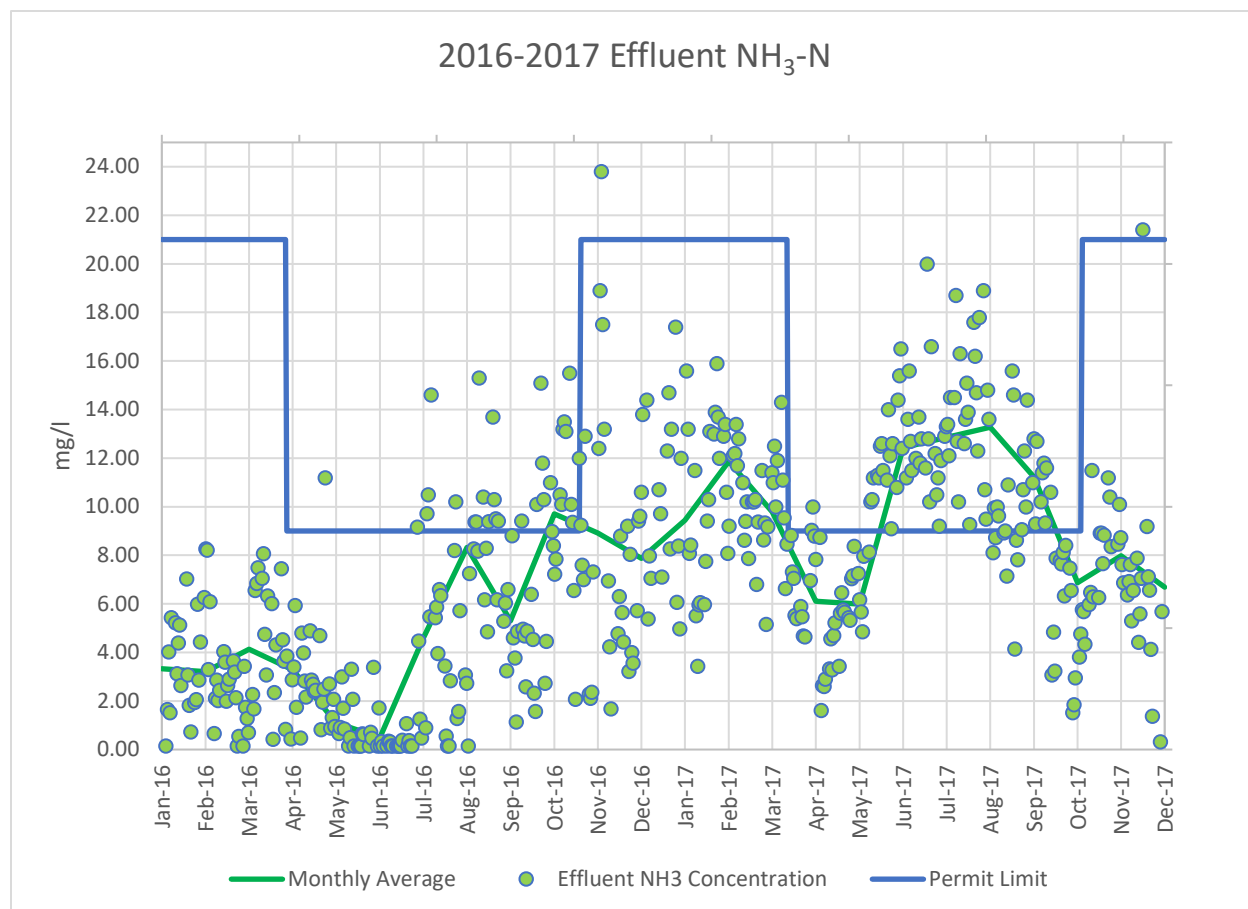
Figure 5. Effluent NH<sub>3</sub>-N Concentrations

Individual daily effluent ammonia values exceeded the discharge limit on 23.9% of the days for which effluent values were measured, which roughly corresponds to the monthly permit violations shown, where the monthly average exceeded the permit limit 5 out of 24 months, or 21% of the time.

Effluent ammonia concentration varies greatly within individual months, ranging from a maximum of 28.2 mg/L in August 2016 to a minimum of 0.15 mg/L observed in several months, including August 2016.

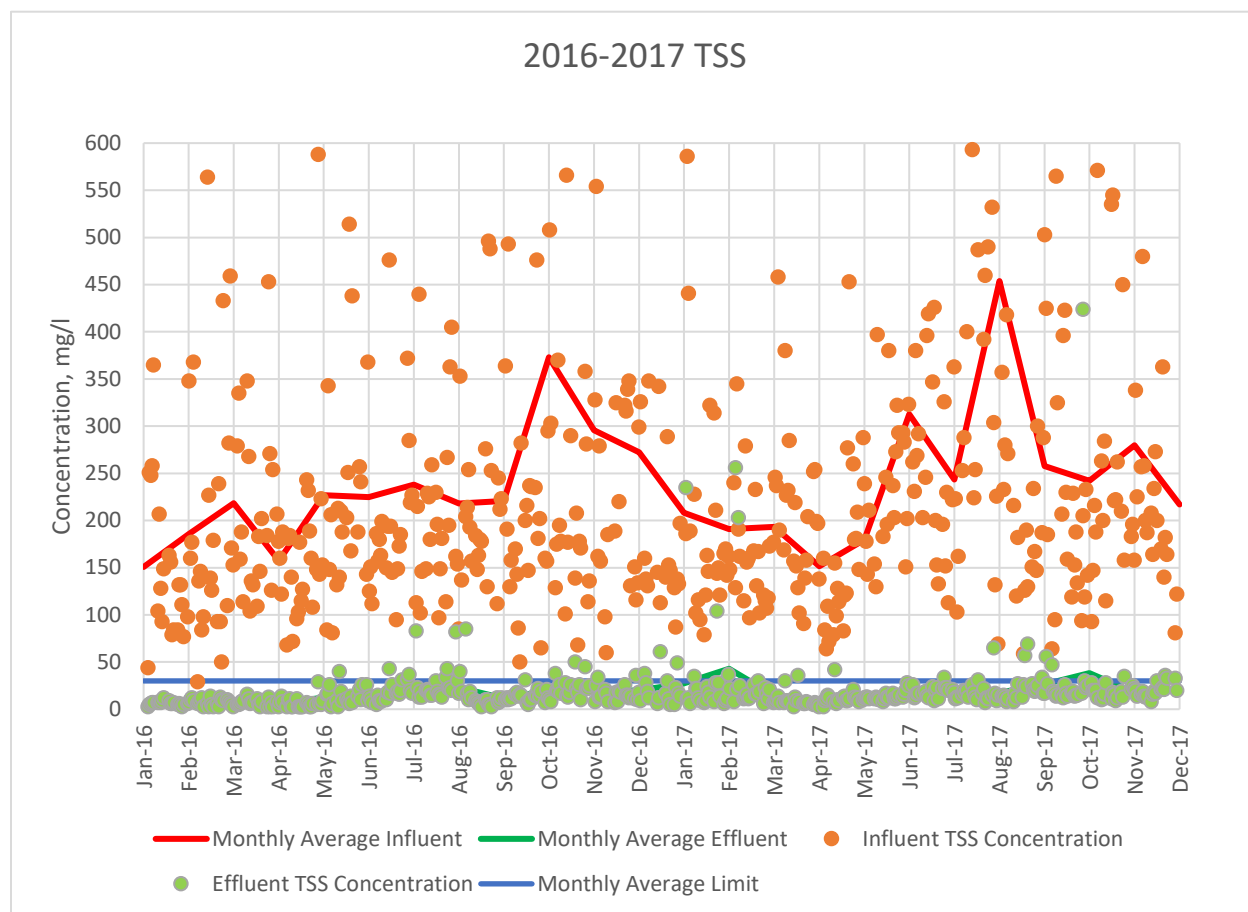
Figure 7. Total Suspended Solids Concentration

Individual daily effluent TSS values exceeded the 30 mg/l monthly average discharge limit on 8.2% of the days on which effluent values were measured, and exceeded the 45 mg/l weekly average discharge limit on 3.2% of days. The plant has had ten effluent TSS concentration violations in the last two years.

Effluent TSS concentration varies greatly over the period of record, ranging from a maximum of 424 mg/l in October 2017 to a minimum below the detection limit.

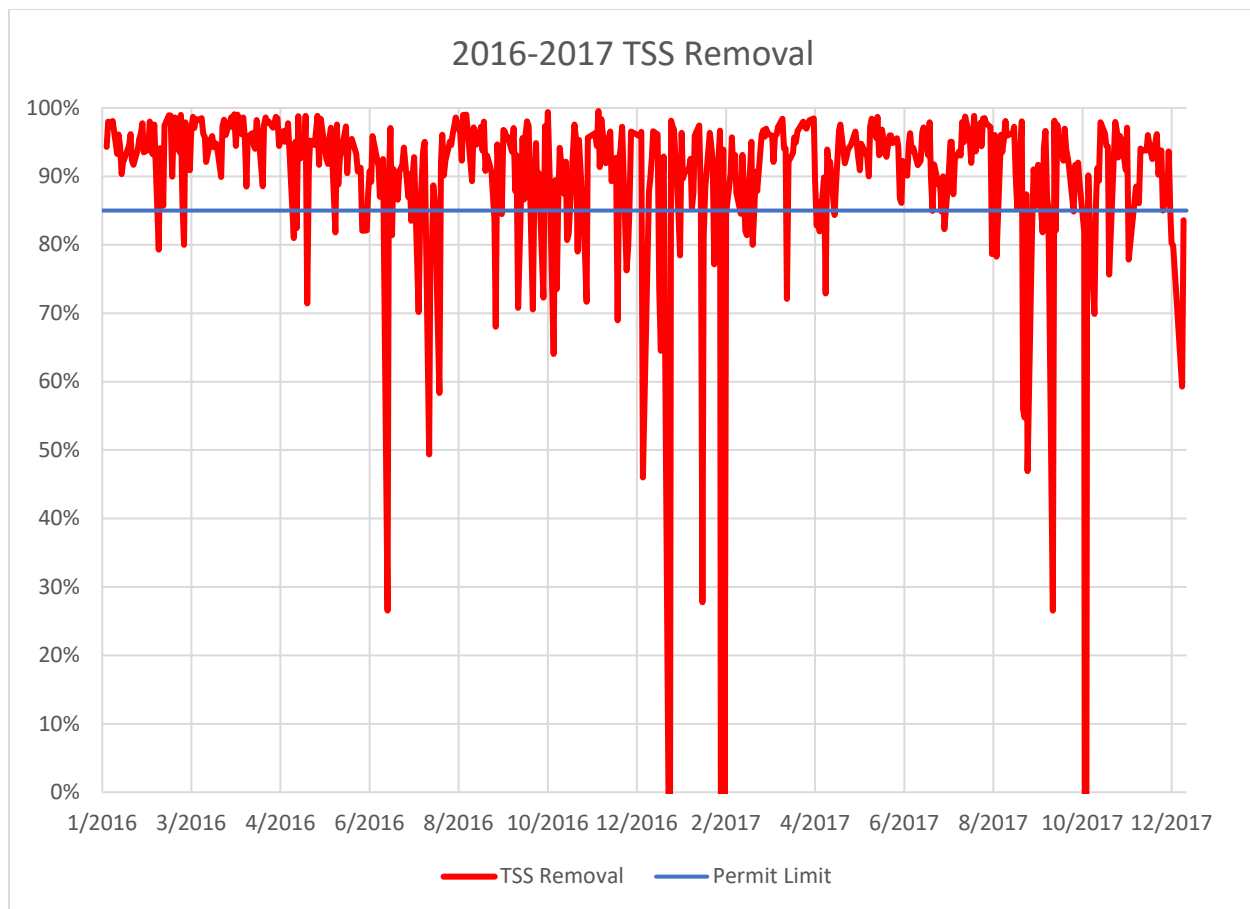
Figure 8. Total Suspended Solids Removal

In addition to the TSS concentration limit, the WWTP's NPDES permit states that the monthly average effluent TSS concentration may not exceed 15% of the influent value, i.e., the treatment process must remove 85% of influent TSS. TSS removal at the plant averages almost 90%, with removal dropping below 85% on 15.7% of days during the period of analysis. There are no documented violations for TSS removal in the past two years.

Previous studies have identified effluent TSS concentrations as problem for the WWTP, and have attributed this problem to design deficiencies in the secondary clarifiers. The secondary clarifiers are only 8 feet deep when design guidelines from various sources suggest that minimum secondary clarifier depth should be 12 feet regardless of flow. The secondary clarifiers also have effluent weirs that are shorter than recommended to handle peak hourly flows. The 2007 McGill Associates report also noted that while effluent from the secondary clarifiers was not tested, the presence of settled sludge in the chlorine contact basin downstream of the secondary clarifiers provided another data point in favor of inadequate performance in the secondary clarifiers.

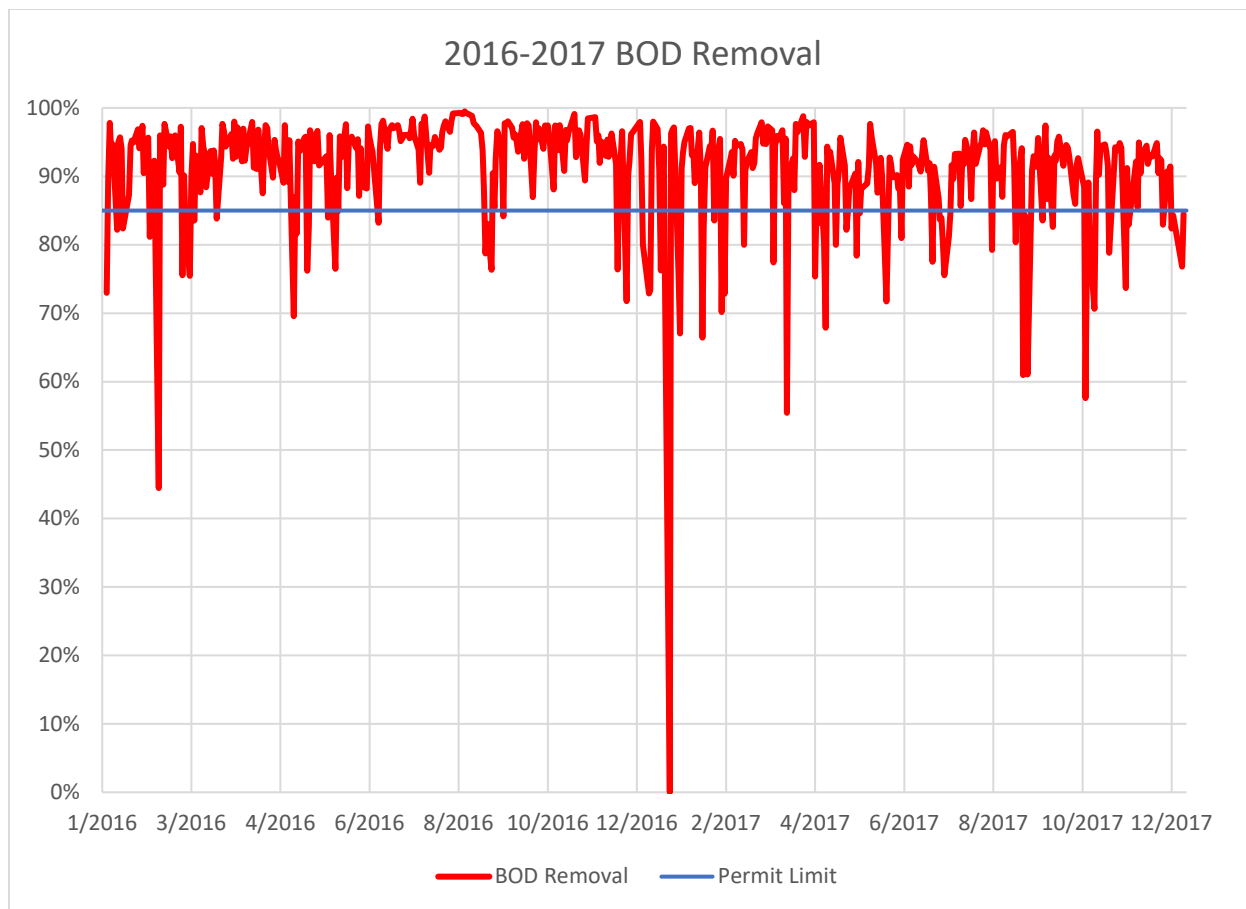
Figure 10. Biochemical Oxygen Demand Removal

Daily BOD removal values were less than the 85% removal target on 15.7% of days. Insufficient BOD removal was discussed in the previous 2007 McGill Associates report as a subject of concern, and it was suggested that the difficulty may be due to low influent values, and may be ameliorated with a reduction in I/I, which would result in wastewater with higher BOD concentrations. During the assessment period from 2016-2017 this does not appear to have been the case. Influent BOD concentrations on days when the plant achieved at least 85% BOD removal averaged 164 mg/l, while concentrations on days the plant could not achieve 85% removal averaged 123 mg/l. Under both conditions it would be possible for the plant to meet its effluent concentration limit of 30 mg/l while still removing less than 85% of influent BOD.

Despite this occasional difficulty in meeting treatment goals, the plant did not exceed its permit limits during the two year period for which data were obtained.

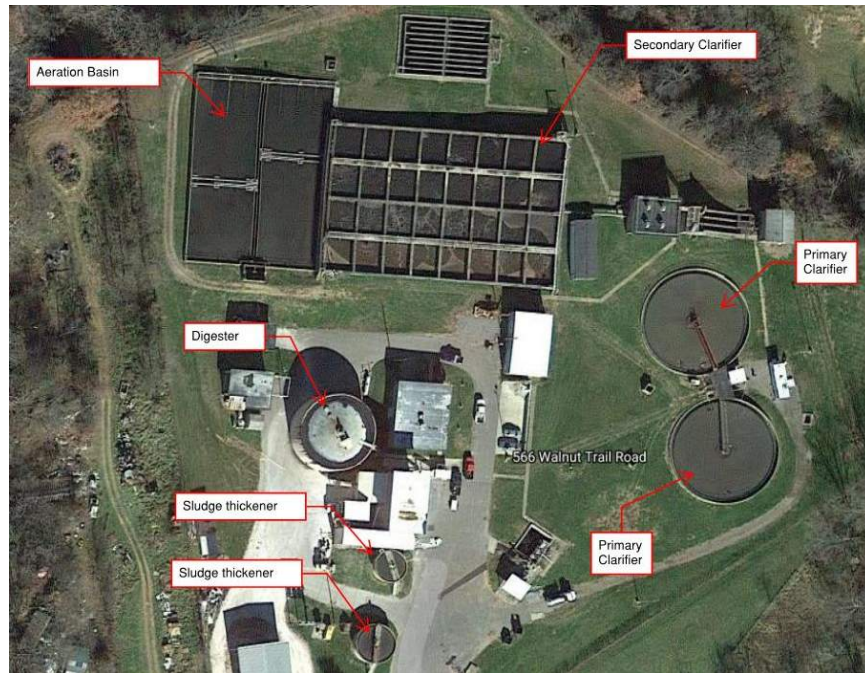
*Figure 1. Waynesville wastewater treatment plant.*
