# **Attachment 16**

## **State Emergency Management Agency Seismic Report**

# PROJECTED EARTHQUAKE INTENSITIES

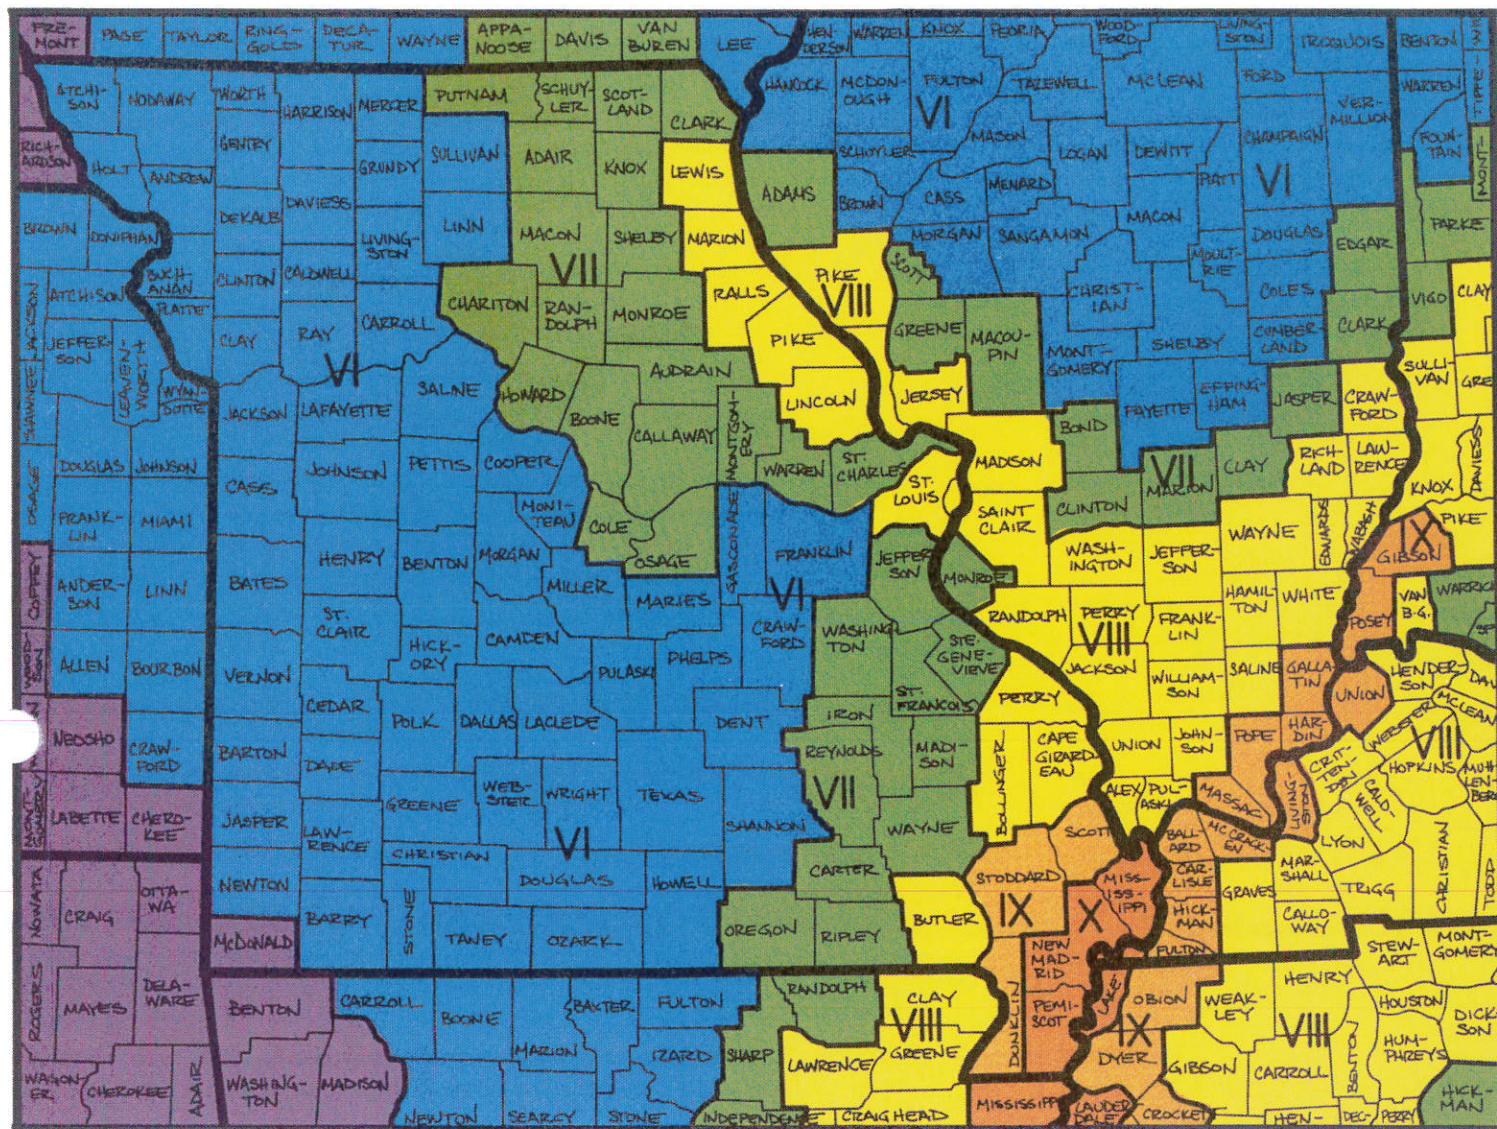
This map shows the highest projected Modified Mercalli intensities by county from a potential magnitude - 7.6 earthquake whose epicenter could be anywhere along the length of the New Madrid seismic zone.

Intensity is a numerical index describing the effects of an earthquake on the surface of the Earth, on man, and on structures built by man. The intensities shown in these maps are the highest likely under the most adverse geologic conditions. There will actually be a range in intensities within any small area such as a town or county, with the highest intensity generally occurring at only a few sites. Earthquakes of all three magnitudes represented in these maps occurred during the 1811 - 1812 "New Madrid earthquakes." The isoseismal patterns shown here, however, were simulated based on actual patterns of somewhat smaller but damaging earthquakes that occurred in the New Madrid seismic zone in 1843 and 1895.

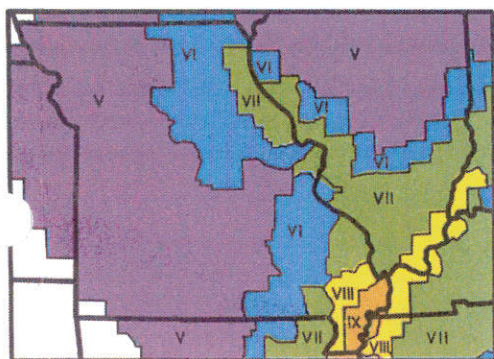
This map shows the highest projected Modified Mercalli intensities by county from a potential magnitude - 6.7 earthquake whose epicenter could be anywhere along the length of the New Madrid seismic zone.

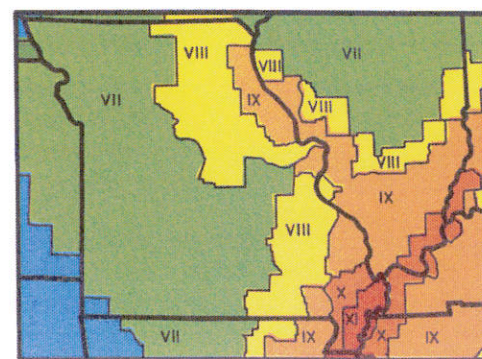
This map shows the highest projected Modified Mercalli intensities by county from a potential magnitude - 8.6 earthquake whose epicenter could be anywhere along the length of the New Madrid seismic zone.
